Upgrade, IST and Powering tests of the 600A Energy Extraction Systems

On behalf of all EE teams involved

MPE Review – June 2, 2015

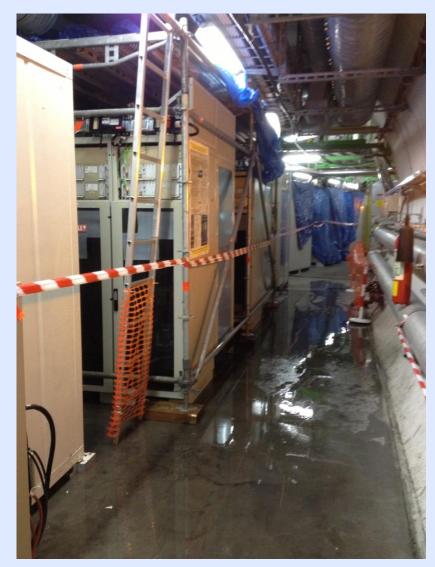
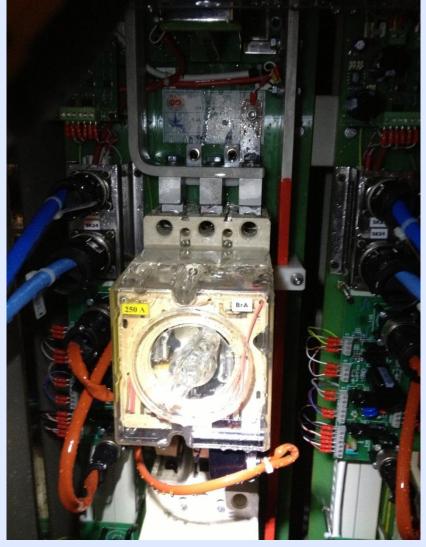
- At many points AC power (UPS) was not present hard to check the systems after interventions.
- "water damage" in UA67 16 systems were replaced by spares which were just delivered 2 months before – reducing the number of new spares from 20 to 4.
- Dust on top of the racks and water under the racks is often event => influence on the systems reliability and breakers contacts.

Water damages in UA67

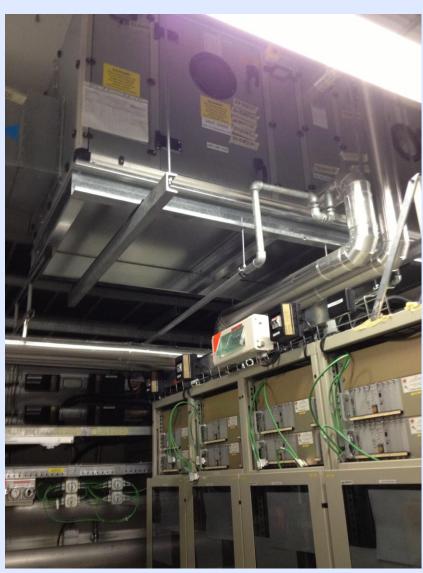
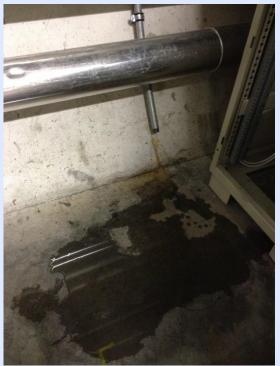
Water on the floor in UA83_87

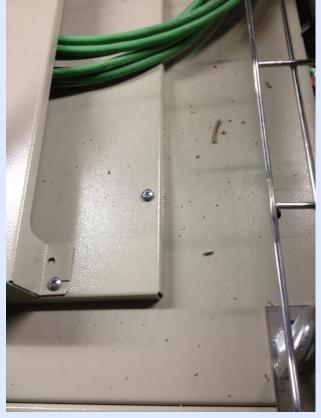
Dust on top of the racks in UA67
