CEA PREVENTIVE ACTIONS FOR XFEL CRYOMODULE ASSEMBLY

Stéphane BERRY completed from Trublet| Thierry at XFEL meeting in 2015 April

COUPLER WARM PART
ASSEMBLY

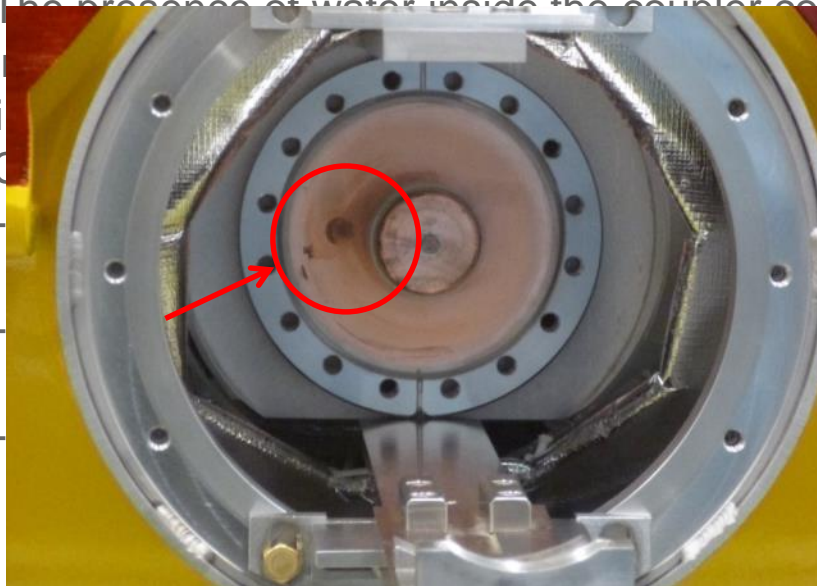
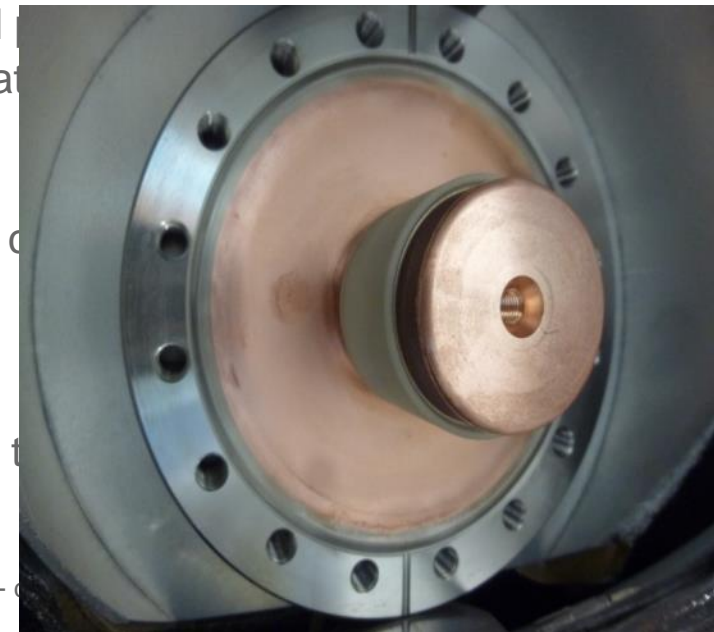
Coupler Cold Part

- During the assembly of coupler warm part on the position #4 of XM18 cryomodule, water has been found under ceramic protection cap of coupler cold part THRI-CP-474 (picture 1 on page 2). Some oxidation marks on the coupler cold part copper surface are visible too (left picture).

- The presence of water inside the coupler cold part...

- C...

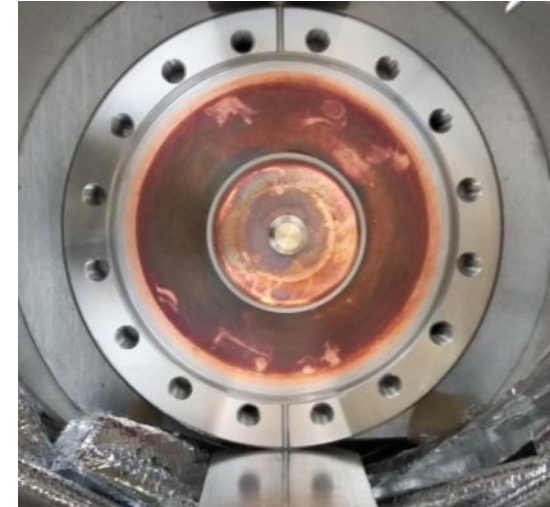
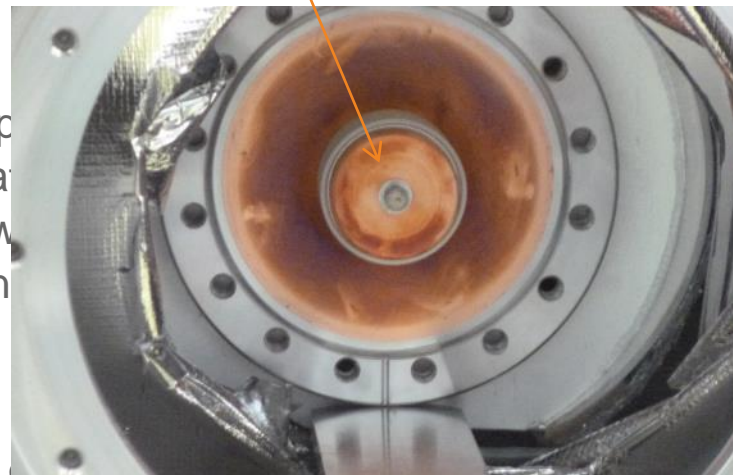
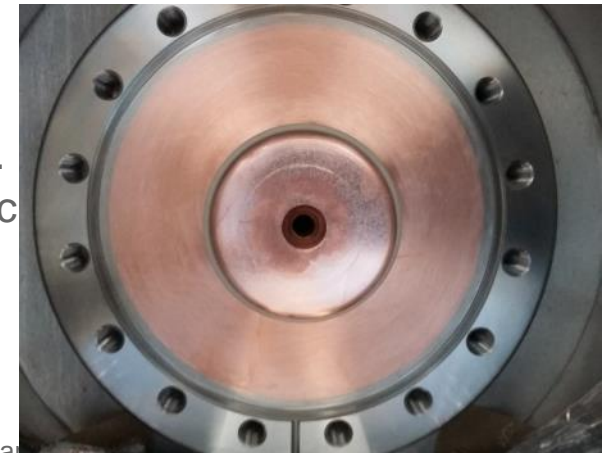
Coupler Cold Part (FAQ-2015-0398-3C XM48)

- During the assembly of coupler warm part on several cryomodules, strong coloration of coupler cold part have been found even if we are **not washing** the test wave guide. Some oxidation marks on the coupler cold part copper surface are visible too (left picture). Most of the time the copper **under the RF contact** is not affected.

- Unknown

- CEA:

- clean the copper surface
- them immediately
- The ceramic waveguide
- acid nor ethanol

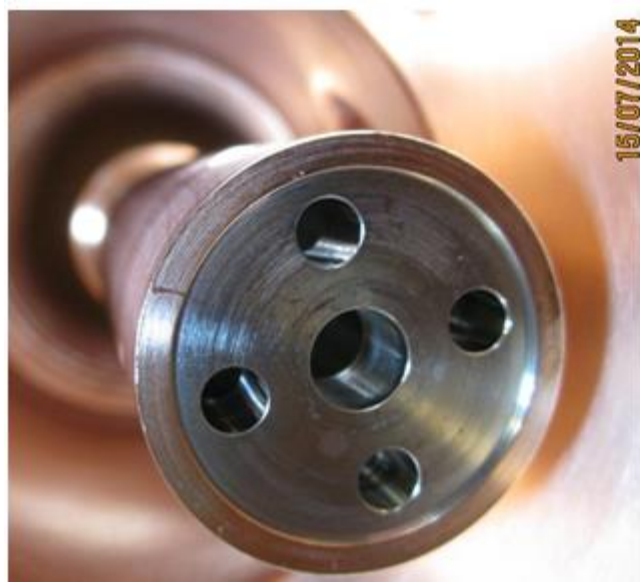
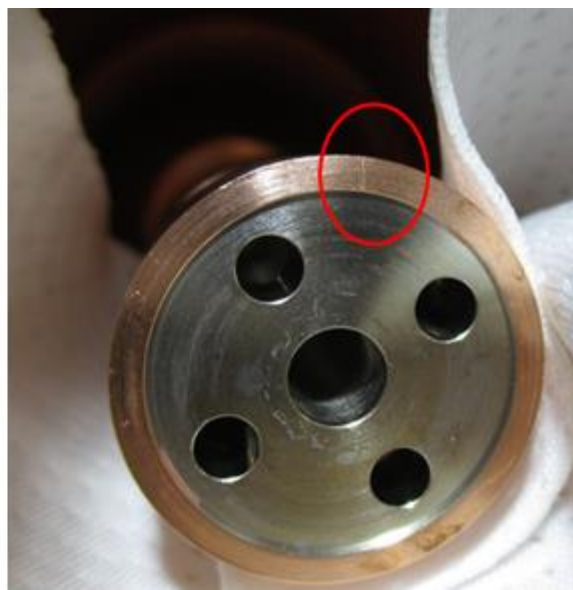
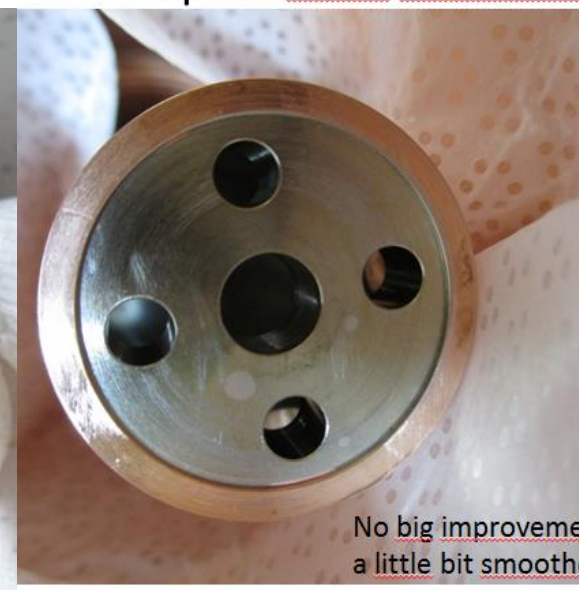
Coupler Warm Part

- Issues
 - Scratch on warm part inner conductor (on RF contact)
- Source
 - Disassembly warm from cold part
- Corrective actions
 - LAL: sand paper to remove thickness which risk to compromise the RF contact

Aspect after treatment :

No big improvement,
a little bit smoother...

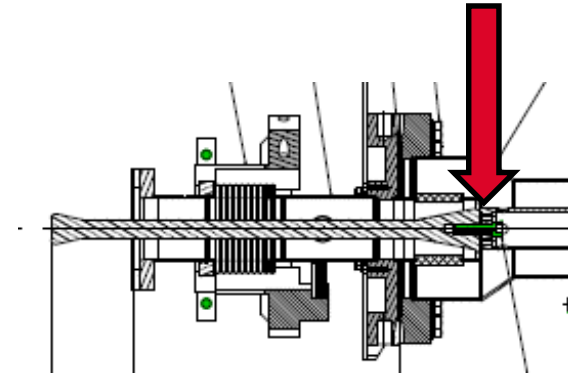
Coupler Warm Part

- T70K overheating

- Antenna screw loose

- New material for central screw and new torque (7Nm instead 5Nm)

- Update of instructions file for coupler assembly to take into account the new torque (in addition the number of the turn of the screw is indicated for memory)
- Use of new torque wrench
- Operators awareness to the issue
- Punctual Audit since XM37

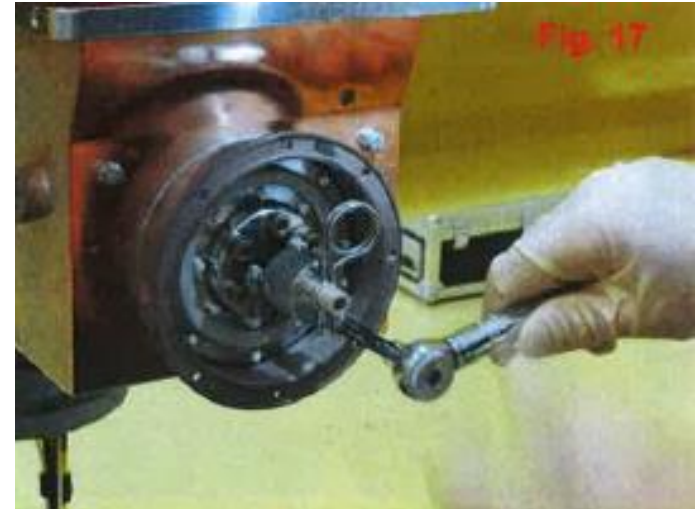
- Discharge/burn

- Capacitor screws loose

- Operators awareness to the issue
- Control that the operators knew the instructions
- Torque controlled at 100% and also le nuts M5 in copper behind the WGB (frequently some nuts are loosed => copper elasticity?)

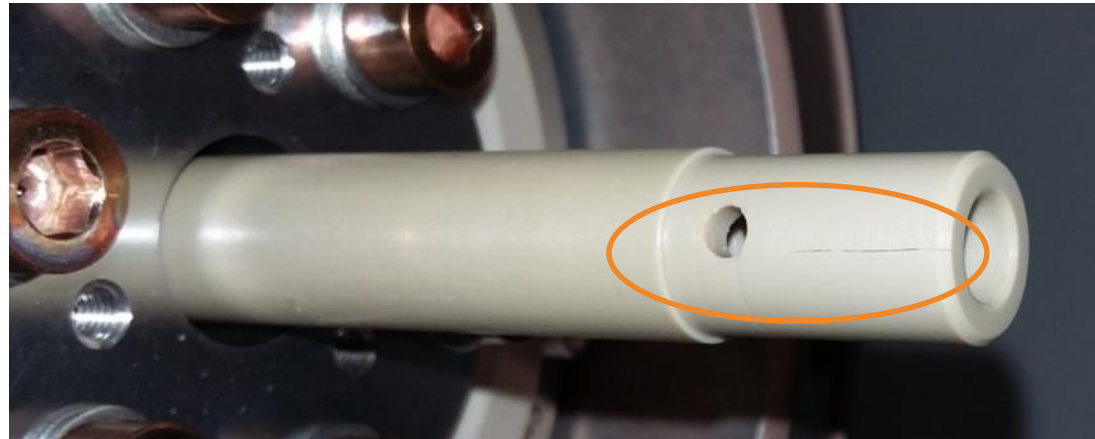
- The complete push-rod need to be exchange if the connecting axle between push-rod and actuator is broken
- Risk to break the PEEK axle (one broken, one damage)

- Fragile and preeminent

- designer:
 - Use a removable part as TTF3 design
