Beam Dumping System

MPP review 12/06/2015

Jan Uythoven for the ABT team

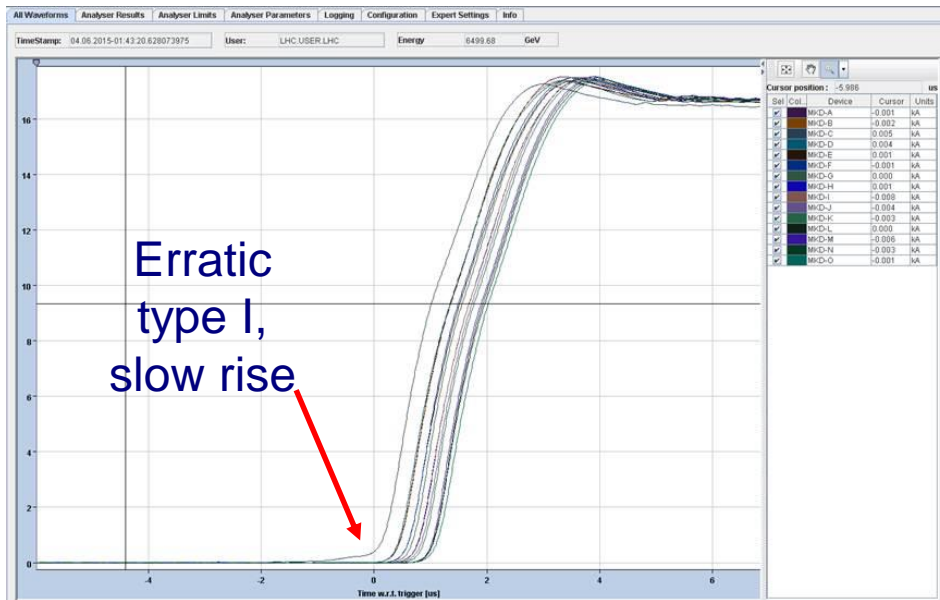
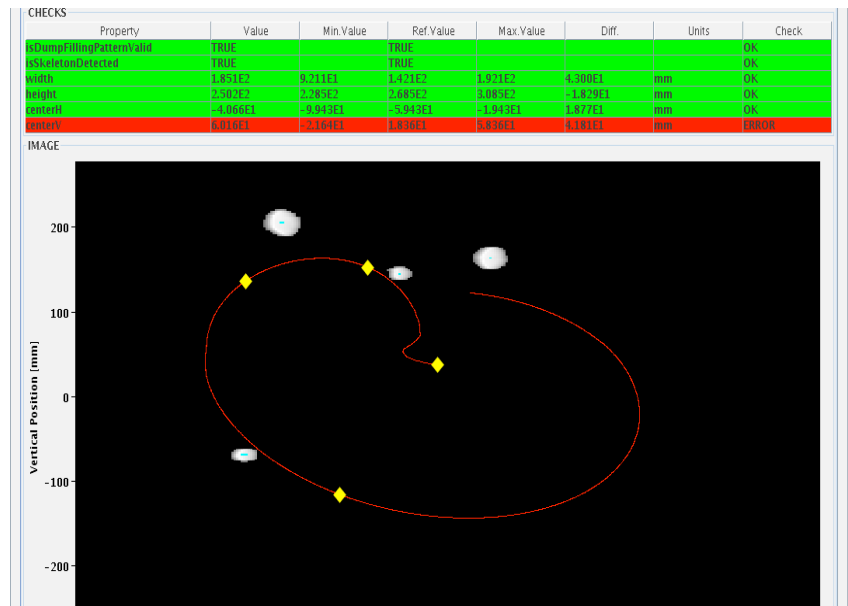
- One so far on 4/6/2015
 - The first asynchronous beam dump of the 3/year/beam announced
 - All detection and redundancy worked correctly
 - 400 ns needed to re-trigger the adjacent generators
- Replaced switch and tests following procedures
 - If tests would not have been successful → replacement of MKD generator
- No beam in the abort gap → no beam losses

No beam in the gap

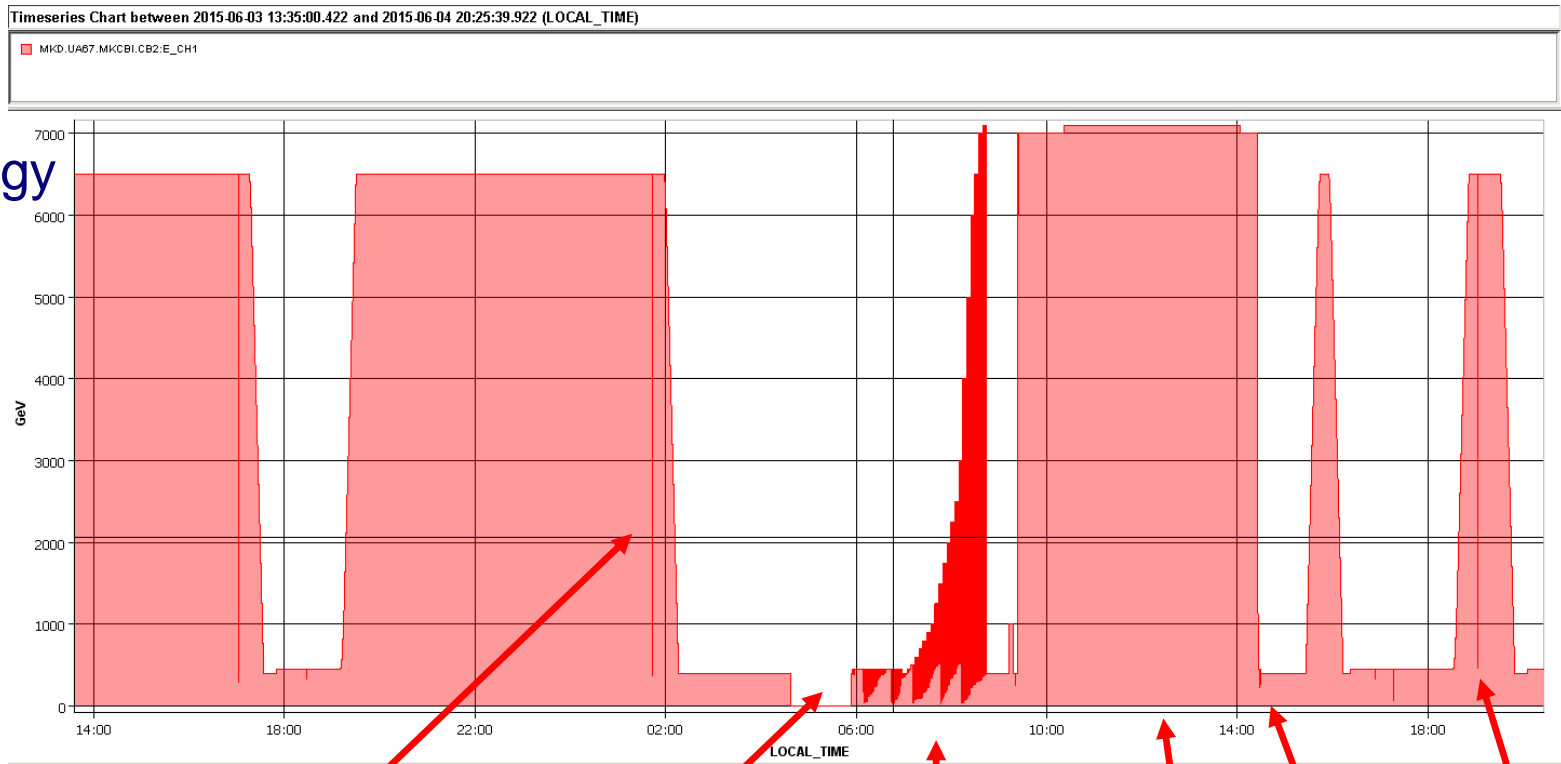
MKD erratic: the Sequence

01:43
Erratic MKD

Switch Exchange

Energy Scan →
new XPOC limits

4 h @ 7.1 TeV

14:15
Back in remote

19:03 Test
dump with
1 bunch at
6.5 TeV

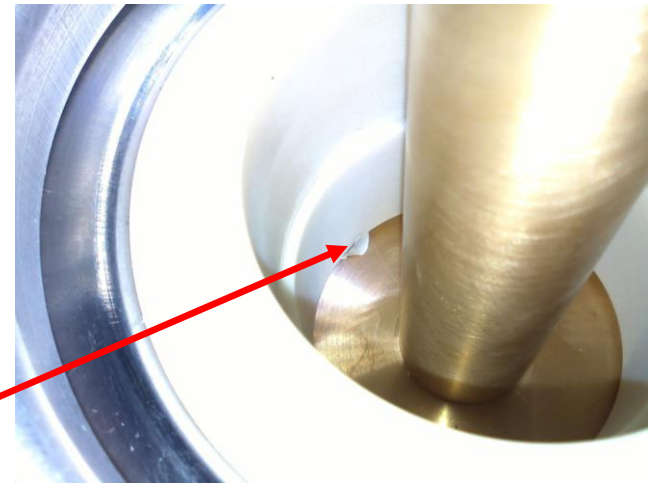
inspection shows piece of glove from previous switch replacement

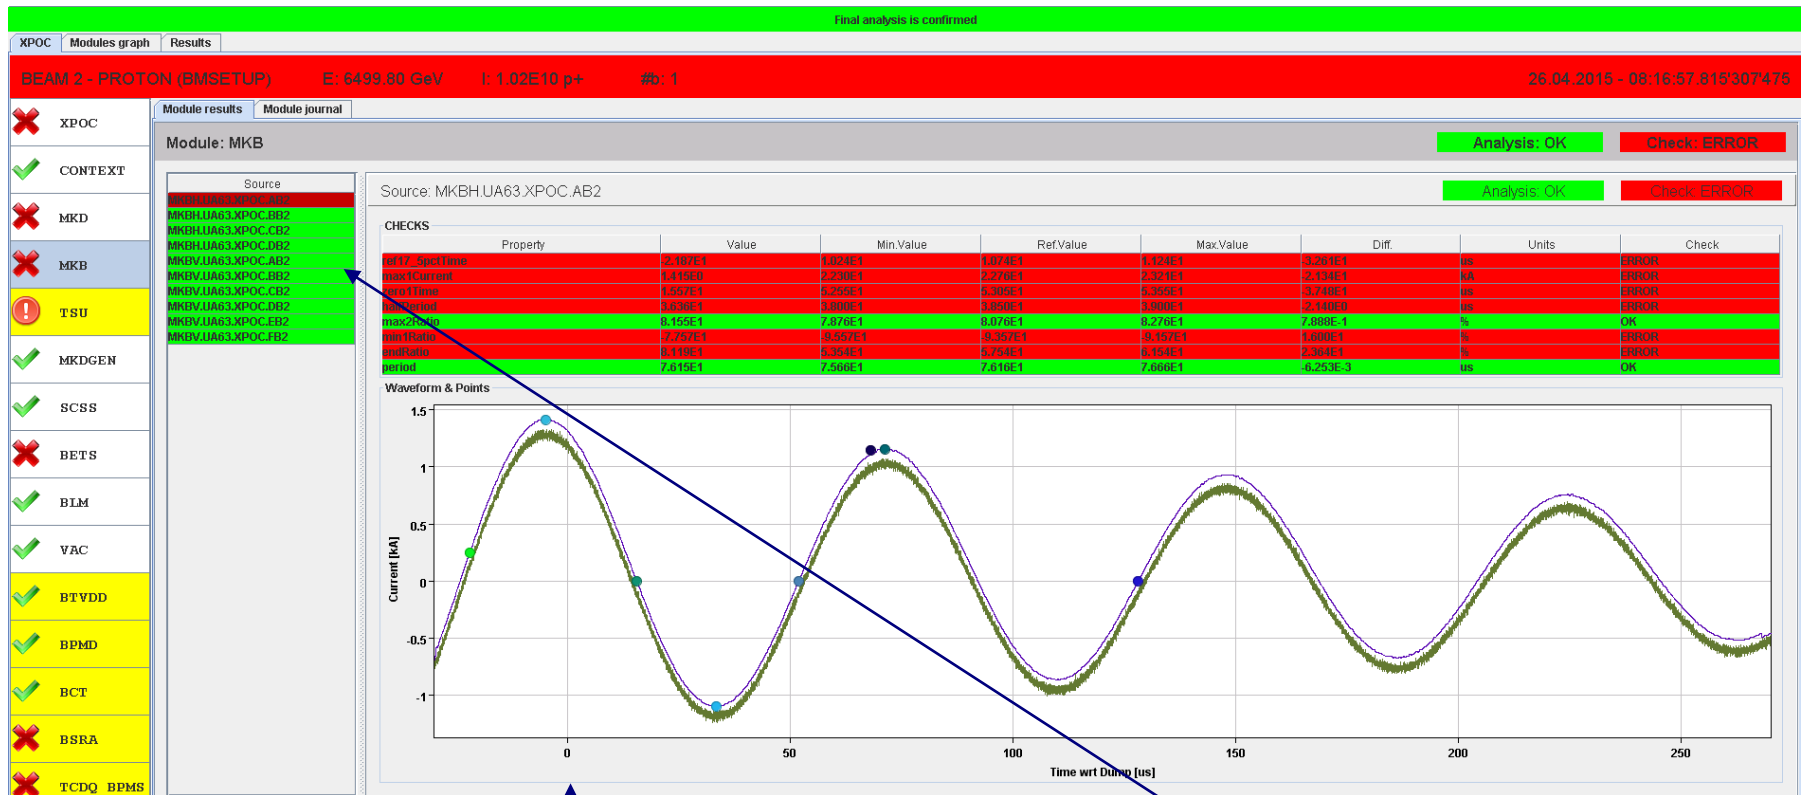
MKB in XPOC

Nominal trigger time

The amplitudes of all other MKB magnets are within XPOC limits: dilution close to nominal

Small amplitude

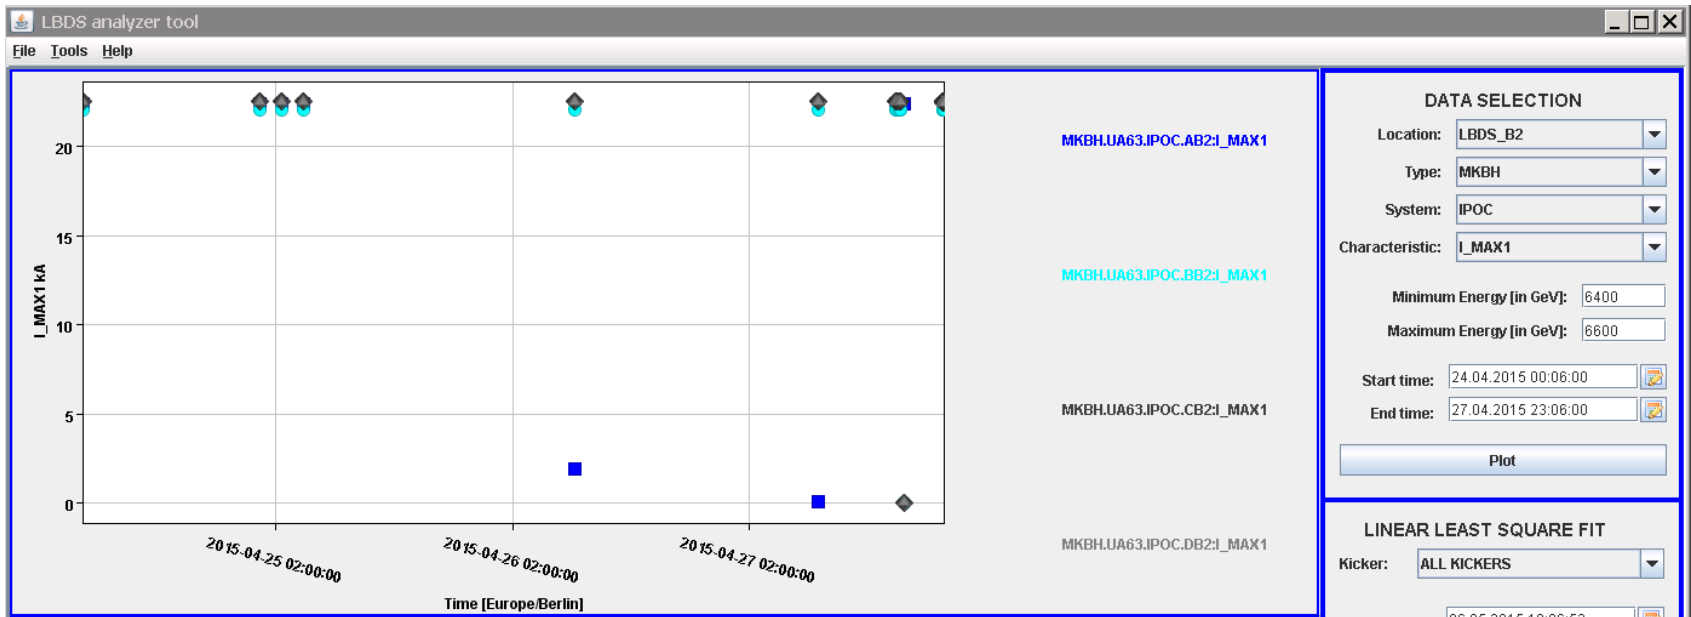
- Dump actually triggered by BETS surveillance of MKB.
- Slow reaction time of order of 1 ms, resulting in small amplitude of MKB where erratic took place
 - So limited impact when in anti-phase with another MKB

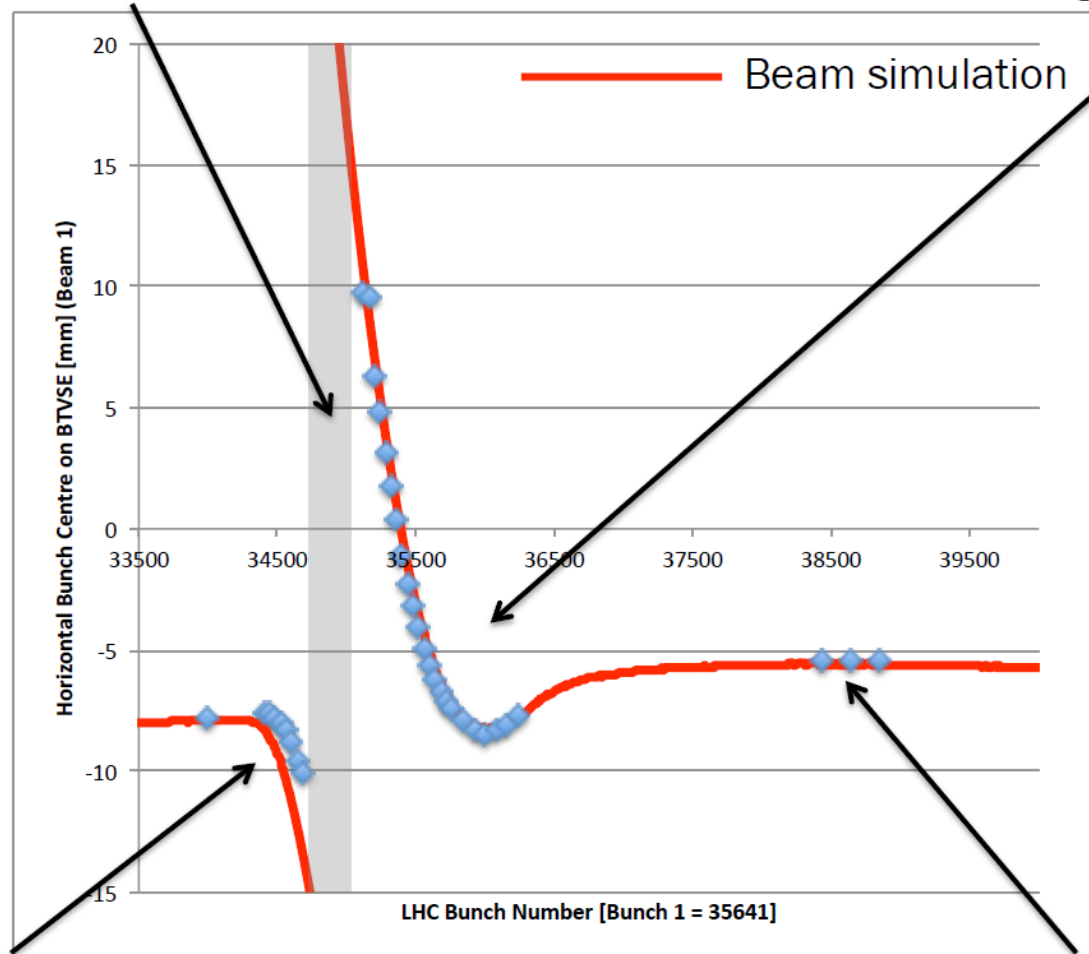
MKD waveform measurement @ 450 GeV

Either lost on TCDQ or misses BTV area:

Top of MKD rise: single kick to TD68.

Start of MKD rise: seen after one extra turn in the LHC.

MKD 100% level
