**Bernd Dehning**

CERN BE-BI

- BLM incident at IP6
- BLM nonconformities
- Signal filter
- Threshold update schedule
- Threshold checks

- Incident with the damage of 18 BLM signal channels and componets
- Date 03.05.2015
  - Three periods of 20 to 30 minutes observed with high voltage disturbance
  - First period:
    - beam dumped by monitor BLMQI.21R6.B1E10.MQ, 13.24.50
    - higher signal already observed in the whole octant, 13.24.31
    - change in HV current observed at 13.23.52

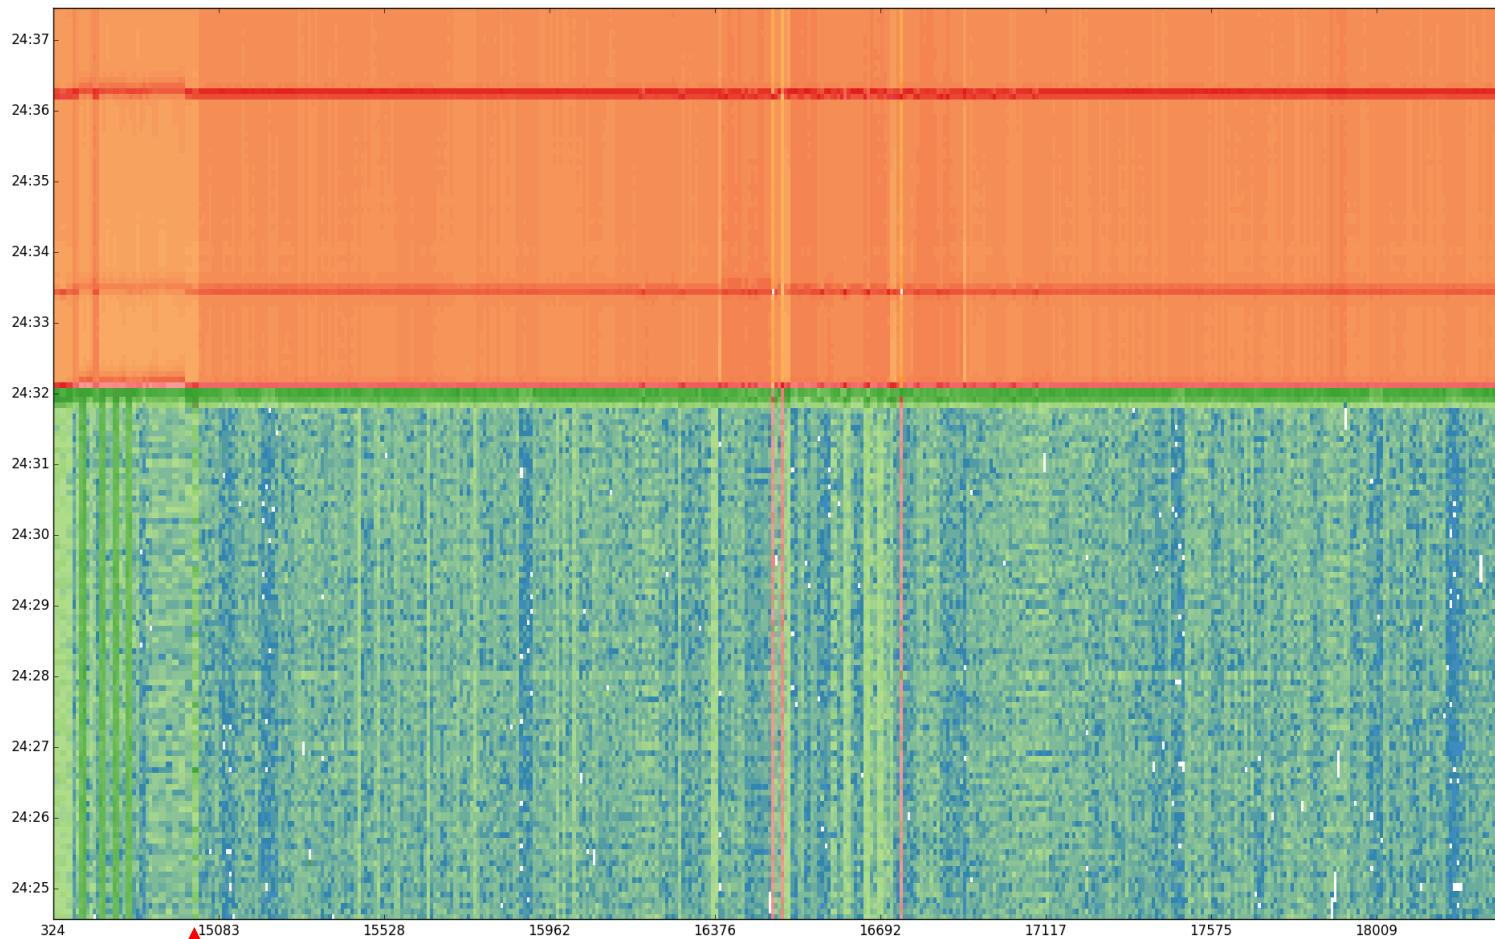
# Point 6L

# BLM signal (color code) vs time vs DCUM (II zoom)

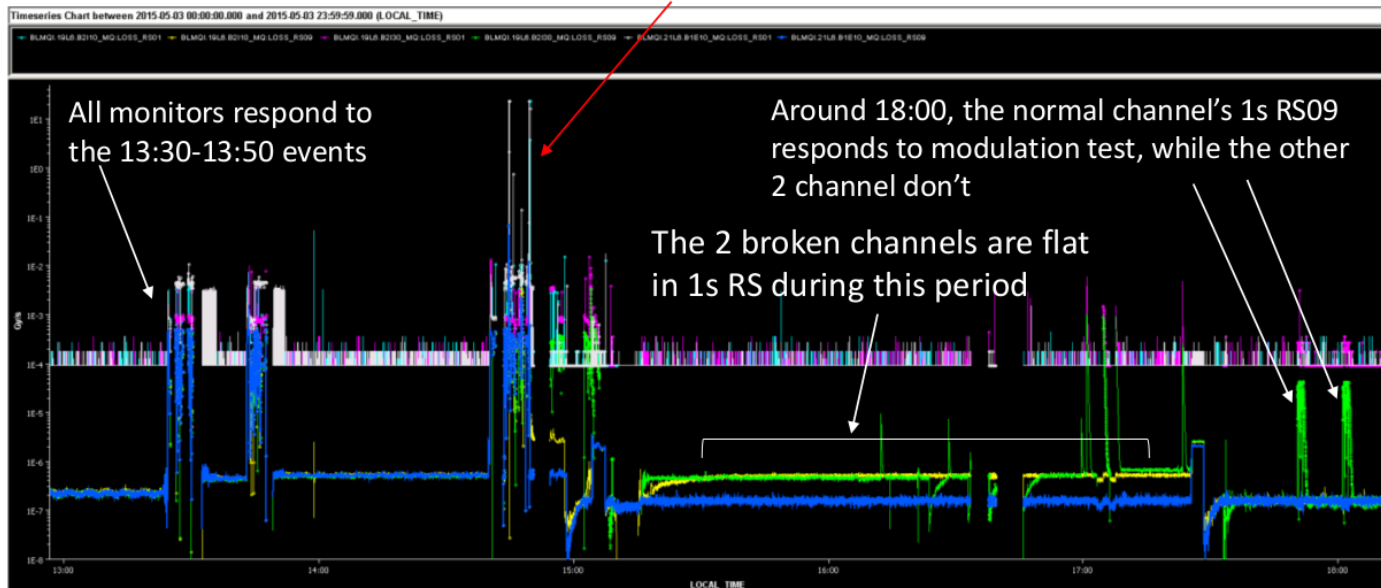
2015-05-03 IP6 HV flash event

RS01 (40us) and RS09 (1.2s) From CFV-SR6-BLML crate

1 normal channel:

**BLMQI.19L6.B2I30\_MQ (card 7, ch 9)**

2 reported broken channels:

**BLMQI.19L6.B2I10\_MQ (card 7, ch 13)**

**BLMQI.21L6.B1E10\_MQ (card 8, ch 10)**

The 40us RS of the 2 broken channels go in saturation, I would suppose this is where they broke
