Update on Sector 34

R.Saban
LEMIC - October 28th 2008

Summary of the analysis

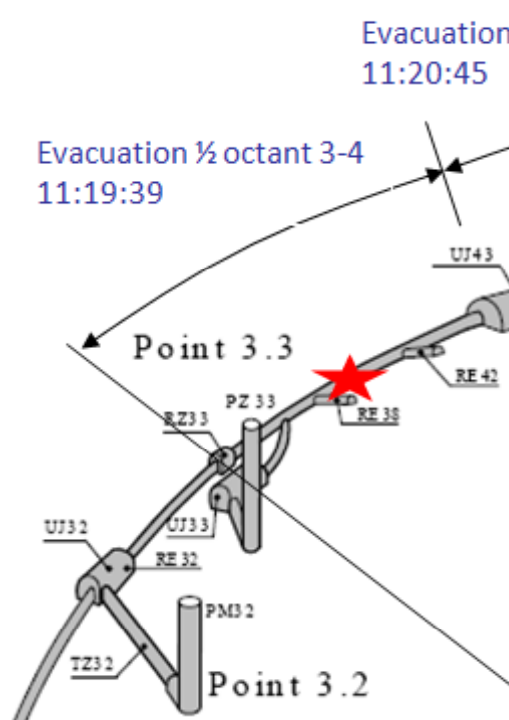
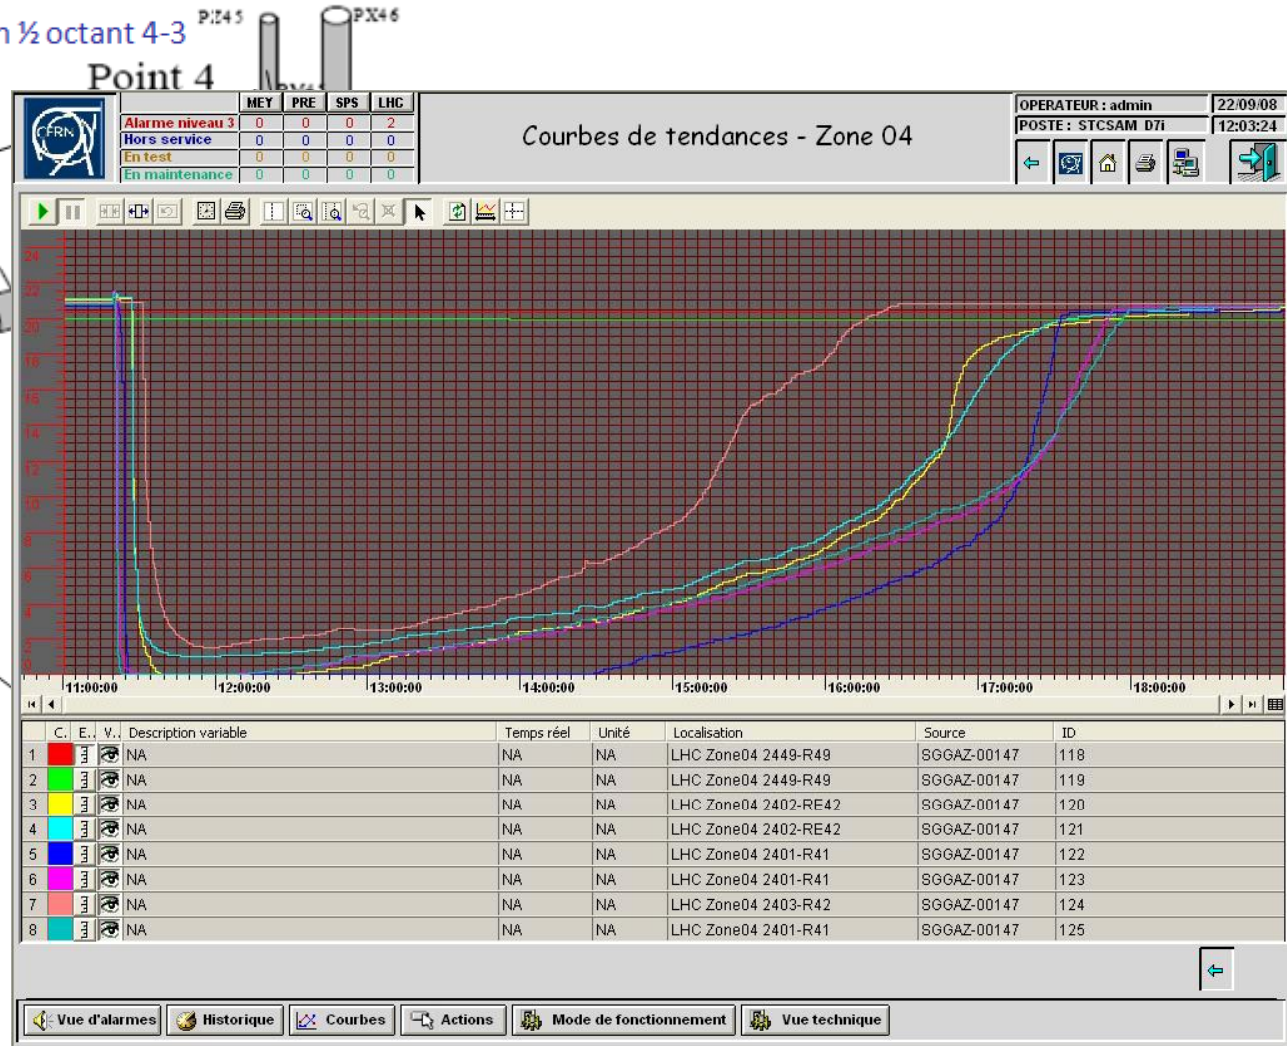
Helium in the tunnel

On 19 September 2008, during powering tests of the main dipole circuit in Sector 34 of the LHC, a fault occurred in the electrical bus connection in the region between a dipole and a quadrupole, resulting in mechanical damage and release of helium from the magnet cold mass into the tunnel. Proper safety procedures were in force, the safety systems performed as expected, and no-one was put at risk.

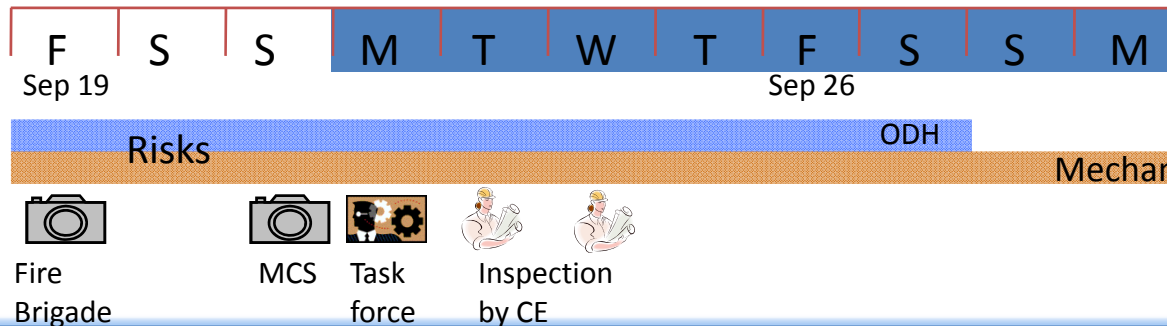
report from Civil Engineering

- ▶ Rupture du radier à l'emplacement du pied de jack arraché et détériorations diverses autour des socles de certains pieds de jack
- ▶ Quelques nouvelles fissures mineures décelées
- ▶ Pas des nouvelles fuites d'eau, mais une légère recrudescence des fuites déjà existantes
- ▶ Pas d'éclats de béton provenant de la voute
- ▶ Pas de modification perceptible dans l'écoulement d'eau
- ▶ Pas des zones sonnant le creux

- ▶ Pas des signes apparents de désordre structurel de l'ouvrage dans la zone de l'incident.
- ▶ Les ruptures en radier concernent seulement le radier secondaire (donc pas d'incidence sur la structure).

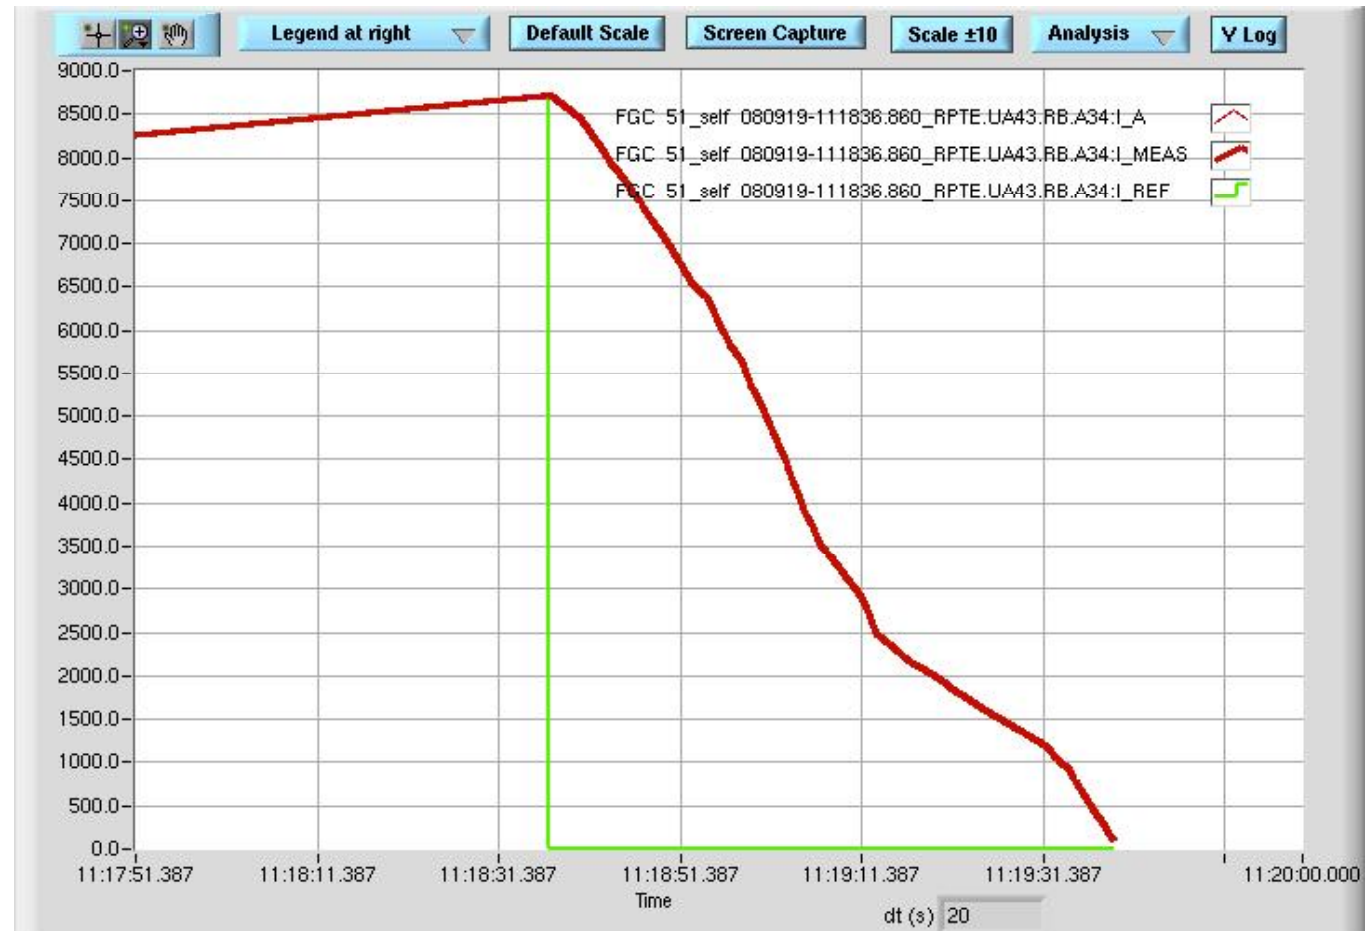
the discharge

- ▶ Anomalous shape far from exponential
- ▶ It takes about 60 s (normal time constant is 104 s)
- ▶ More than 100 dipoles quenched

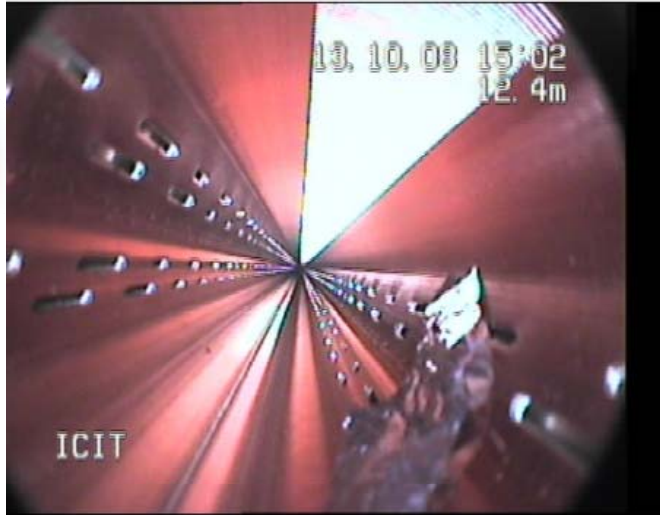
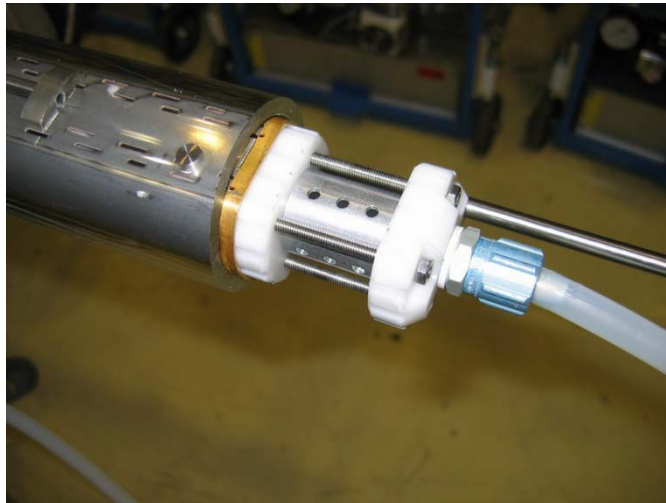
opening of the beam tubes

The first test of in-situ cleaning of the beam vacuum tube in sector 3-4 was done last Friday.

The test revealed that the soot cannot be simply sucked by a vacuum cleaner but a combined action with a brush is required.

Only MLI could be sucked with the current device. However, a preliminary test was done with a brush, but without sucking.

This test was conclusive to remove the soot from the beam screen surface. AT-VAC is now building a new prototype with a brush incorporated with the pumping device.
