# Qualification of the CMS Digital Optohybrid

# CMS Control Link Digital Optohybrid (DOH)

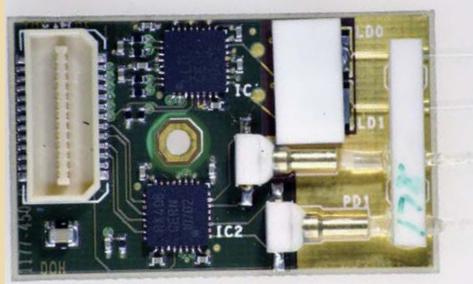
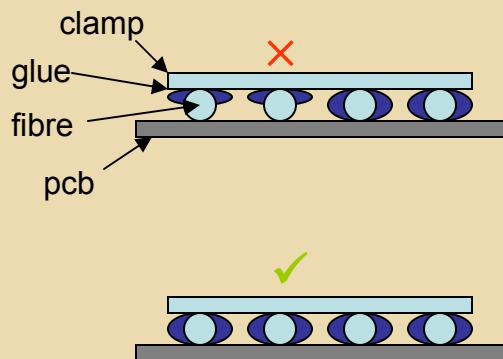
Kapsch fibre clamp

Inspection test	# failures
Fibre clamp	10
Laser cover	20
QR code	2
Soldering	12
Fibre buffer rupture	5

- DOH has undergone an extensive series of tests
  - Good functionality
  - Quality of assembly
    - 1<sup>st</sup> Pre-production failed visual inspection
    - 2<sup>nd</sup> Pre-production much better:
      - Redesigned fibre clamp
      - Redesigned assembly jig
- Remaining issues
  - Buffer ruptures on fibres
  - Soldering of photodiodes onto DOH pcb
- Production phase
  - 100 DOHs in August 04
  - Expect to reach production rate of ~200 DOHs/month

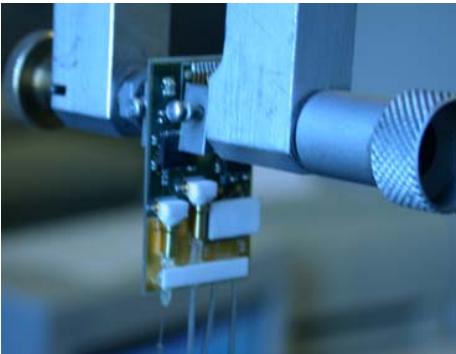
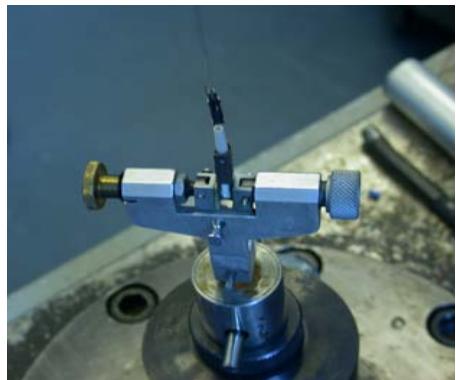
- Attach 700g to fibre
- 3/40 fibres failed (all lasers)

- Pull fibre until it fails
- 2/36 fibres below spec  
(all lasers 5.5N & 6.7N)

- Fibre strength reasonably good
- Revise DOH pull strength specification
