QPS OPERATIONAL ASPECTS

M. Pojer, CERN, Geneva, Switzerland

The status of the quench protection system after LS1 is reviewed, between challenges and major faults. The energy extraction issues are also analysed. Attention then focuses on the operational software tools and interfaces. The foreseen major modifications and improvements during YETS are discussed.

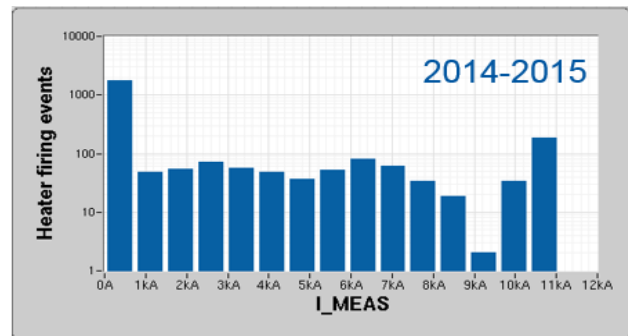
To re-activate the communication, a power reset procedure was set, which was initially not optimized: if not done properly, quench heaters were discharged in the attempt of re-establishing the communication. About 170 quench heaters were discharged at zero current from the end of the commissioning in March '15 (Figure 1 and 2), and most of them because of this communication issue.

Figure 1: Quench heater firing since October 2014 (QPS-IST included); about 2525 were fired at full charge, while about 1650 were fired at zero current.

A firmware upgrade is ready and will be deployed during the YETS on all units (436) affected by the communication bug. It will be carefully tested at the end of YETS, but should be transparent for re-commissioning.

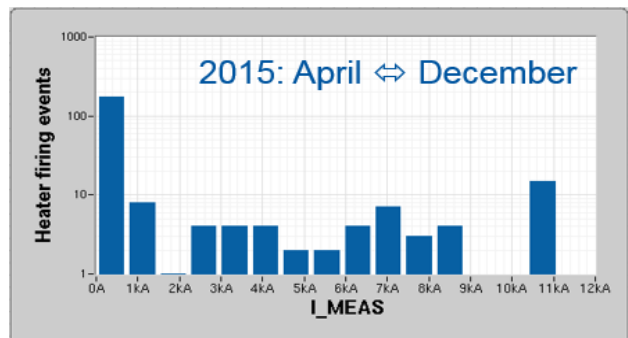
Figure 2: Quench heater firing since April 2015 (1st beam in the machine); about 234 were fired at full charge, while about 170 were fired at zero current.
