LHC RF system reliability

LHC run 2: all RF trips

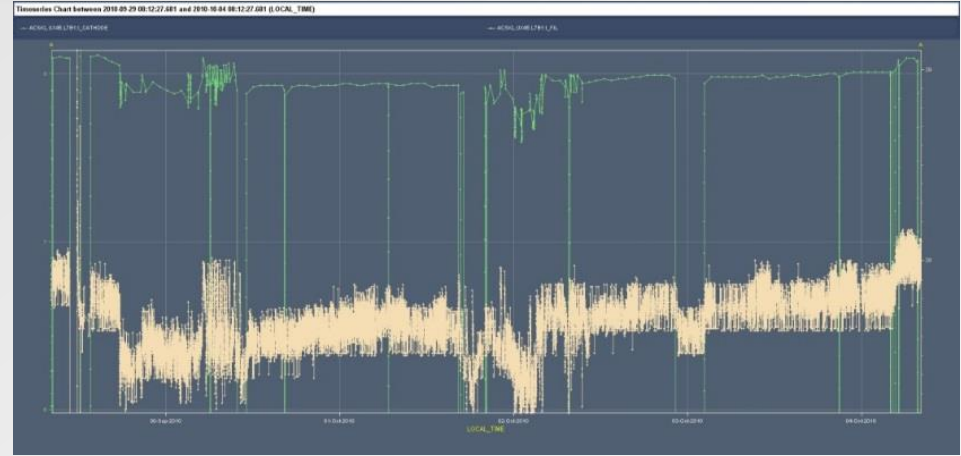
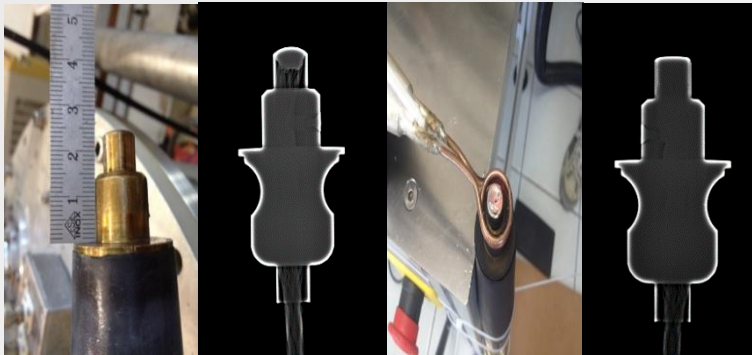
Summary of Run 1 & LS1

- ❖ Statistic of RF faults dominated by:
 - ❖ Spurious crowbar trips
 - ❖ Klystron filament glitches

- ❖ All HV connectors were found defective => repair campaign
- ❖ Crowbars: Thyratrons replaced by Solid State devices (better performances & reliability)
- ❖ 8/16 klystrons replaced – age profile

No more klystron filament glitches
No more spurious crowbars trips

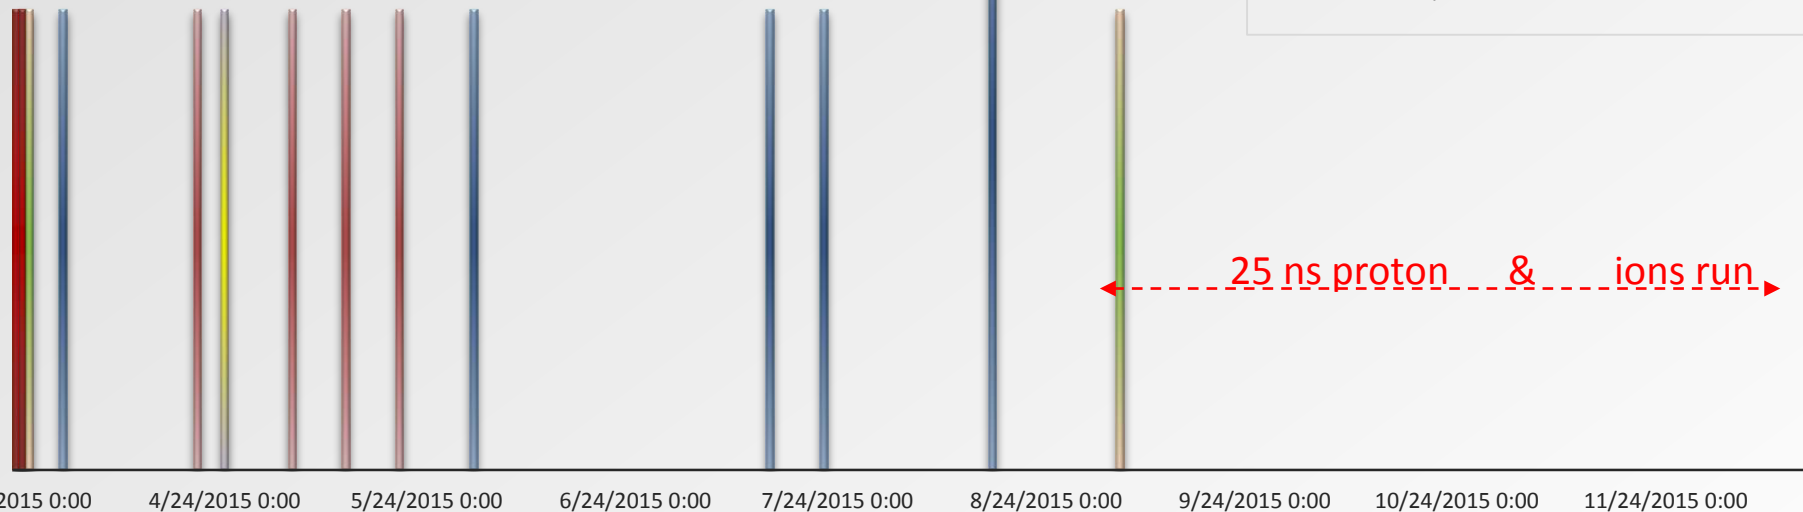
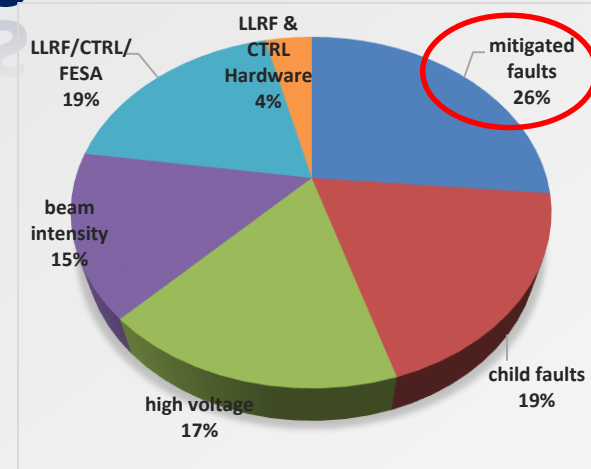
Mitigated faults

- Interlock levels
- Main coupler blocked: communication protocol error in control card. Solved during TS1
- Temperature glitches: Solved during TS2
- No trips since mid-September

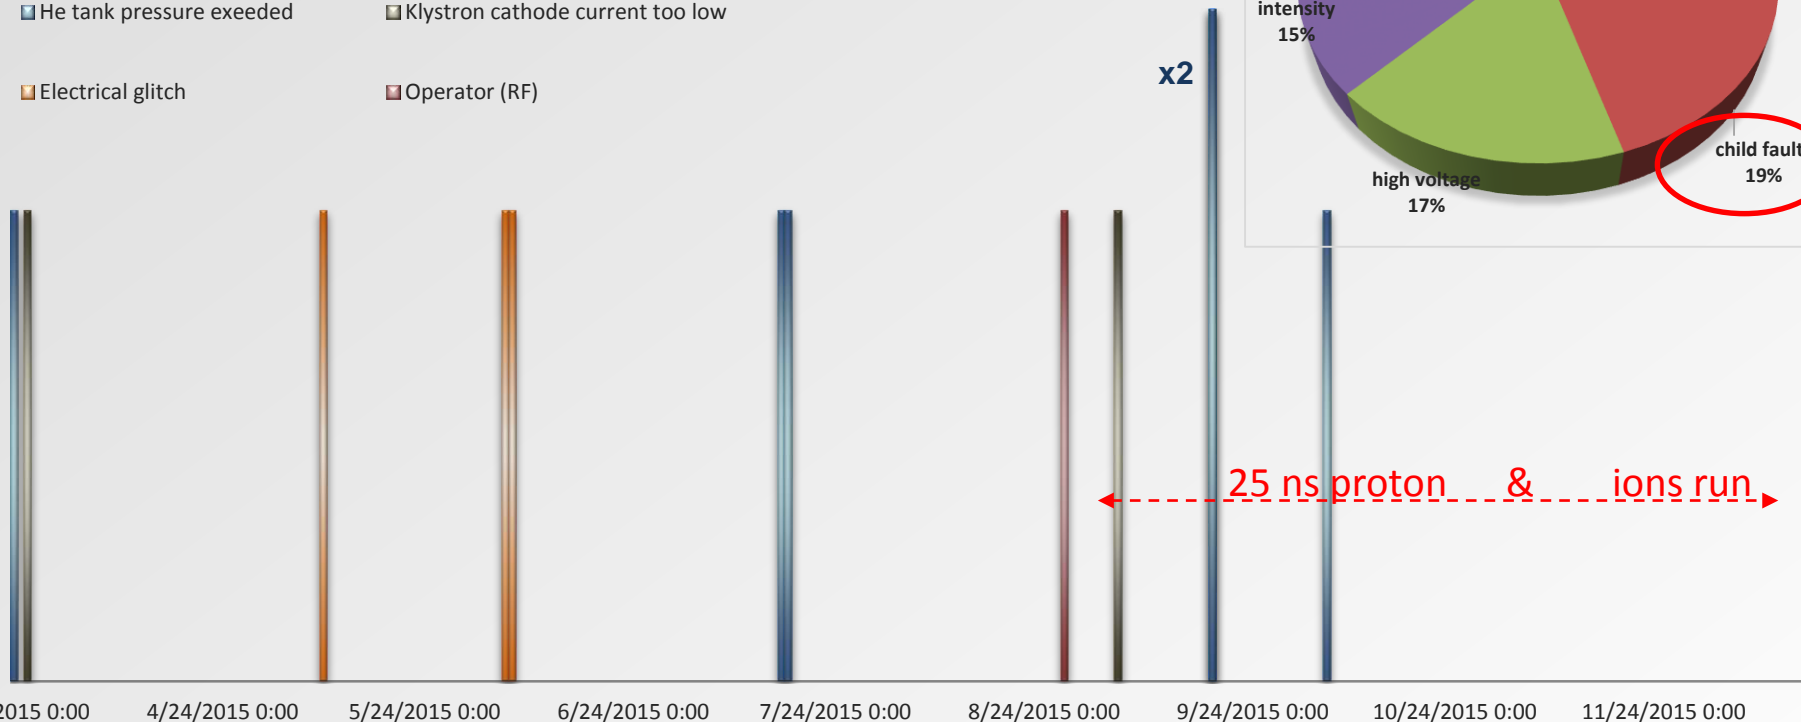
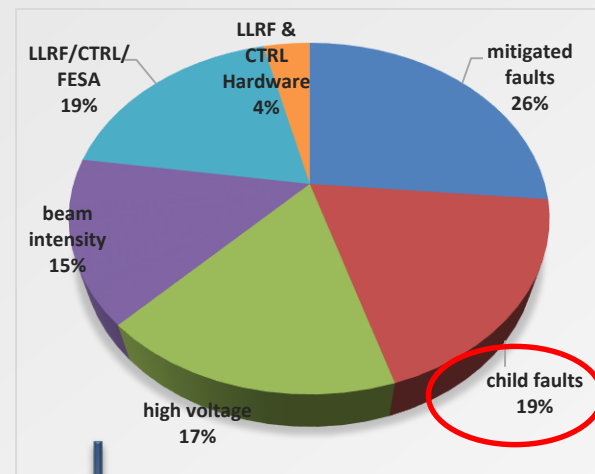
“Child” faults

■ He tank pressure exceeded
■ Electrical glitch
■ Klystron cathode current too low
■ Operator (RF)

- Electrical glitches : e.g. thunderstorms
- Loss of cryogenic conditions: related to the increase of beam intensity (heat load on beam screen)
- 2/13 beam dumps

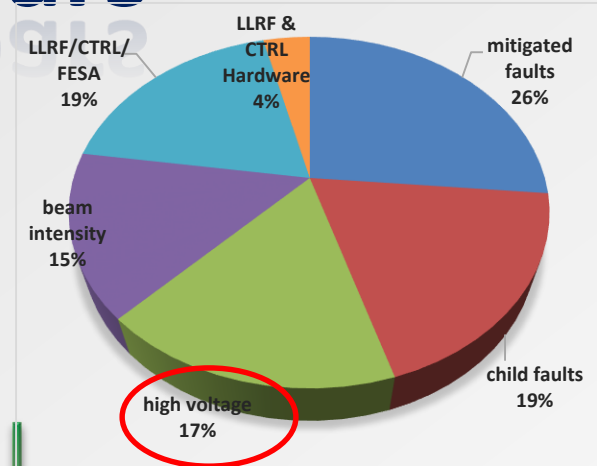
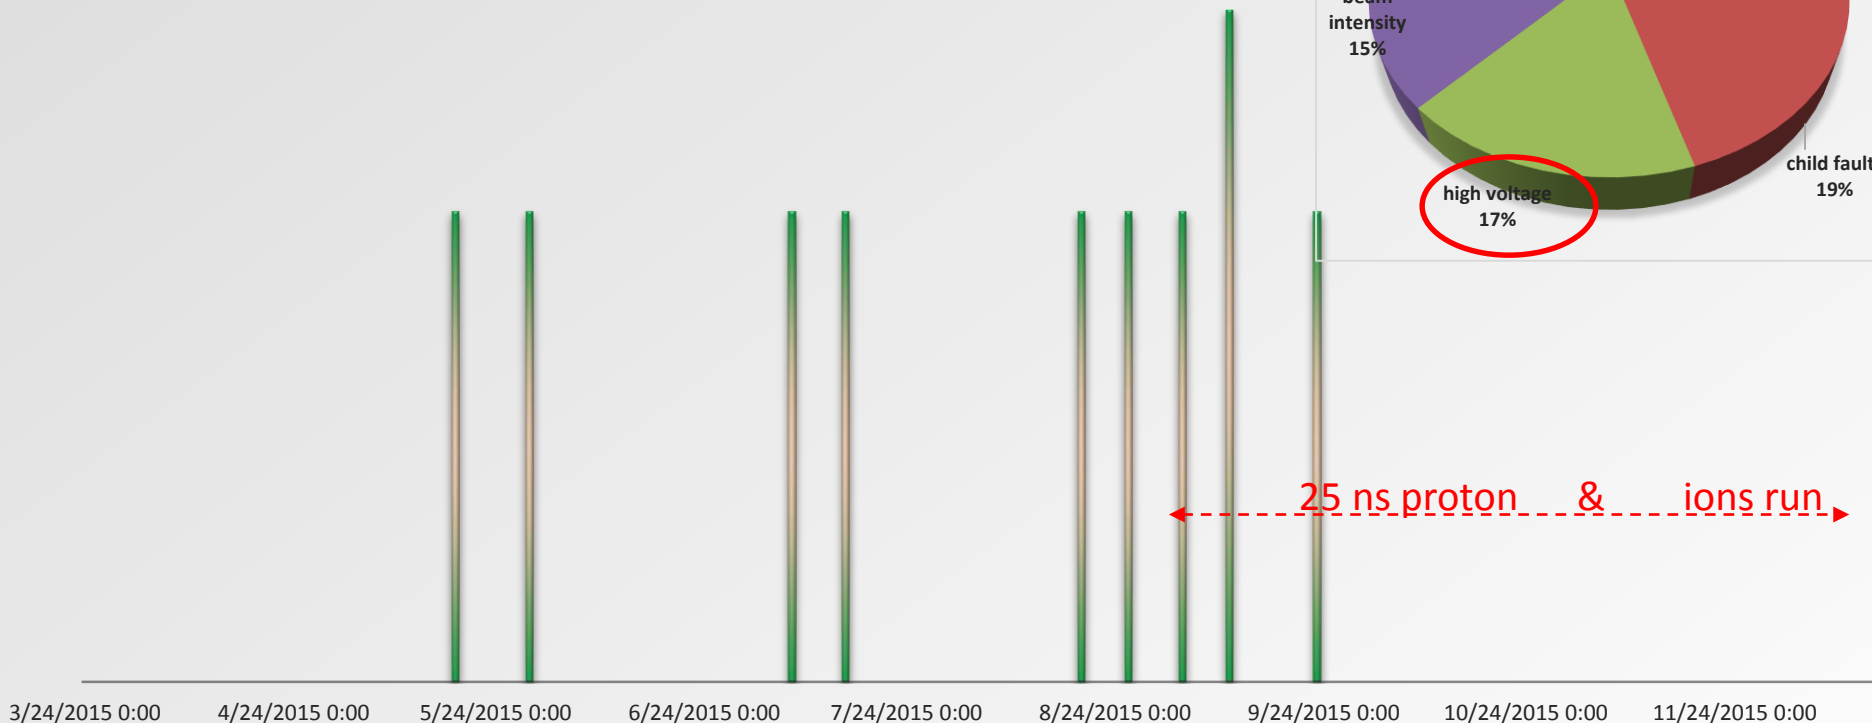
HV system: crowbars

- Major cause of trips during run1
- All “real” crowbars (klystron vacuum activity)
- ALL (except 1) soon after restarting the RF system (in particular after long periods at 10kV)
- 1 beam dump

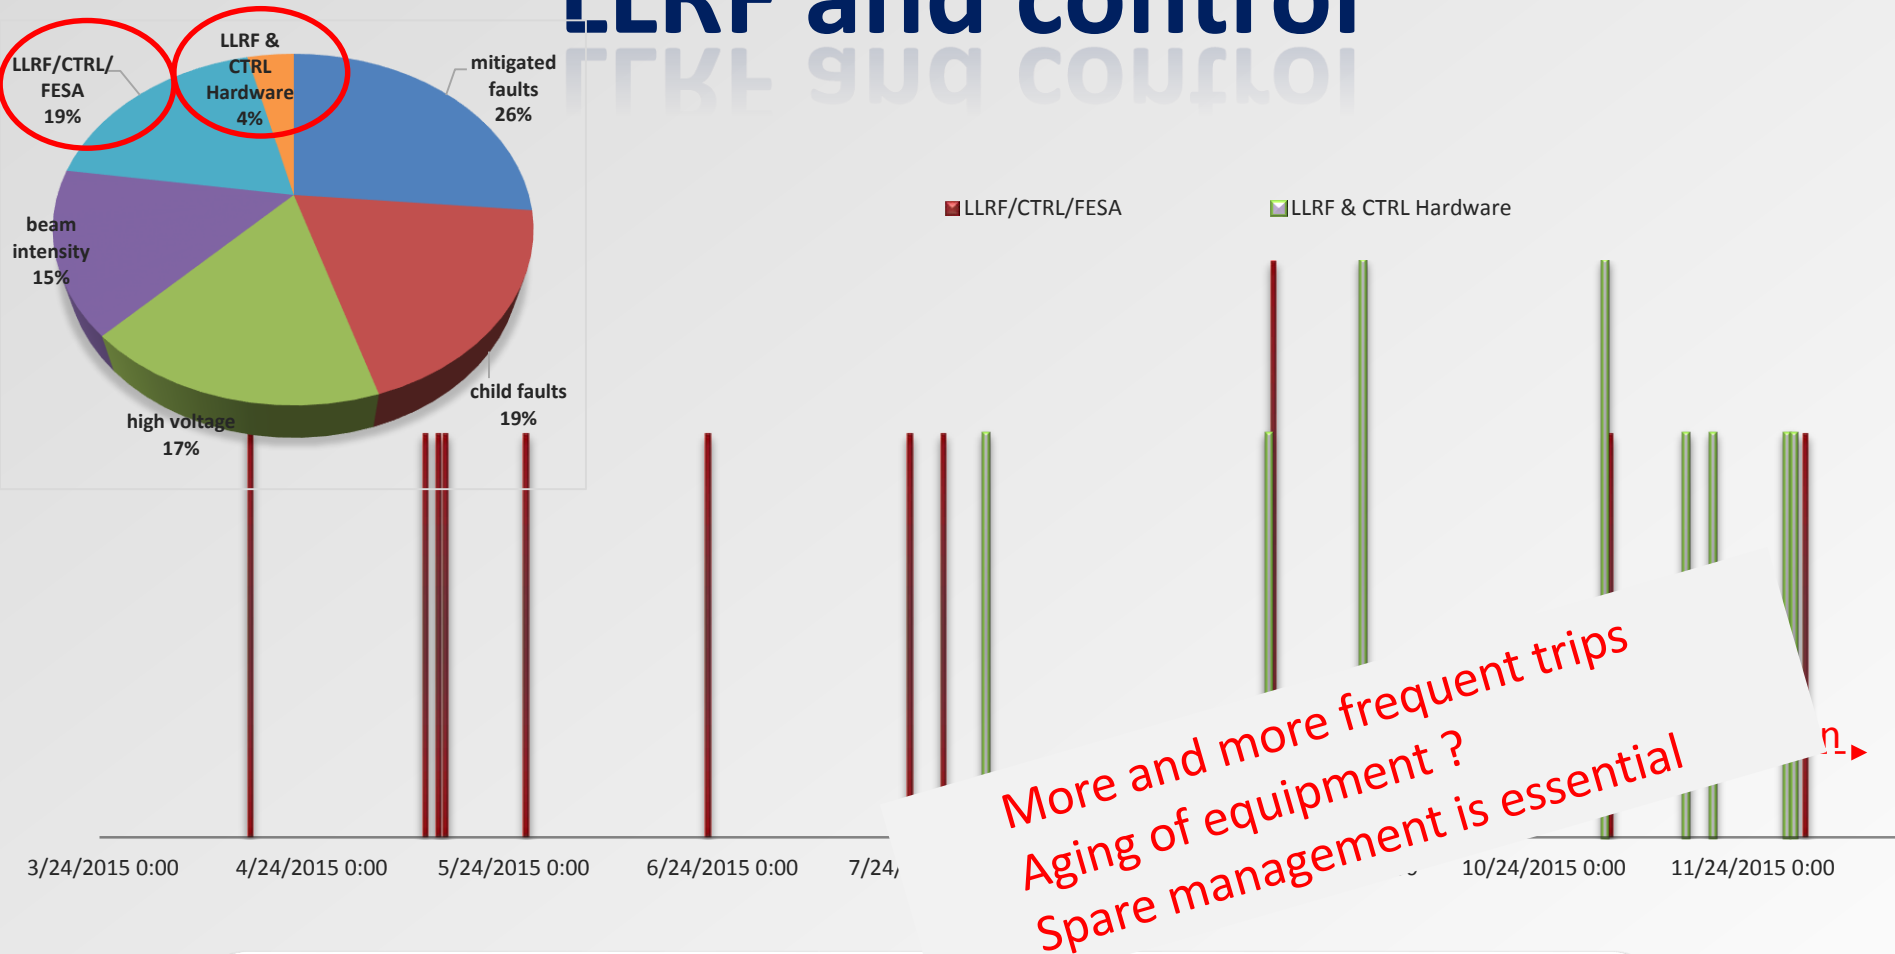
LLRF and control

- Reboot, FESA hiccups, loss of RF frequency reference
- Several LLRF cards, PLC/CTRL IO modules, 5V power supplies replaced
- 3/13 beam dumps

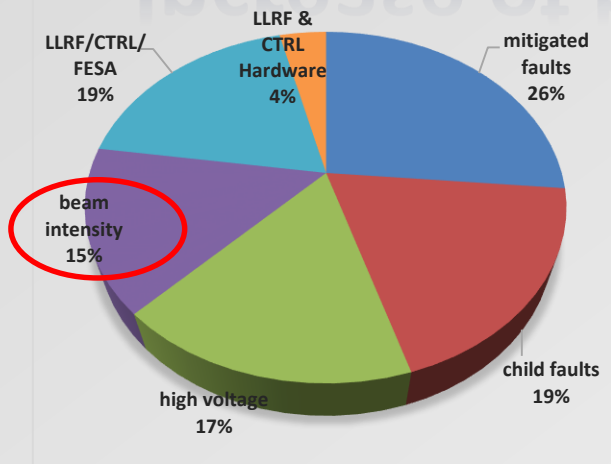
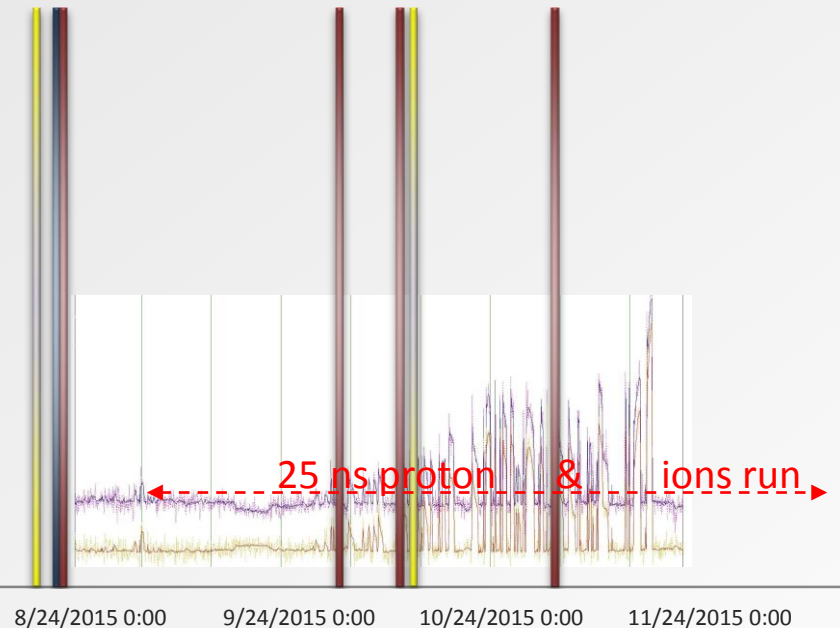
Increase of beam intensity (& RF power)

■ Klystron vacuum
■ Cavity main coupler window temp
■ Arc detector (klystron side)

- Klystron vacuum: Klystron oversaturated => LLRF fine adjustment
- Cavity main coupler window overheated => Better cooling system under study
- Arc detector: no evidence of real arcs!. Maybe radiation induced? => YETS: modif + diagnostic system
- 7 beam dumps (50%)
