# Spectrometer Solenoid Recovery: Options for Moving Forward

Mark Palmer

*Fermilab*

*October 26, 2015*

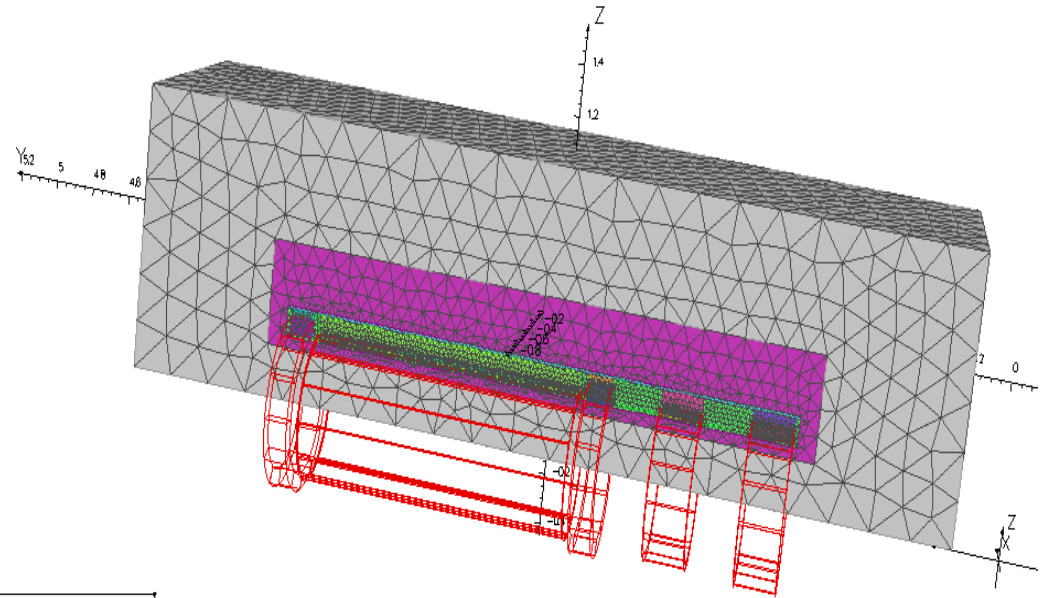
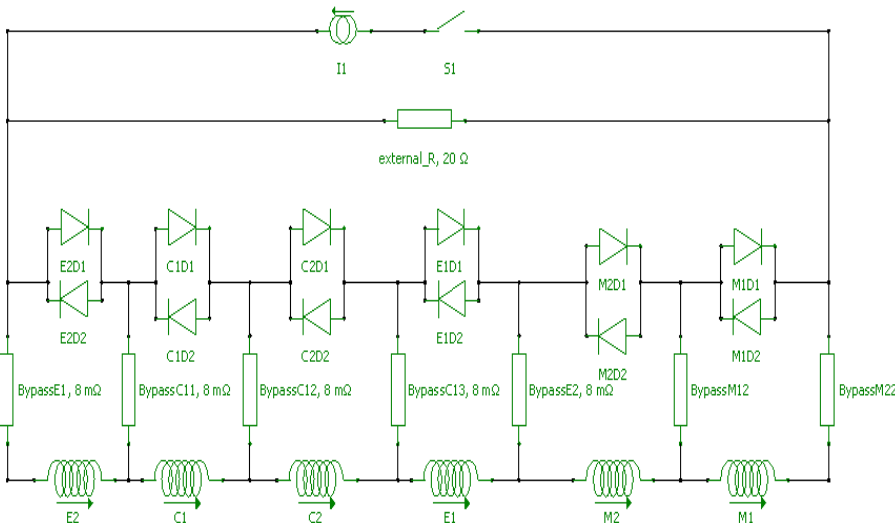
- Quad model built in VF
- Quench initiated in the inner layer of the E2 coil.

- All coils are powered by a single powers supply.
- A 20  $\Omega$  external resistor goes across all the coils.
- Switch opened when the overall voltage across the E2 coil exceeds 0.2V.

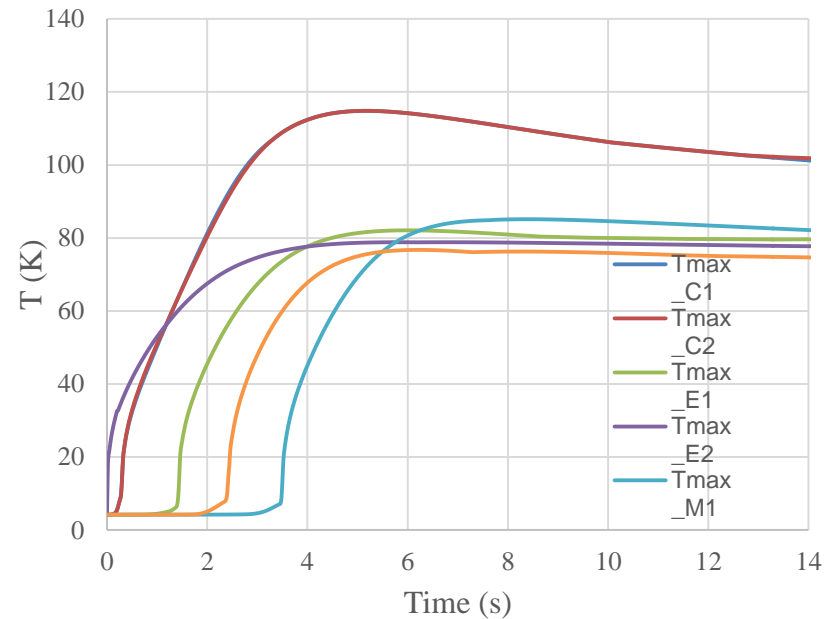
Hot Spot Temperature

- C coil also has the highest hot spot temperature among the coils.
