NuMI Horns Experience

NBI2006
September 6, 2006
NuMI Horns Experience
Jim Hylan / FNAL
Page 1

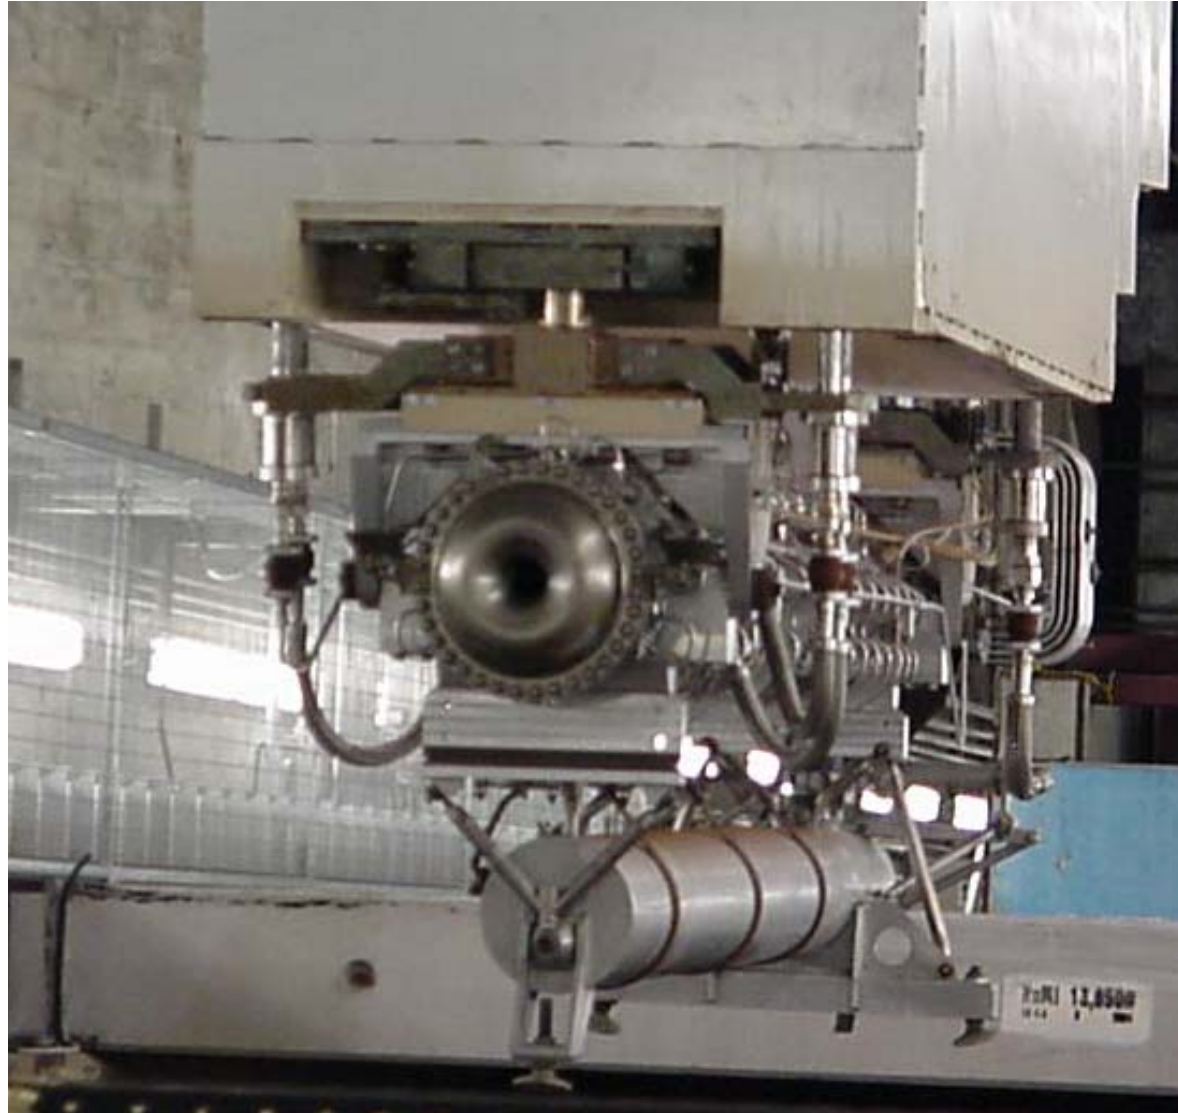
Horn 1, after a year of beam

Inner Conductor Corrosion

Why is corrosion in general so bad ?

Ionized air produces ozone, nitric acid, ...

Note the water from dehumidifying the re-circulating air has PH of 2.6

Why does end bell of horn look great, and parabolic section horrible ?

Don't know, but...

End cap is in 18 mph wind

Parabolic section is relatively dead spot for air motion

Bad air may be building up in dead spot

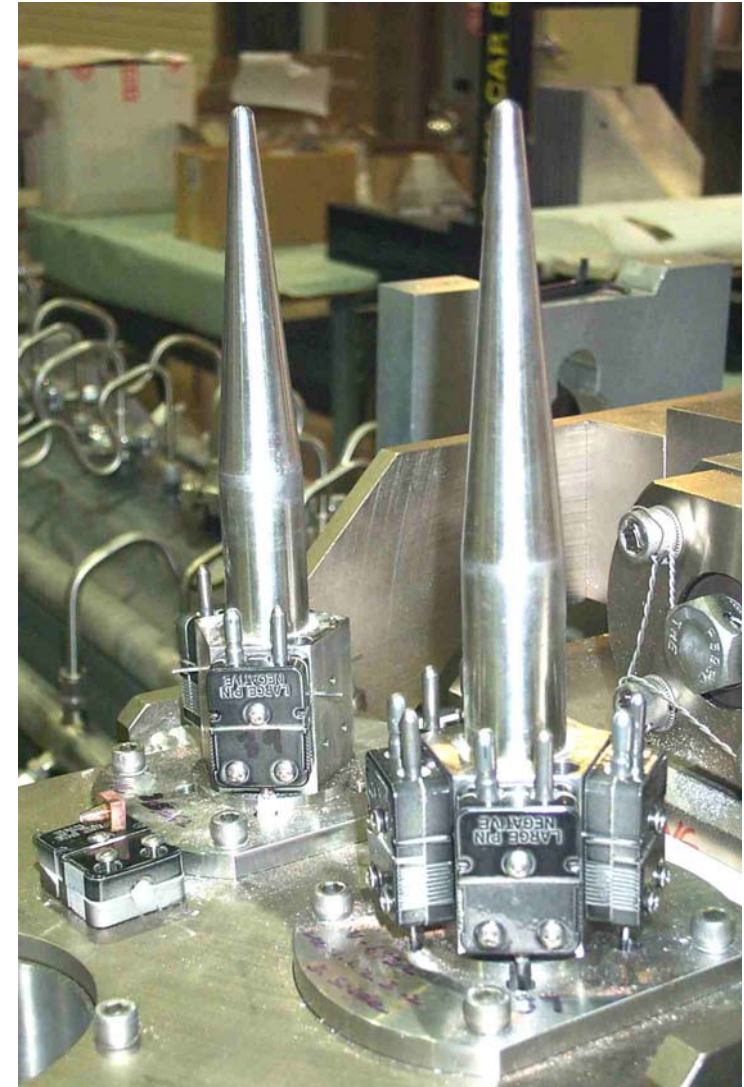
Used type J thermocouples
with ceramic connector for remote connection

The iron pin on the connector corrodes
– need to look for something else

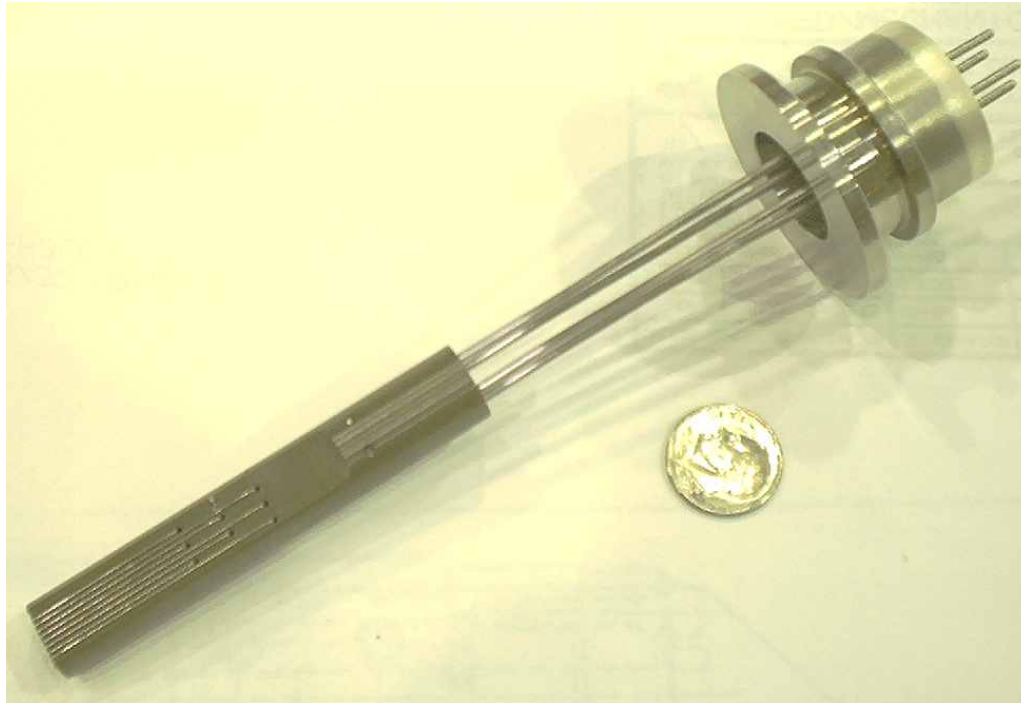
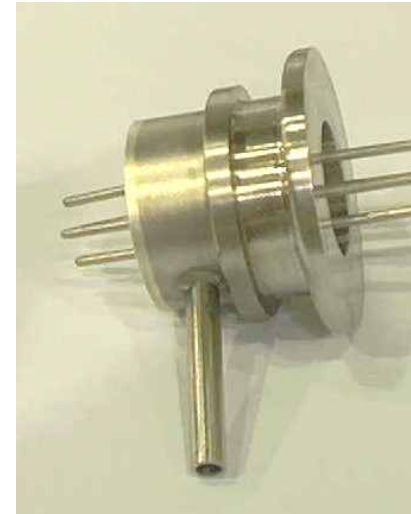
Bdot field monitoring coils inside horns

The wet environment in the horns has been problematic for the un-insulated wiring.

After implementation of better coherent noise cancellation circuit,
the three b-dot coils on each horn run well enough to check field stability.
But would totally isolate these from water in future.

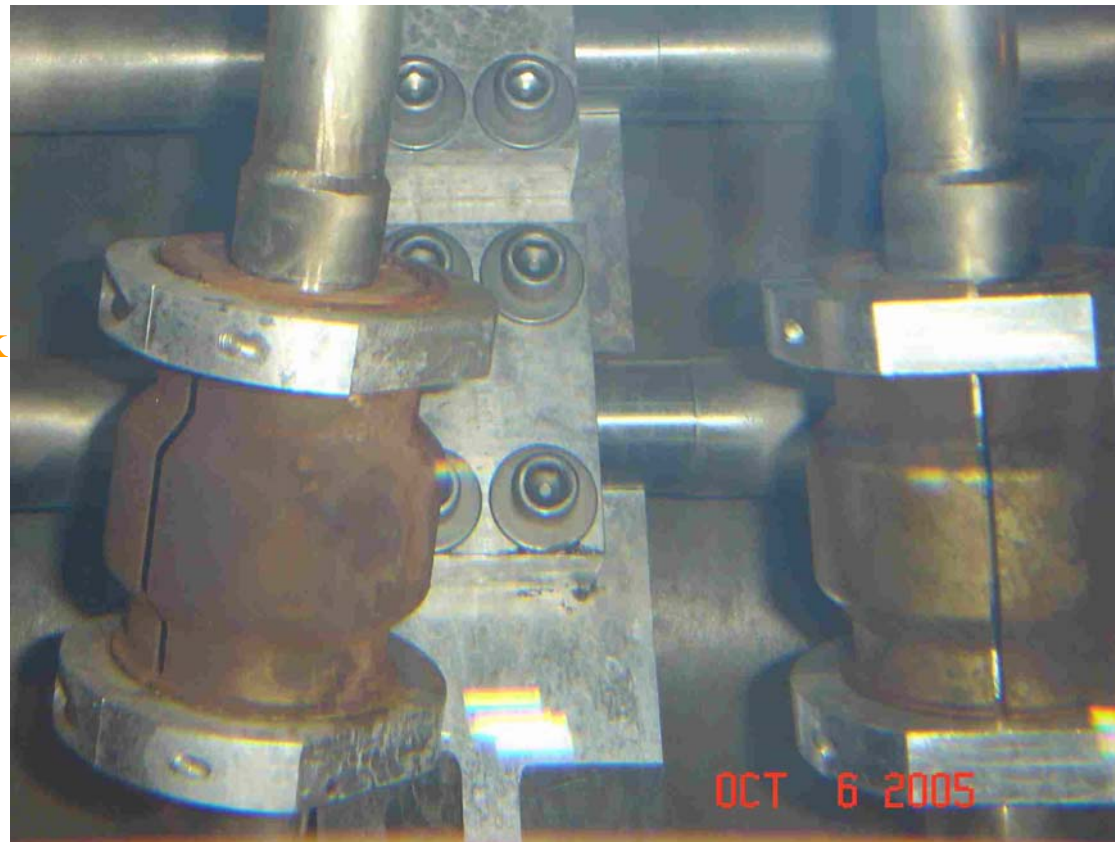
Have brazed ceramic electrical insulators on horn water lines
They are strain-relieved with invar+ceramic clam-shells

On horn 1, developed a 7gal/day
water leak on line to spray header

On horn 2, leak on suction line
drew air in, reducing amount
of water ejector pump could
remove from horn collection tank

Speculate braze corrodes...
planning to switch from brazed
to a shrink-fit ceramic/steel
connection for spare horns

Both ceramic sections were
successfully replaced

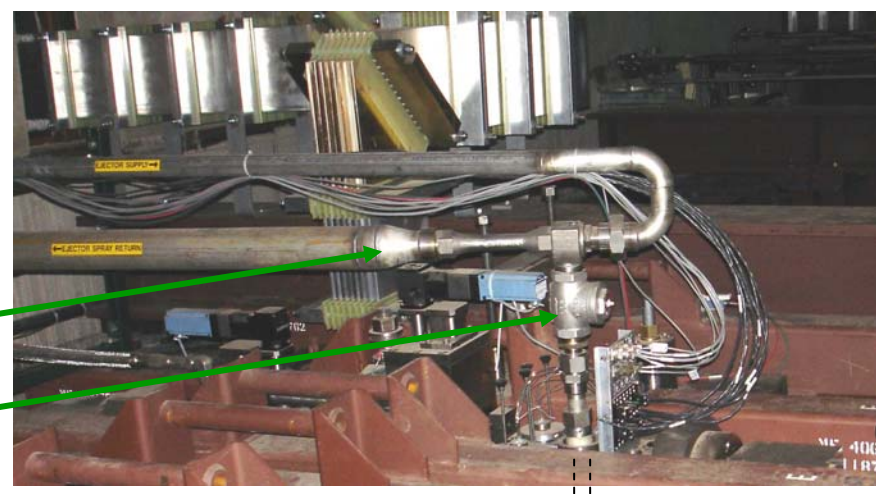
Ceramic electrical insulation
*hole here in suction line
drawing in air
reducing water suction*

Cut suction line for repair

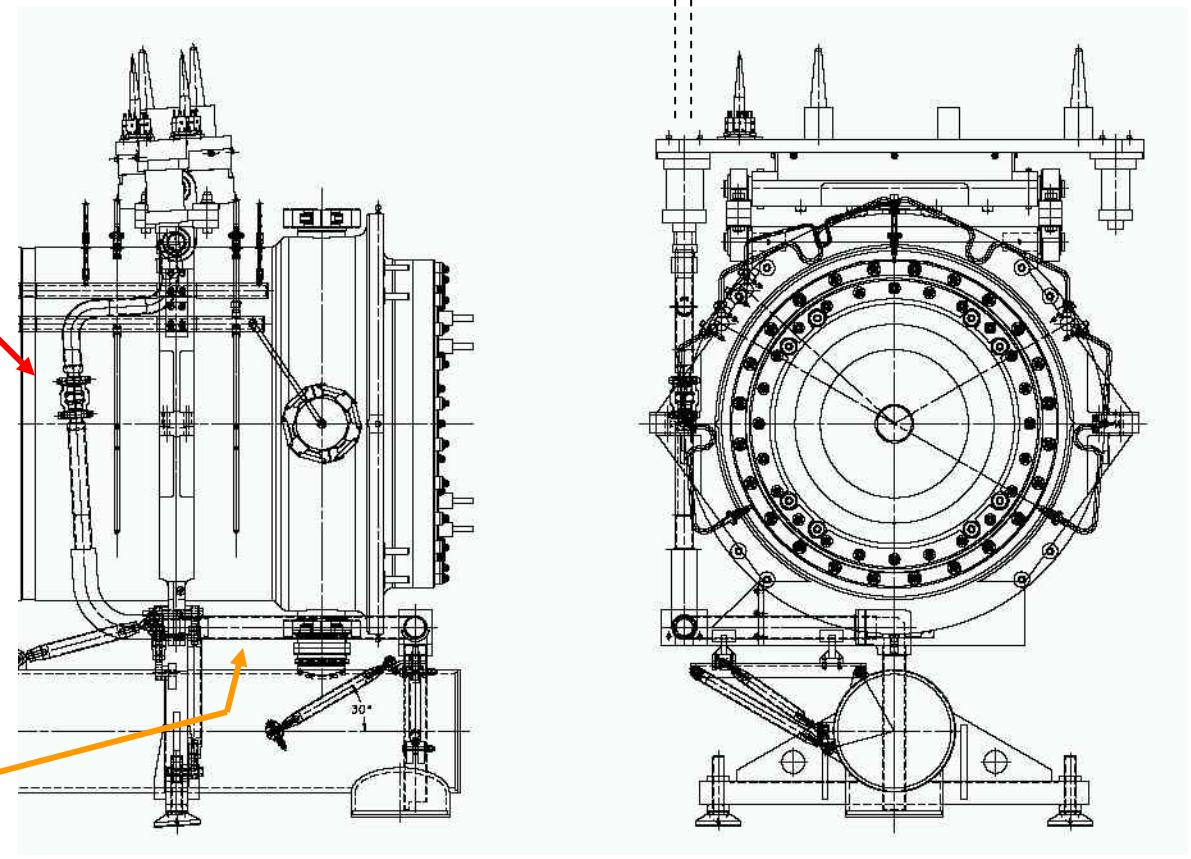
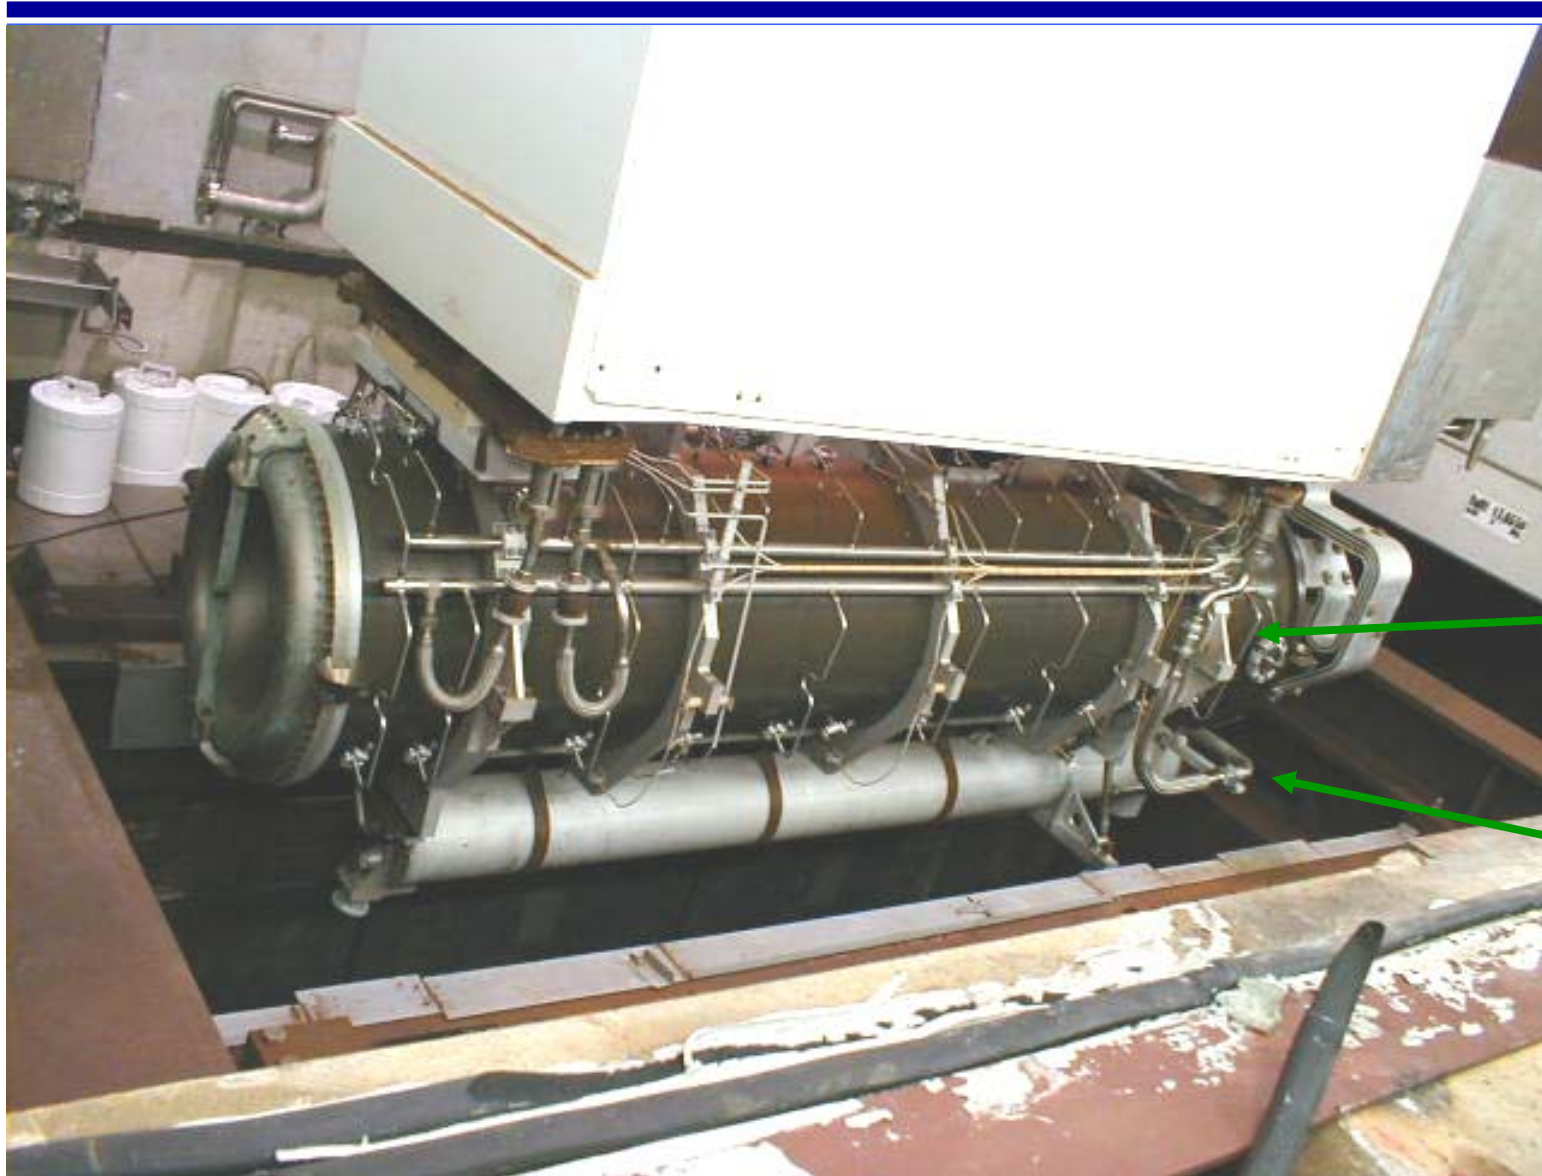
Horn 2 going back in shielding after suction line replacement

New
ceramic

Water
suction
line

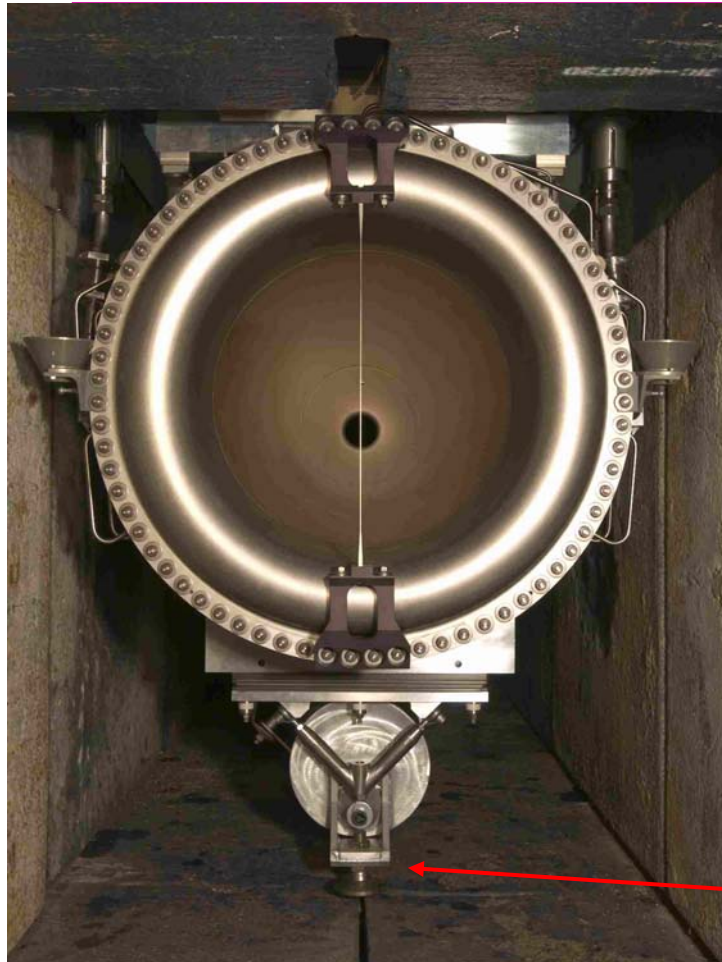
Horn 2 before beam
1.5 inch clearance foot to floor

Horn 2 ground fault - - loose foot on horn

Owl shift Thurs. Sept. 29, 2005 intermittent horn trips.
 Owl shift Sat. Oct. 1, hard ground fault of 1 ohm.
-removing stripline fingers Horn 2 + stripline block
-when Horn 2 moved to work cell ground fault cleared
-foot left behind in chase, nut had vibrated off
-scorch marks seen under foot

Moved old foot, installed new foot

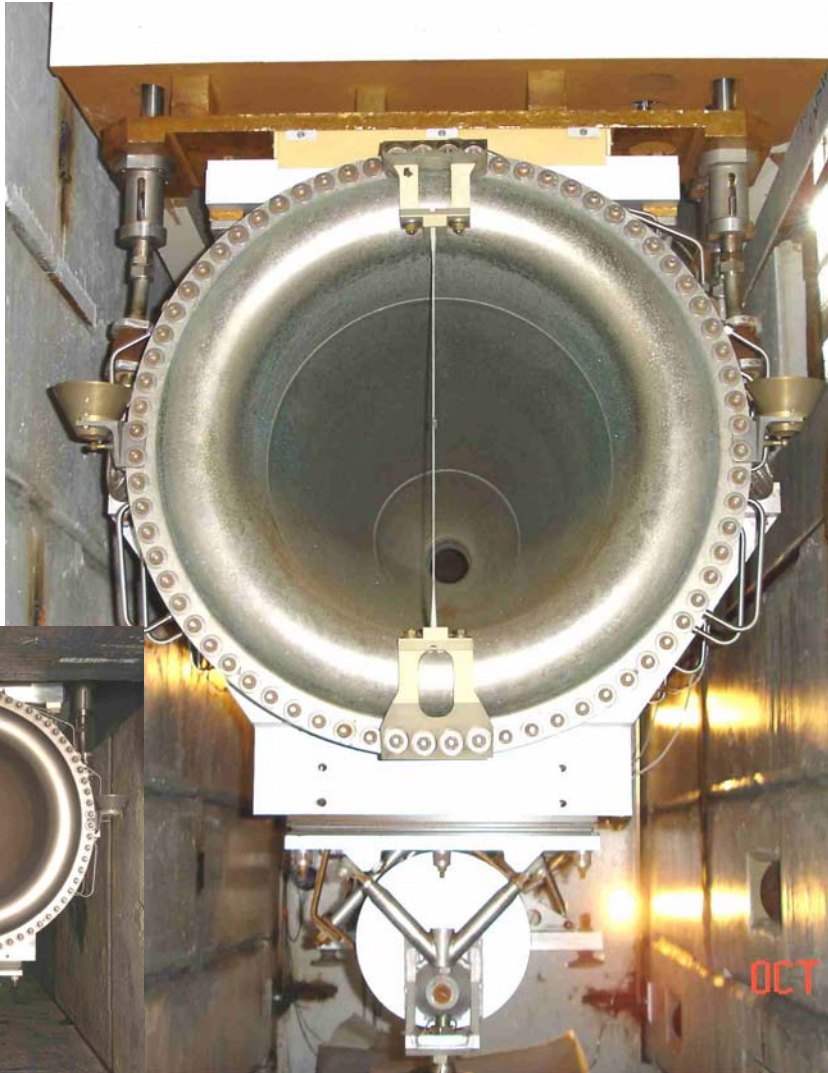
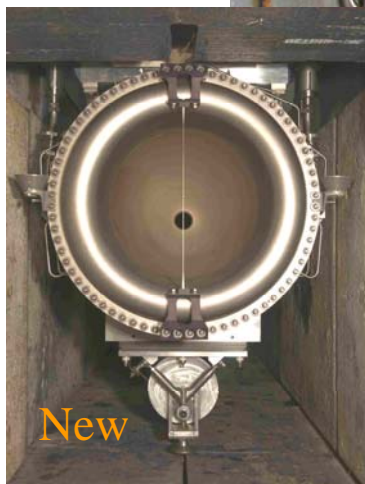
Visual inspection of horn 2

Zirconia Ceramic changed color
- ivory to coffee

Alumina Ceramic unchanged

Nickel-coated aluminum inner
conductor shows slight discoloration
- bottom covered by rust dust

Al cross-hair - lots of surface corrosion

Anodized Al outer conductor is good

Stainless parts look OK

Other horn 2 feet corroded in place

No obvious problem spots

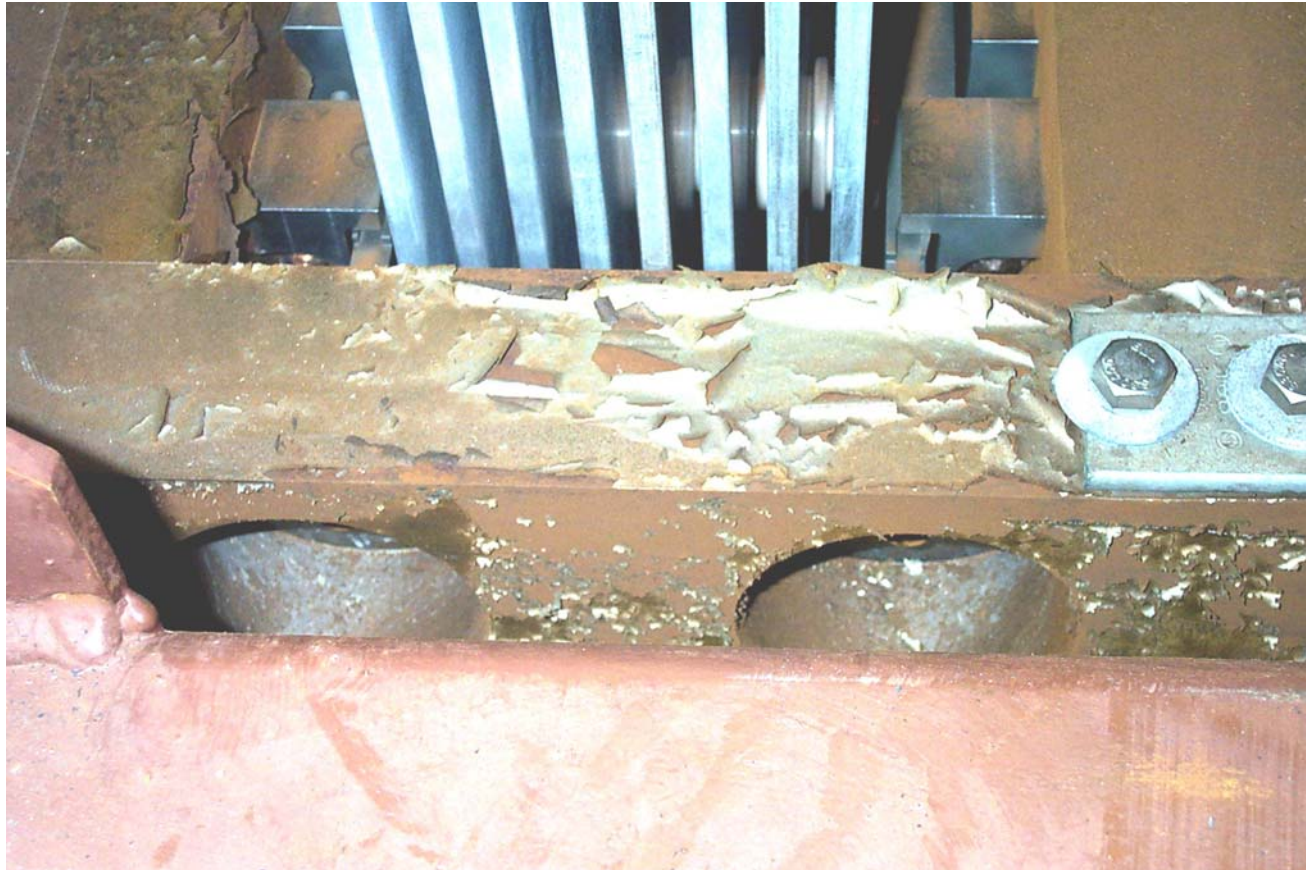
Strip-line block flake problem

Strip-line shielding block
is steel with nickel coating

Nickel is flaking off,
sometimes shorts stripline
but has always burned off
after 1 to a dozen pulses

We have rebuilt spare
strip-line block with
non-flaking technology
but haven't needed to
use it yet

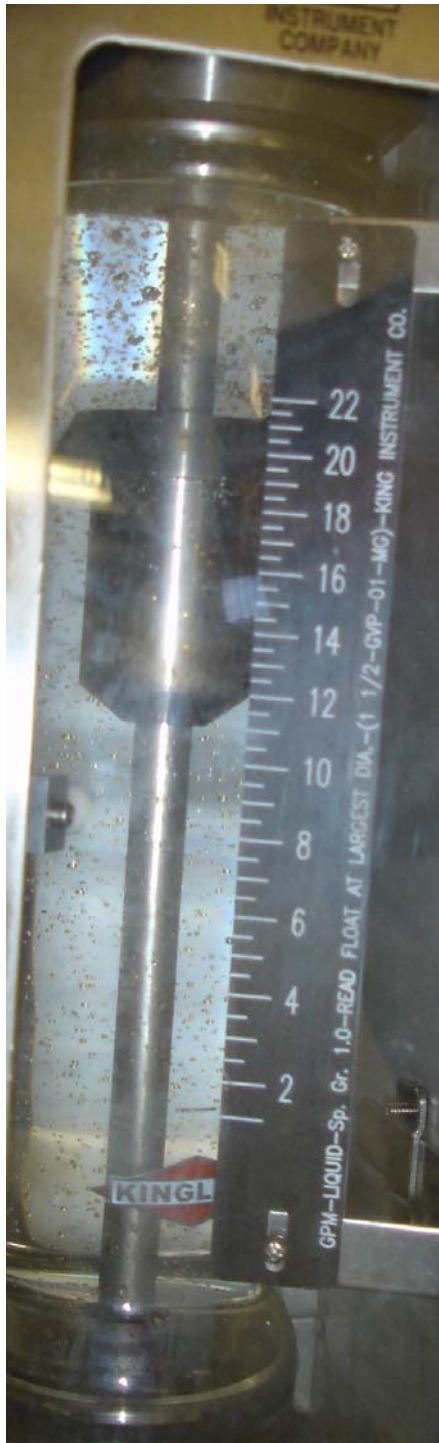
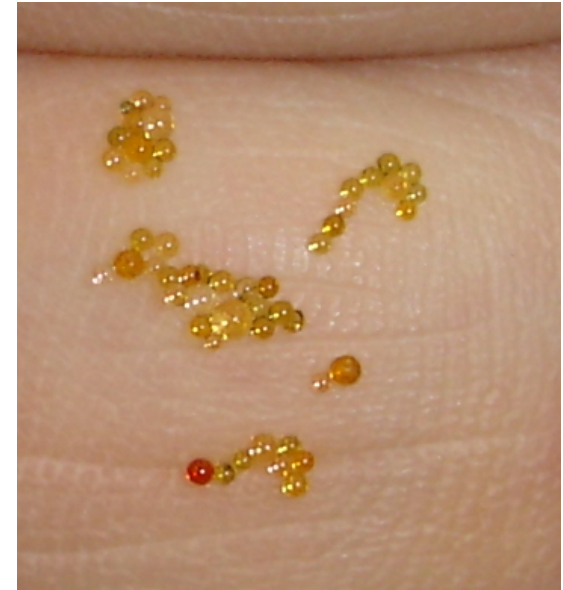
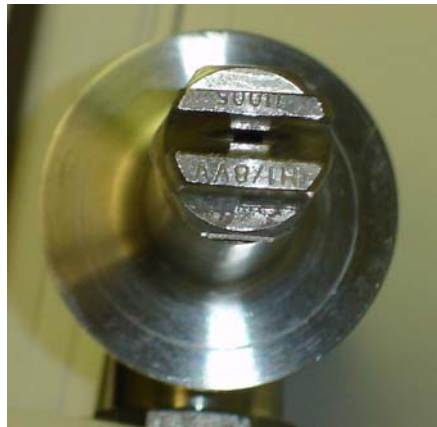
June 30, 2006, resin beads from deionization bottle clogged the water spray lines on Horn 1

← Horn spray flowmeter with beads

New, uncontaminated beads →
Beads are ~ 20 mils diameter

Horn nozzle for inner conductor is elliptical ~40 mils short direction (48 total)

outer conductor nozzles round, 25 mils diameter (19 total)

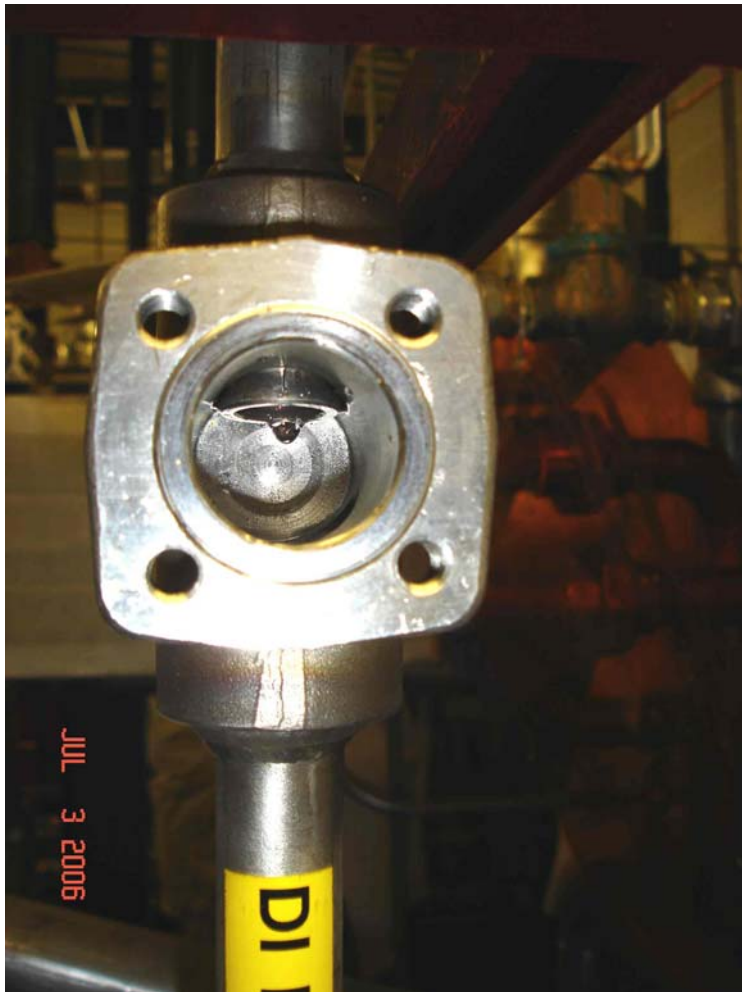
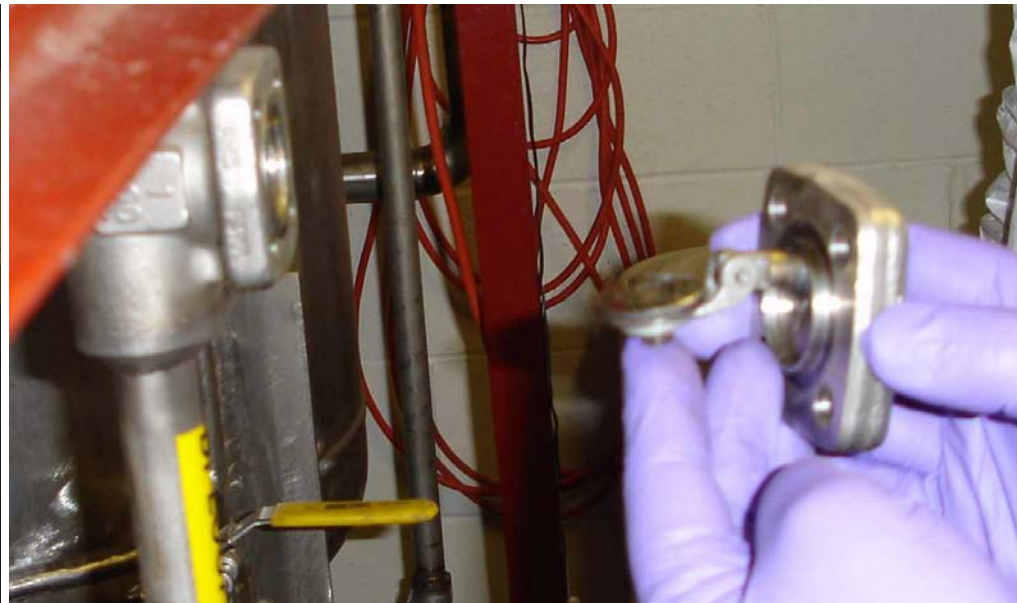
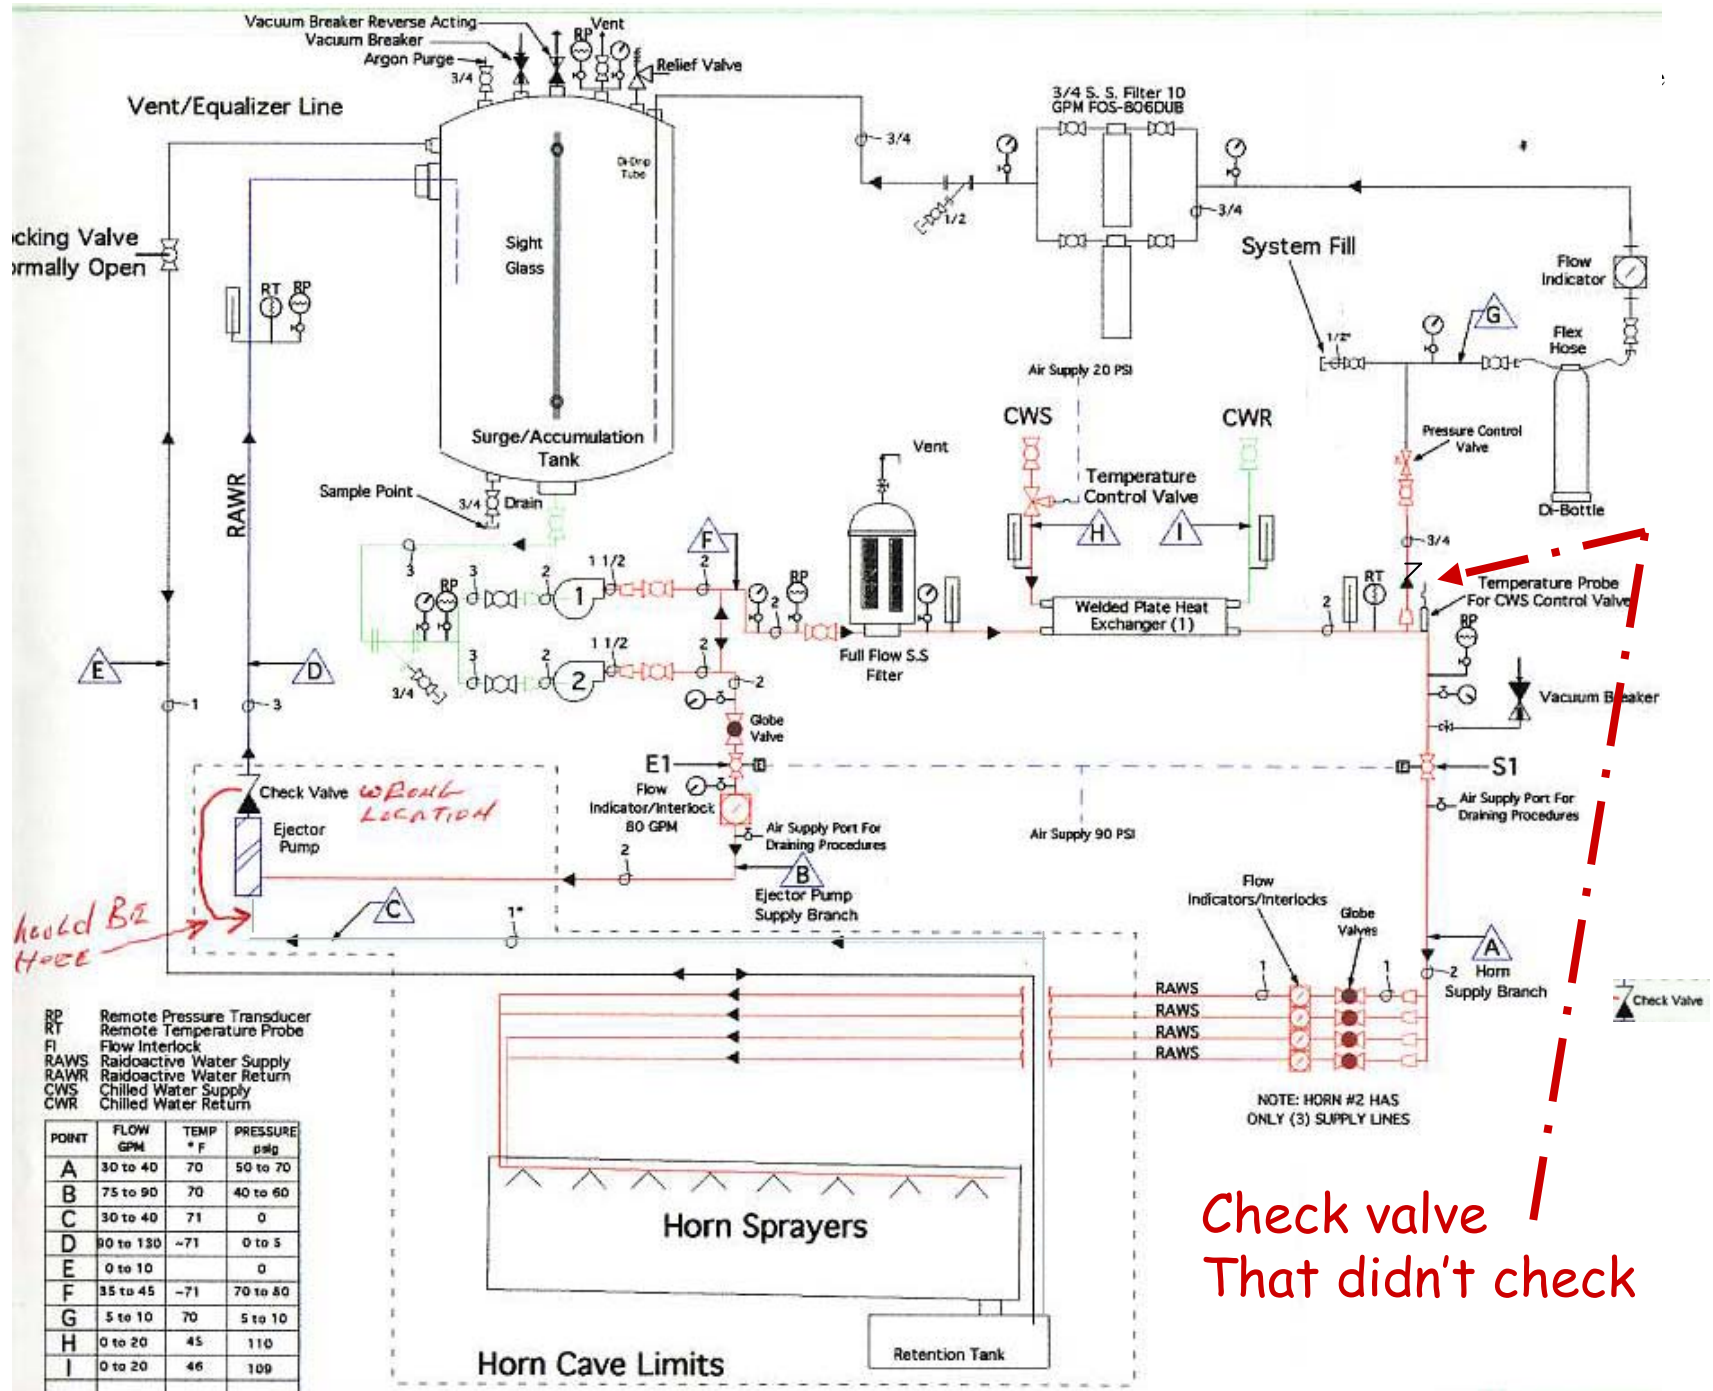
The gravity un-assisted check valve

When water skid was turned off for maintenance,
beads floated backwards
through improperly mounted check valve
