HIE-ISOLDE

Commissioning report

Walter Venturini Delsolaro
on behalf of the HIE ISOLDE Commissioning team

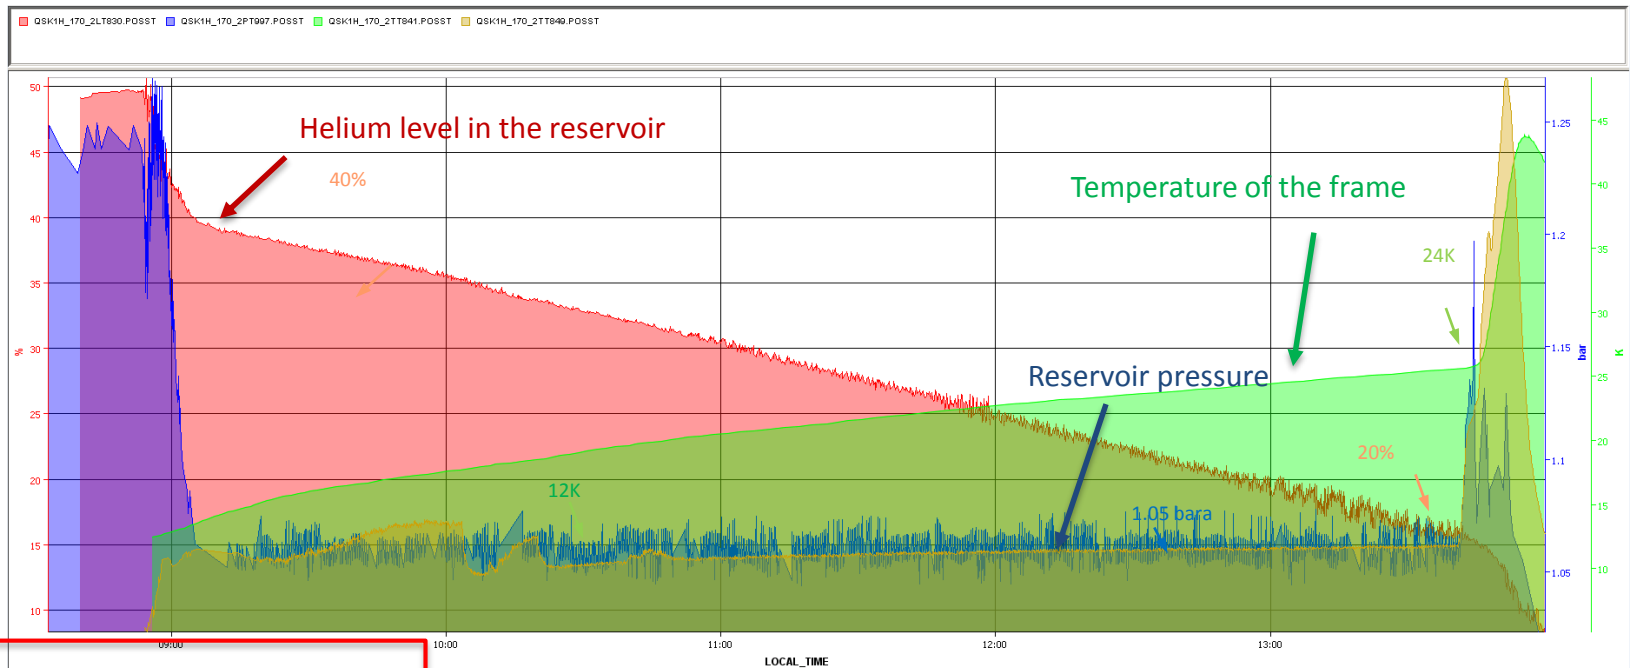
Static heat load measurement at 4.5 K

- **STATIC HEAT LOAD WITHIN EXPECTATIONS; NO ANOMALY. CRYOSTAT DESIGN QUALIFIED**
-

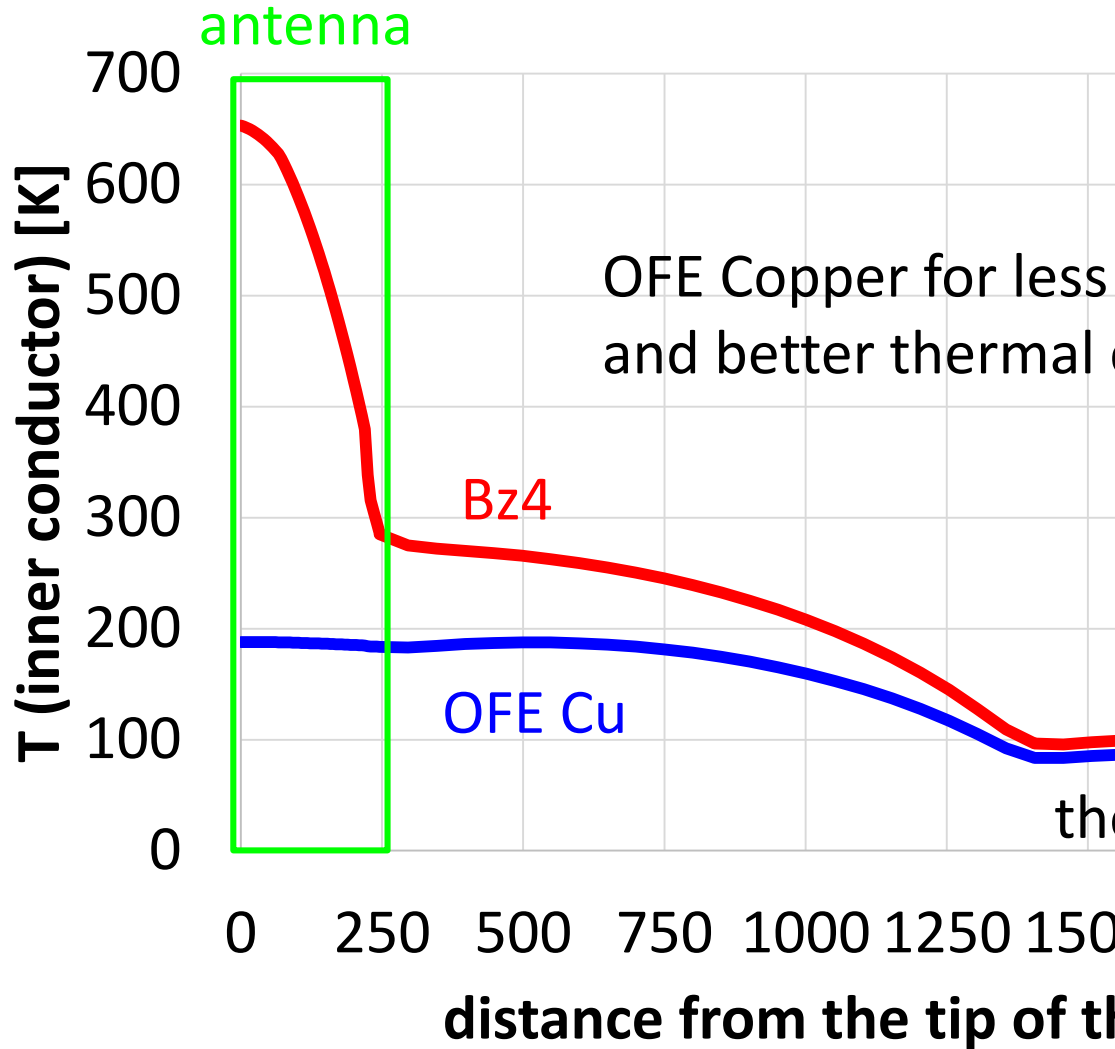
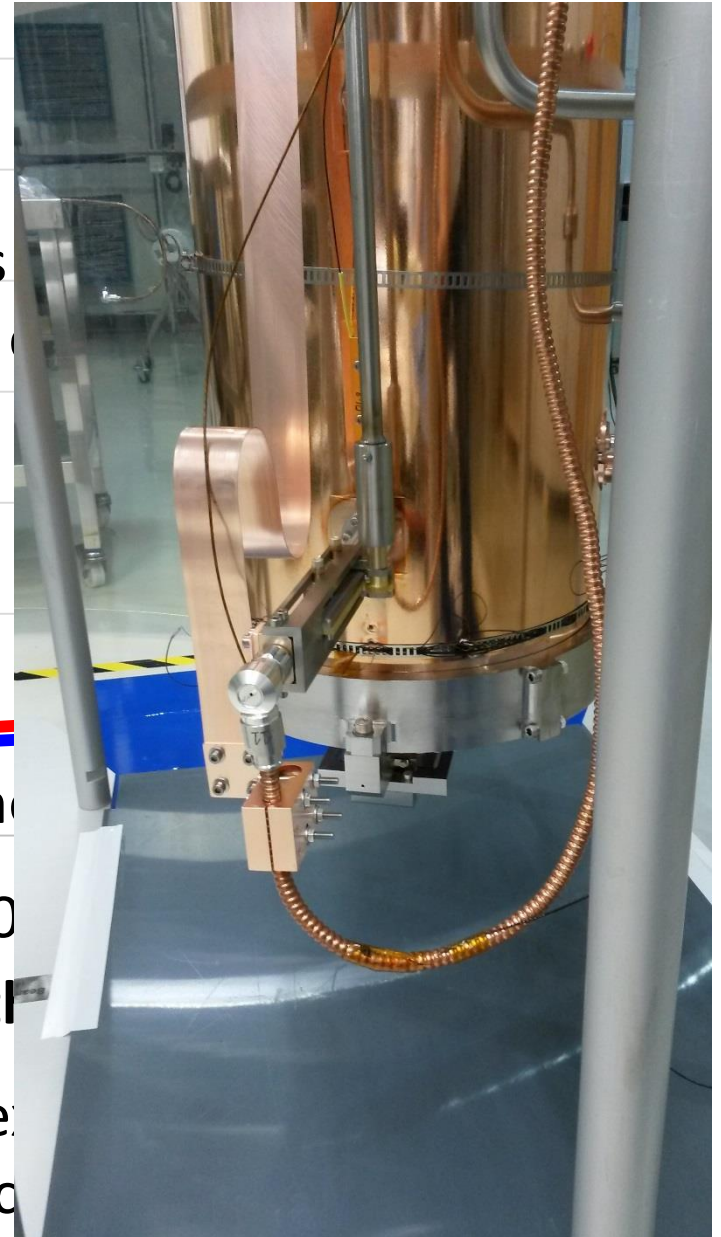
The contact between the antenna and the inner conductor of the cable is brazed

Bz4 \rightarrow OFE Cu (250W)

The simulation has *not yet quantitatively* e
 \rightarrow A **more conservative modification** is nec
