Operational Experience with the MICE Spectrometer Solenoid System

Sandor Feher

Fermilab

8/30/2017

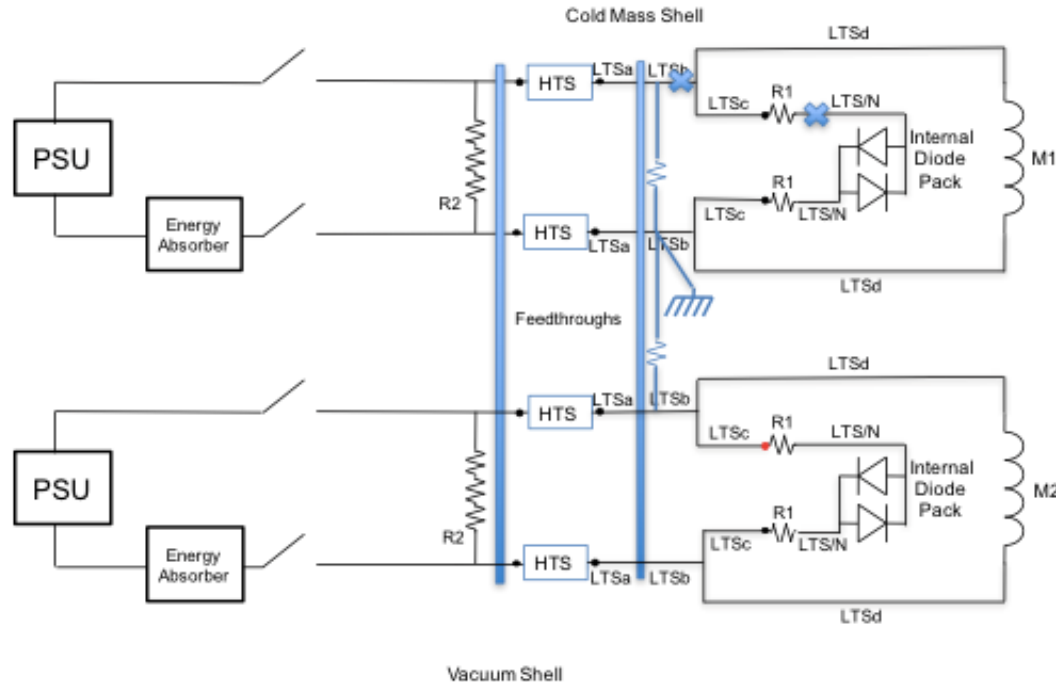
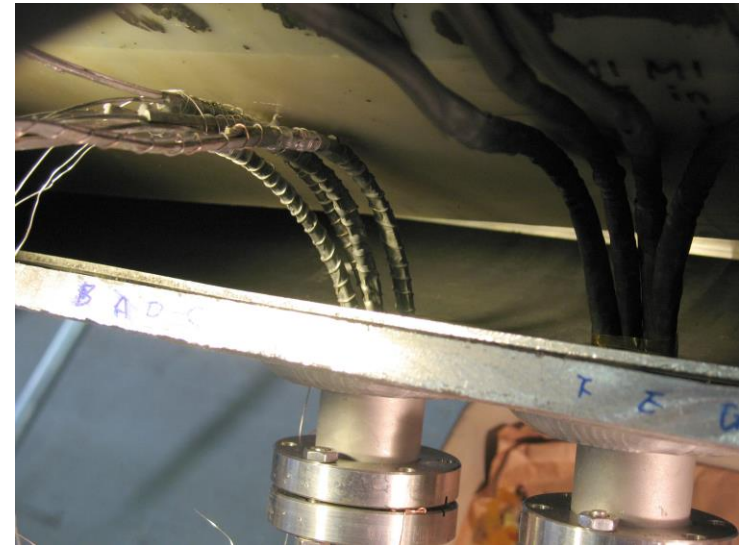
SSD after q6

Electrical tests were performed to verify the status of SSD

- M1 circuit was opened
- one of the M1 lead was shorted to ground
- between the two M1 leads the resistance was 5.7 k Ω
- between the M2 and M1 lead the lowest resistance was 2.6 k Ω .

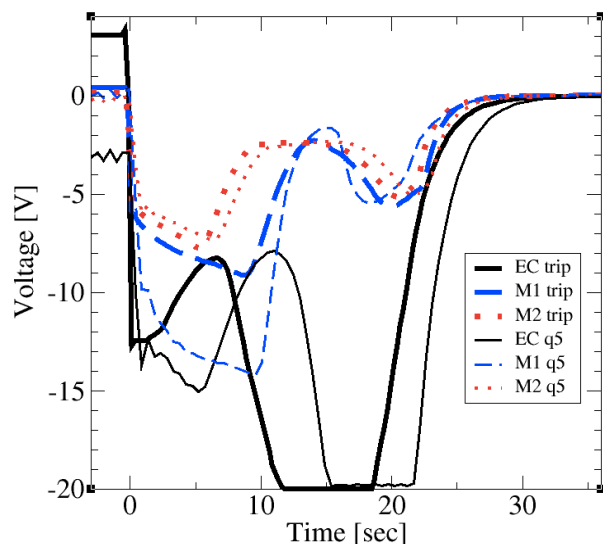
SSD Trip quench 5 and 6

Sequence: first q5 then a trip event

5th quench EC quenched first (M1 current at 198 A) was a normal quench with normal Voltage traces

The trip during ramp down (M1 current at 195 A)

- No EC quench
- M1 absolute voltage is a lot larger than expected
- M2 quenches about the same time as it quenched during q5

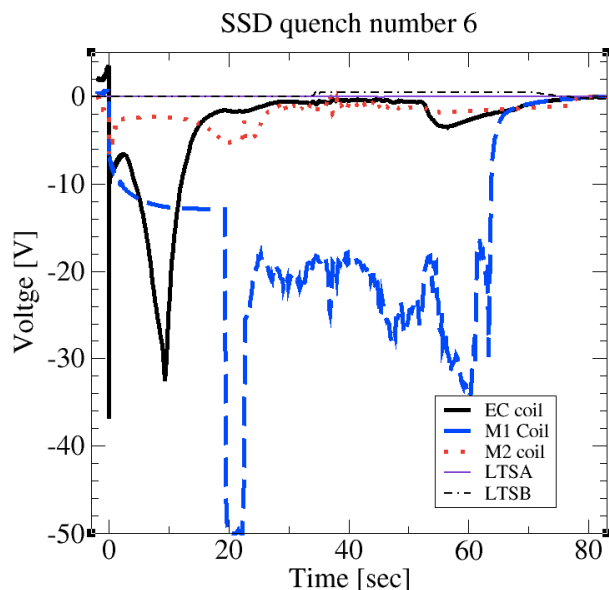
During the 6th quench (M1 current at 258 A) M1 was arcing

- EC quenched first
- M2 was not powered – quench back delayed significantly
- M1 circuit opened at ~ 20 sec
- M1 shorted to ground at ~ 30 sec
