LHC Status Report

96th LHCC meeting, CERN 19th November 2008

Interim Summary Report on the analysis of the 19th September 2008 incident at the LHC

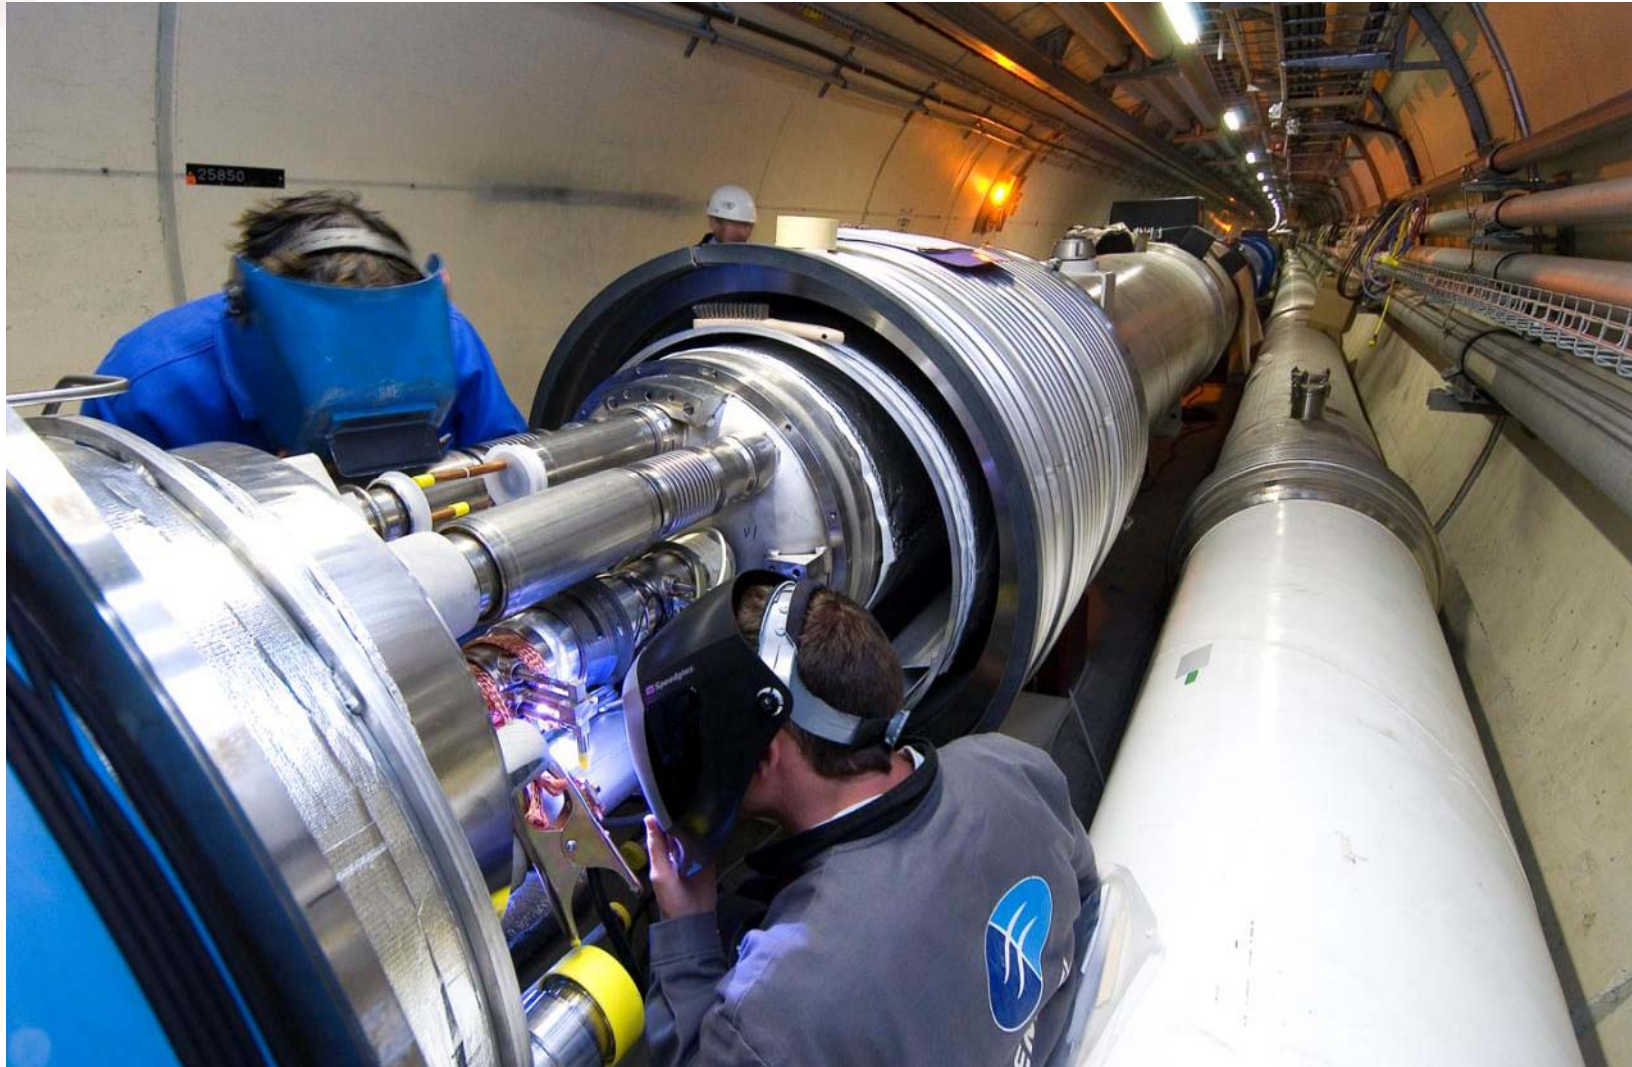
19th september incident

On 19 September 2008 morning, the current was being ramped up to 9.3 kA in the main dipole circuit at the nominal rate of 10 A/s, when at a value of 8.7 kA, a resistive zone developed in the electrical bus in the region between dipole C24 and quadrupole Q24. The first evidence was the appearance of a voltage of 300 mV detected in the circuit above the noise level: the time was 11:18:36 CEST. No resistive voltage appeared on the dipoles of the circuit, individually equipped with quench detectors with a detection sensitivity of 100 mV each, so that the quench of any magnet can be excluded as initial event. After 0.39 s, the resistive voltage had grown to 1 V and the power converter, unable to maintain the current ramp, tripped off at 0.46 s (slow discharge mode). The current started to decrease in the circuit and at 0.86 s, the energy discharge switch opened, inserting dump resistors in the circuit to produce a fast power abort. In this sequence of events, the quench detection, power converter and energy discharge systems behaved as expected.

Within the first second, an electrical arc developed and punctured the helium enclosure, leading to release of helium into the insulation vacuum of the cryostat.

The spring-loaded relief discs on the vacuum enclosure opened when the pressure exceeded atmospheric, thus relieving the helium to the tunnel. They were however unable to contain the pressure rise below the nominal 0.15 MPa absolute in the vacuum enclosures of subsector 23-25, thus resulting in large pressure forces acting on the vacuum barriers separating neighboring subsectors, which most probably damaged them. These forces displaced dipoles in the subsectors affected from their cold internal supports, and knocked the Short Straight Section cryostats housing the quadrupoles and vacuum barriers from their external support jacks at positions Q23, Q27 and Q31, in some locations breaking their anchors in the concrete floor of the tunnel. The displacement of the Short Straight Section cryostats also damaged the “jumper” connections to the cryogenic distribution line, but without rupture of the transverse vacuum barriers equipping these jumper connections, so that the insulation vacuum in the cryogenic line did not degrade.

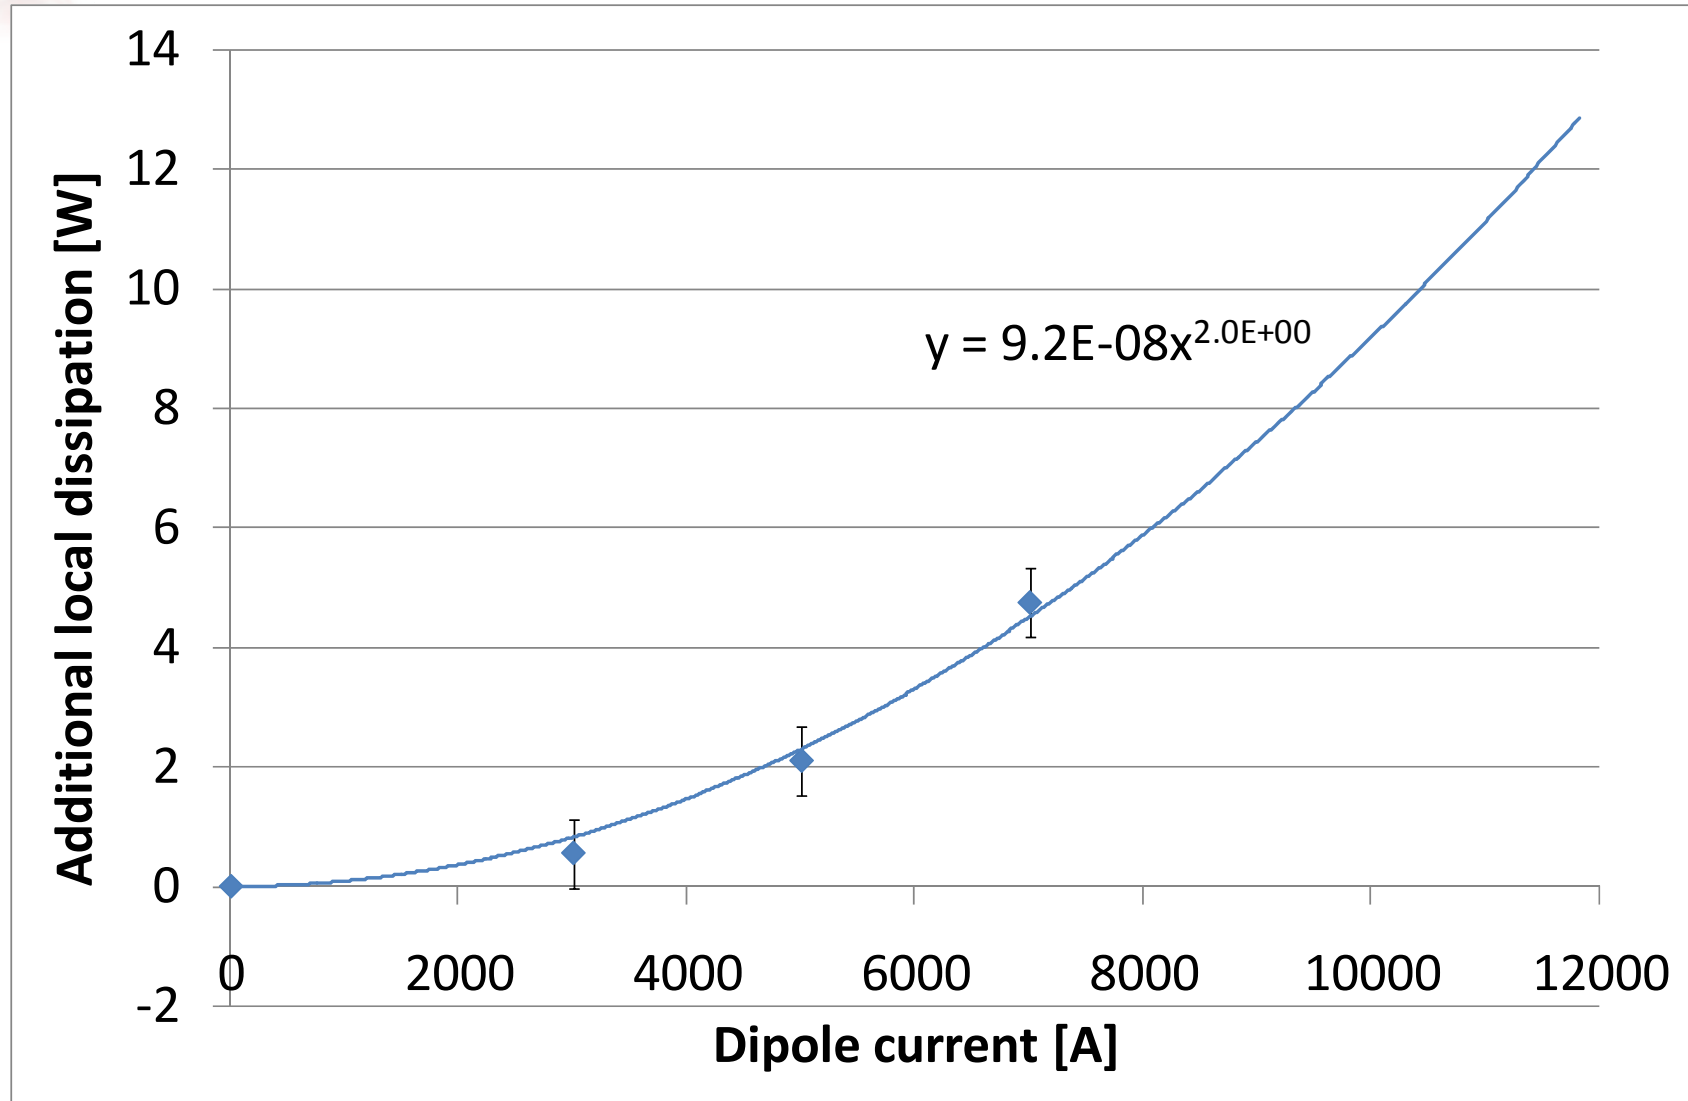
Additional local dissipation in 15R1

- **Calorimetric measurement during the repowering of sector 1-2 has confirmed an additional resistive heating in the sub-sector 15R1**
 - The corresponding electrical resistance is about 90 nW

- At nominal current the additional heat dissipation will be about 13 W (not an issue for cryogenic system)
- **The present calorimetry measurement is impressively good thank to:**
