Electrical Performance of LHC Magnet Circuits

F. Rodriguez Mateos, TE/MPE-EE
Chamonix 2016
Session 3: LHC Hardware Performance

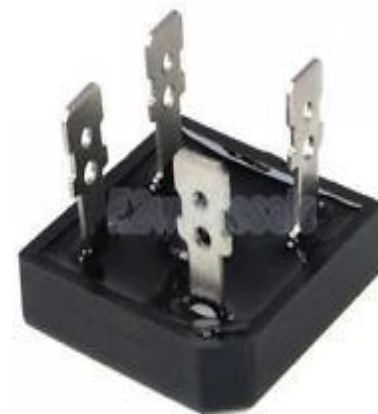
- One issue (22/07/15) due to an AC/DC bridge rectifier which failed in short circuit leading to an impossibility to **close** extraction switches of the related RB EE system in S34 in Point 3.
 - This has been the **third such a case registered since 2007**
 - Study is still on-going and a possible re-design of this auxiliary circuit could be planned for future LS
- Two issues due to quadrupole dump resistor cooling fan failure:
 - 03/11/15 - A fault of the fan (wrong connection of the terminals) tripped the local circuit breaker preventing of having the extraction switches of RQD.A43 **closed**
 - 13/12/15 - A ruptured fan-stator coil slowed down the dump resistor **cooling** process of RQF.A12 energy extraction system
 - **Three broken fans have been registered since 2008**

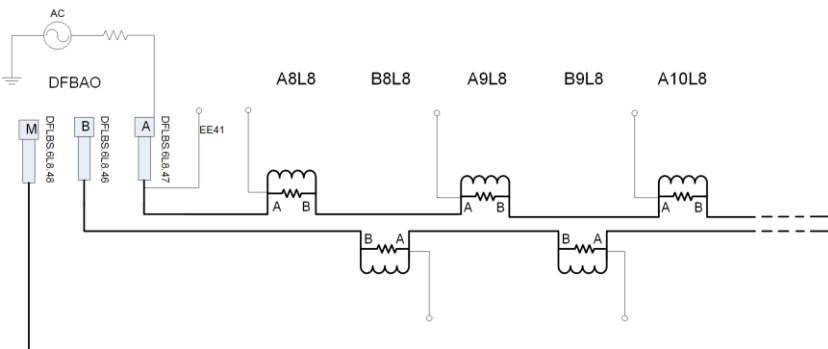
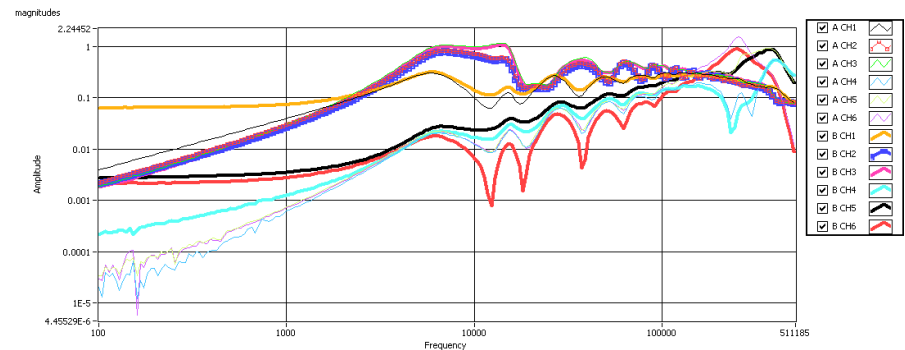
RCS.A78B2

- This earth fault is conditioned by the powering of other circuits, independently from the powering of the RCS circuit itself
- Machine can operate without this circuit
- **However** the origin of the fault needs to be understood as soon as possible
 - Plan corrective interventions at this location, but also preventively at other symmetrical locations
- Type-test results from a special measurement set-up:
 - Noise levels are fairly low
 - Measurement precision is high
 - Results are nevertheless very difficult to interpret due to a complex topology of the circuit
 - One more calibration run needed at fully superconducting state
