Technical news, shutdown and TISD

Thierry Stora on behalf of Richard Catherall

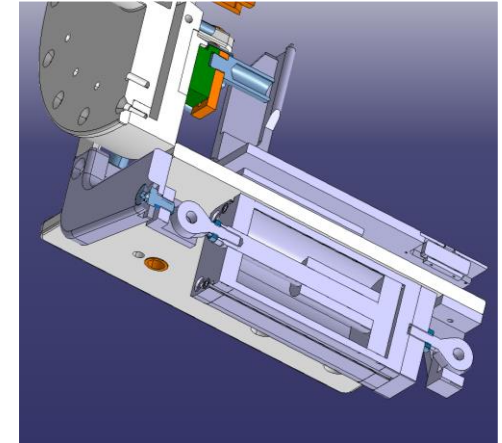
Observations...Monday 13th July

- Unable to pump target #541, then target #519.
- Potentiometer value OK but large uncertainty.
- Human intervention for observation:
 - Target clearly not connected to Front end + A lack of coupling force
- Compressed air electrovalves in HRS separator confirms that Frontend piston has internal leaking

Replacement and outlook

- Piston replaced with spare identical : ~ 1 min (Collective dose observ 66 μ Sv & repair 51 μ Sv)
- With piston lifetime ~ 6 months, exchange GPS piston in Sept 2015 after 2 weeks w/o protons.
all metal replacement... if finished and tested, or with identical standard piston with PU seals.

All metal pistons should be available for replacement during the next shutdown

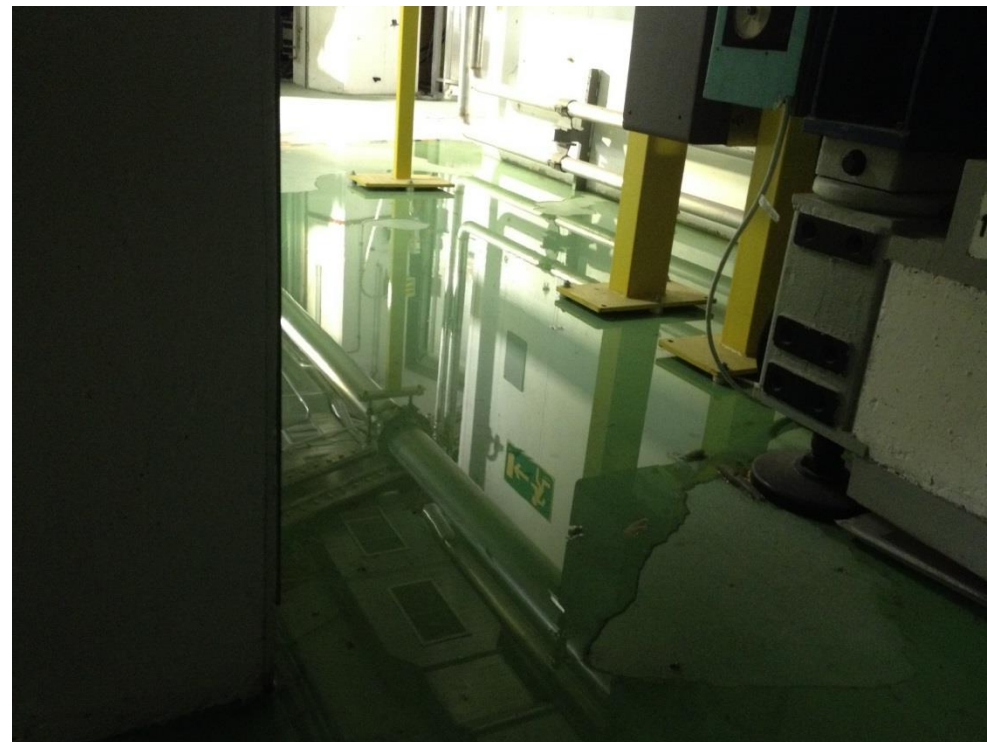
Water leak – Tuesday 28th July 2015

- Alarm on water detectors in both GPS and HRS trenches
 - Repeated filling of water reservoir not detected due to slow rate (6lh^{-1}). This will be modified this shutdown
 - <1cm of water in GPS trench
 - Water puddle underneath BTY line between GPS and HRS Frontends
- A disconnected tube and faulty valve used for the purge of the magnet cooling system.
- A permanent repair will be done during the YETS

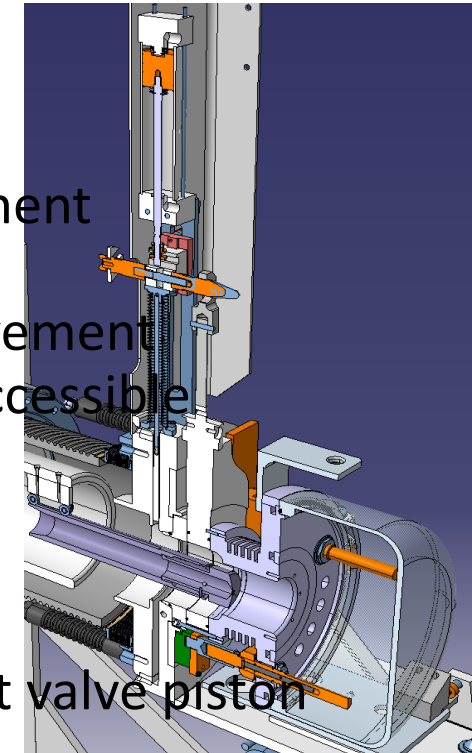
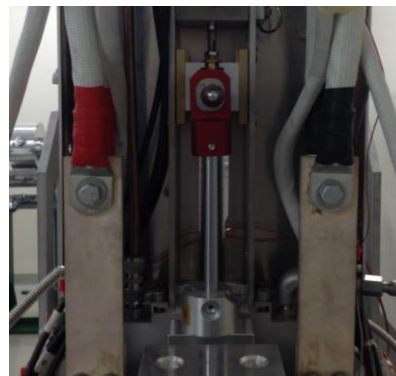
- The valve on target #543 could not be moved to its fully closed (sealed) position
- No sign of movement could be observed on the cameras (all interlocks ok)
- A compressed air tube in the HRS separator zone was reconnected but still no movement
- An electro-valve on the same compressed air line was found to have a fault.
- These were (all replaced in January 2015 as a preventive measure) still no piston movement
- The compressed air pressure was checked in the line No sign of any CA leaks in the accessible areas

Possible causes

A compressed air leak in the line situated in the less accessible areas

- This has happened 1x / only checked by measuring P at the entrance to the target valve piston

A compressed air leak at the CA connection with the piston

- Possible due to orings in connectors: Would be heard/seen upon intervention

The extraction electrode is still inserted : since interlocks are OK : only if mechanics are broken internally

The target valve is gripped

The piston is gripped

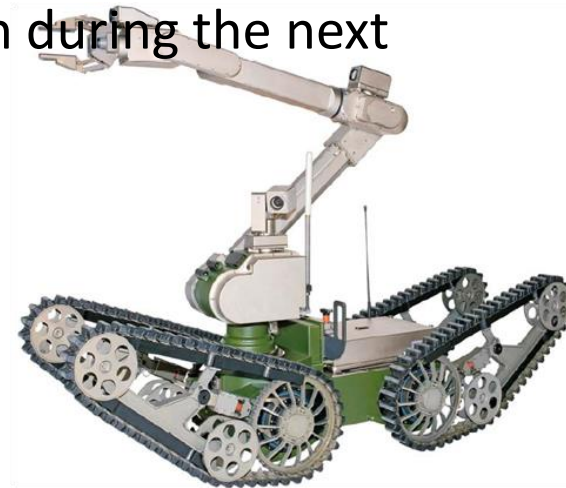
- All possible causes were checked and everything was working fine with the exception that the valve closed but did not seal: Acceptable for target removal; Was probably the case all the time but...
- Poor visibility from existing cameras
- A certain stress accumulates under these circumstances
 - An accidental high dose received by one person
 - CERN hierarchy (On one occasion Richard was asked to present the issue to the IEFC before the actual repair)
 - CERN safety
 - Physics program etc

- **Improve on cameras** : Telescopic camera design on-going. Ready for installation during the next shutdown
- **Improve on redundancy of feedback from Frontend movements**
 - During long shutdown period due to inaccessibility
- **Precede any human intervention with a Telex intervention**
 - Better diagnostics through visualization
 - Possible to do minor interventions if prepared beforehand

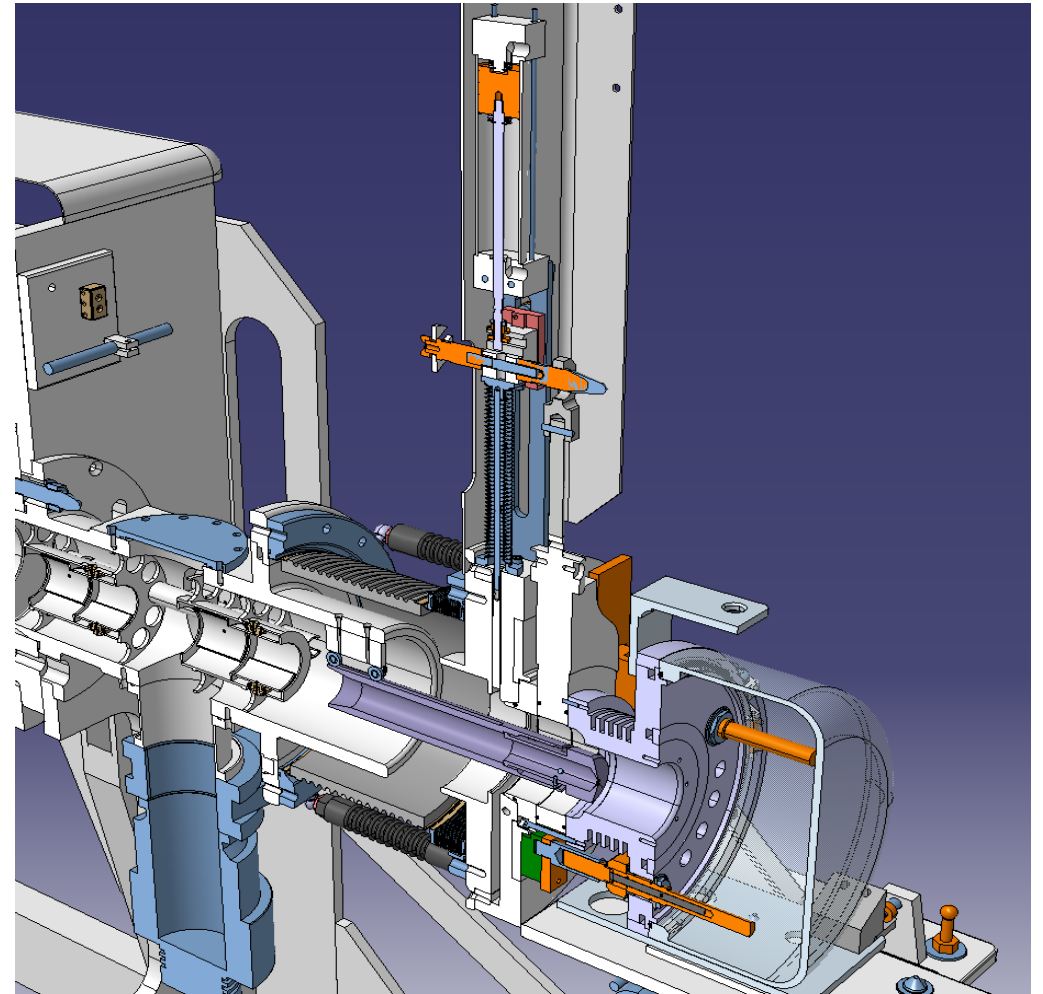
- Tuesday 11th August
 - The extraction electrode on the GPS Frontend could not be moved back to its home position
 - Stopped at position 153 instead of 178.
 - This is required to close the shutter and target valve prior to a target change.
 - All external infrastructure checked
 - Compressed air, controls etc

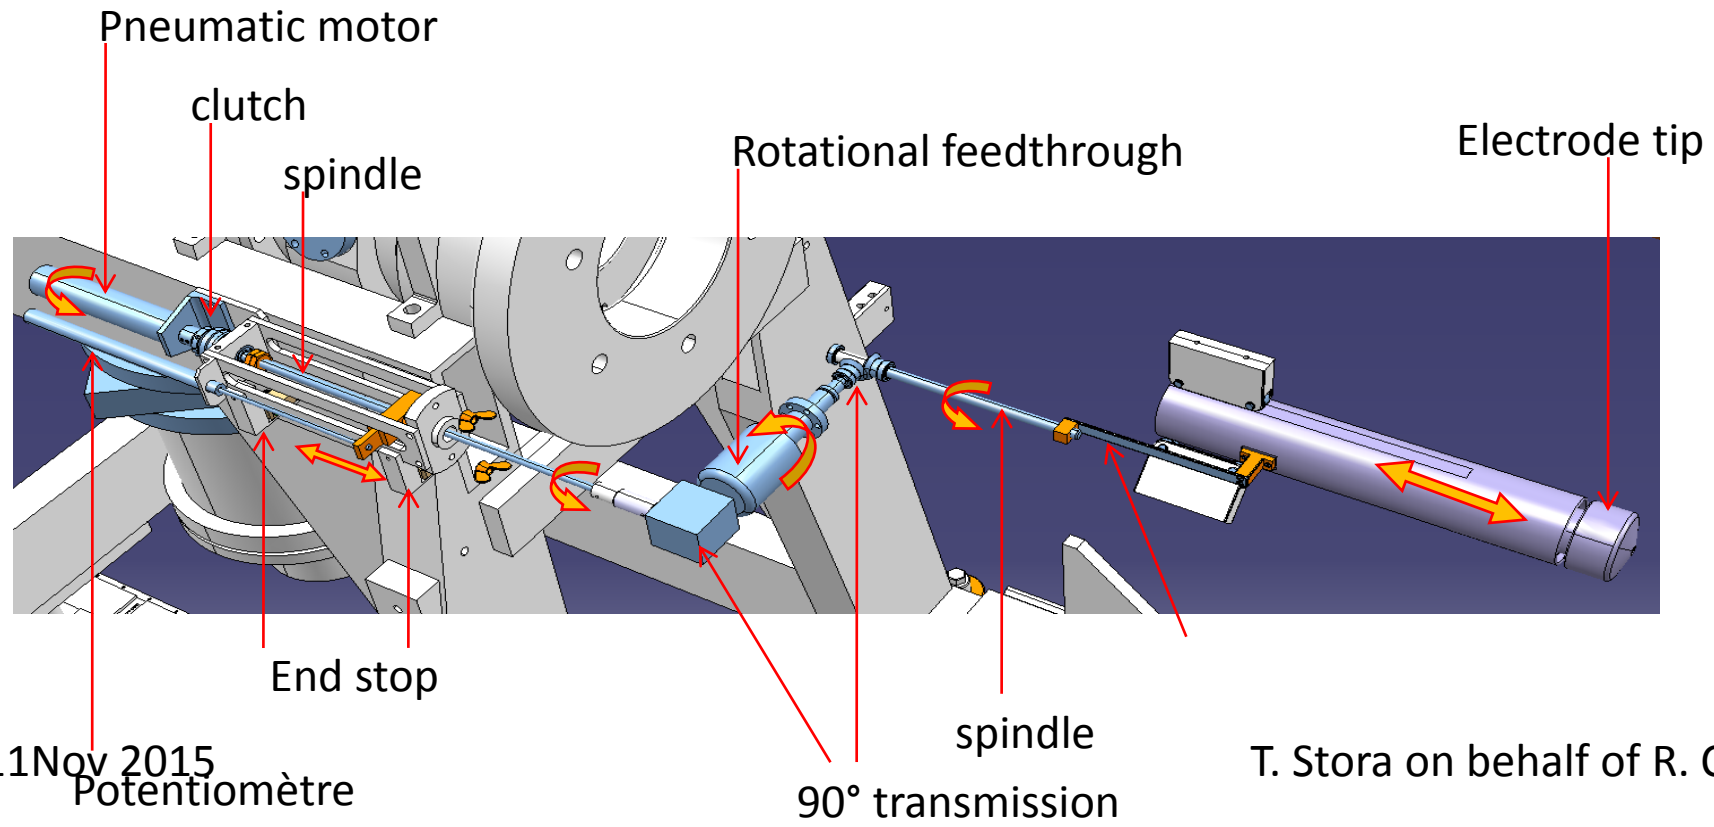
- Wednesday 12th August
- Sent in Telemax robot to visualise and to identify cause of problem

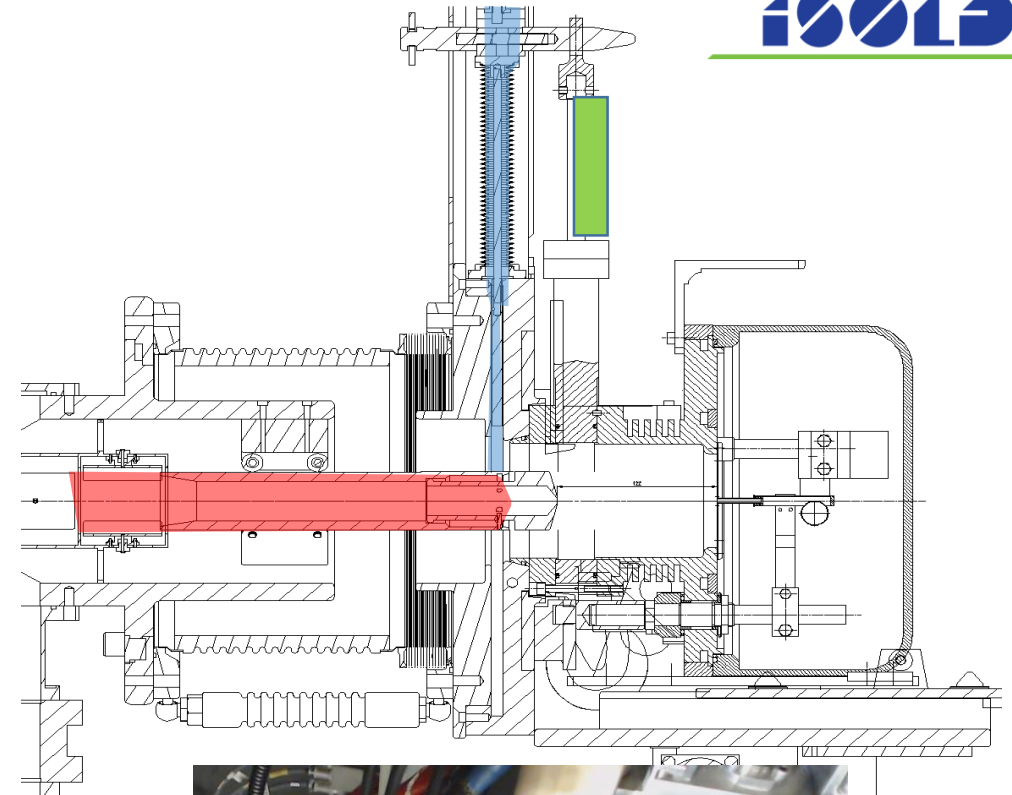
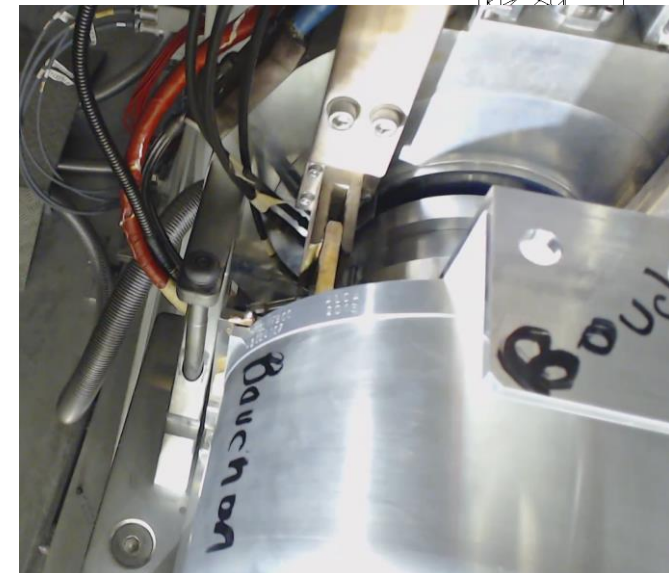
- Removal of highly radioactive target with Kuka robot to facilitate possible future interventions.
 - Repair or failure of Telemax
- Delicate operation due to unknown position of EE
- Used Telemax to place a support to maintain valve in open position
- Target uncoupled and after inspection, support removed with Telemax and target removed by Kuka robot
 - Valve closed (but not sealed) by gravity
- **But plug target didn't couple correctly?**
 - **Neither did the second plug target**
- After further observations, the problem was located at the connection between the clutch and the spindle.

- 25th August
- Replace clutch screws with bigger and easily accessible pointed screws
- But...
- 2 screws on the 90 deg. transmission were also loose!
- Loss of synchronisation between real EE position and potentiometer measurements
 - Slippage
 - During tests, shutter hit the EE tip even though at home position
- **Replacement of target coupling piston**
 - Same as recent HRS coupling failure
 - Planned to be done as a preventive measure

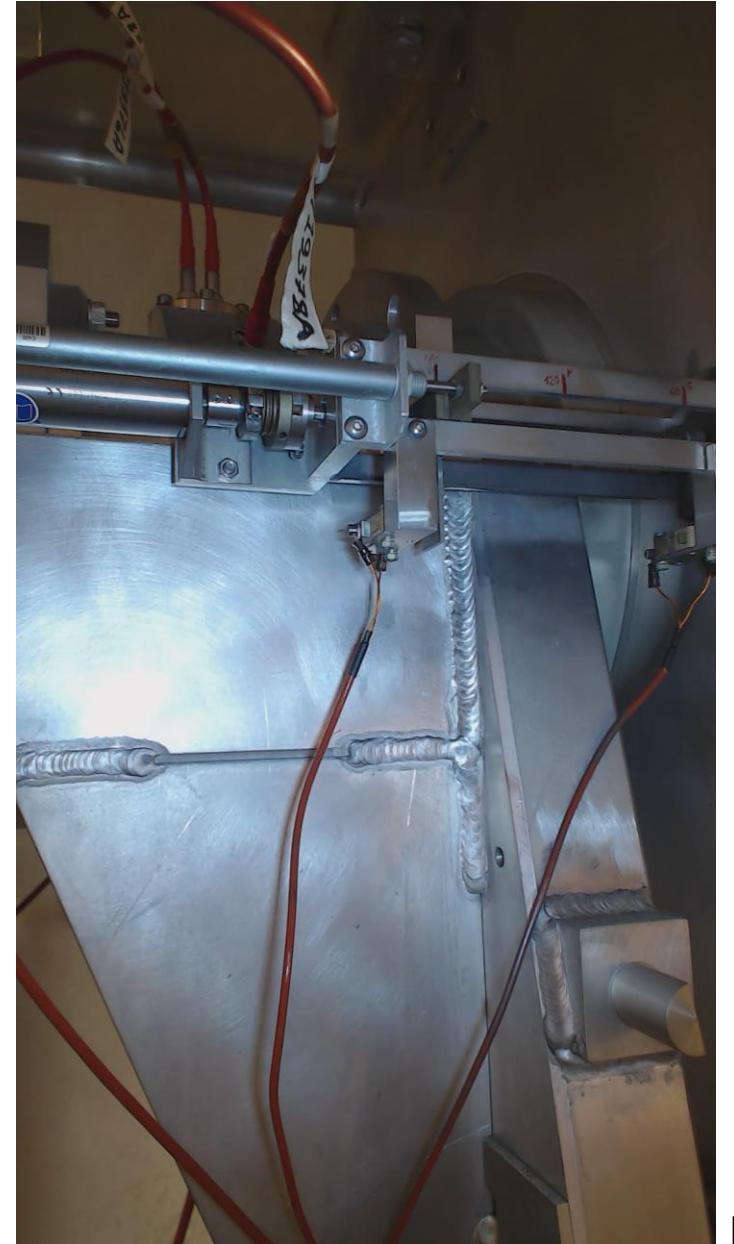
- Extraction electrode couldn't be moved more than ~40mm (instead of up to 120mm)
 - During tests, a mix up in the EE/shutter/clamping process ended in the finger not being engaged in the target valve.
 - EE collided with valve and the tip had become dislodged in its support.
- Plate for micro-switch triggering had to be re-adjusted
- 26th August..12:00
 - Extraction electrode repaired and GPS FE deemed operational again.

- Vibration seems to be the cause of the screw loosening and we will have to revise the EE mechanism during the next shutdown
 - Very difficult for internal pieces
- The Telemax robot has been instrumental in diagnosis and consequently reducing the collective dose
- Hidden consequences of trying to improve on reliability
 - New robots > new coupling table > new piston design/configuration
 - Stepping motors with encoders > compressed air motors > new EE mechanism
 - All tested but not tried...
