Repair of 34

Chamonix 2009

Other systems - what needs to be done? Repair and reinstallation of other systems

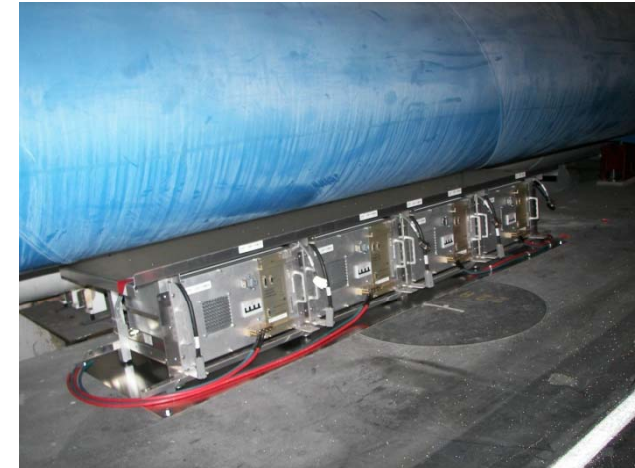
PC 60A - problems

4 converters showed traces of oxidation (Cell 28).

3 converters have required repairs:

- RCBH30.R3B2 (dead capacitor due to cold?)
- RCBH24.R3B2 (Overvoltage through current lead voltage taps)
- RCBV24.R3B1 (Overvoltage through current lead voltage taps)

Their DC connectors on DC cable side have to be changed

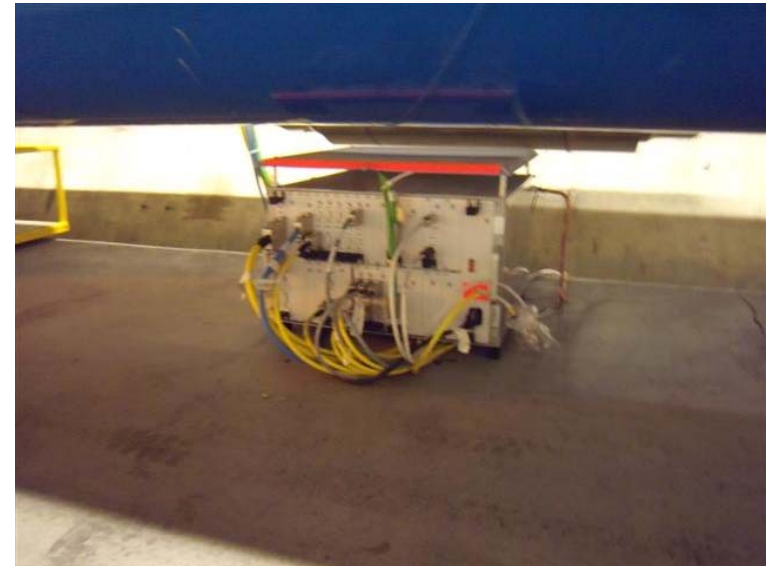
CRYO inst - problems

**Only one card was blown out,
most likely because of a small
piece of MLI creating an
internal short circuit**

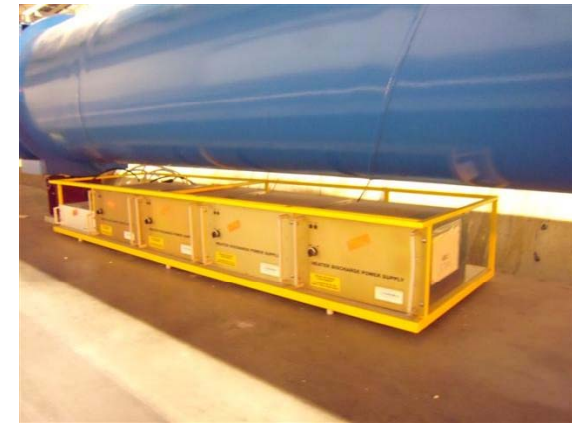
QPS racks - problems

- Only QHPS in the D-area have been removed
- Some of them have been analyzed and many have seen a dielectric breakdown at the level of the input diode bridge for charging of the capacitor
 - No clear explanation (due to condensation inside?)
 - They can be easily repaired
 - Removal of the others depending on the situation

- All of them have been removed
- All at right of D-area have been cleaned
- Analysis to be done in all the others

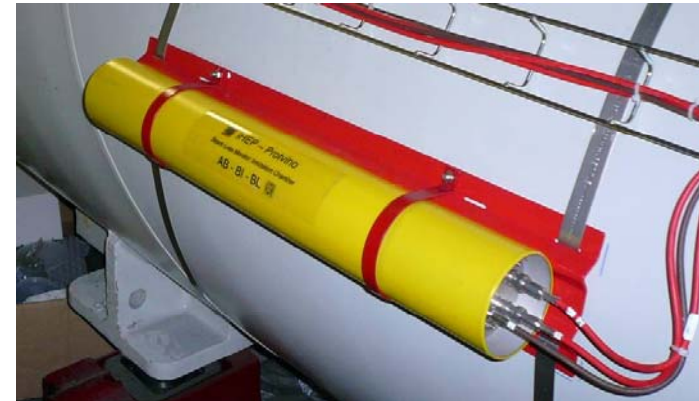
RU.L4 removal (?)

Broken internal resistance
(manufacturing problem)

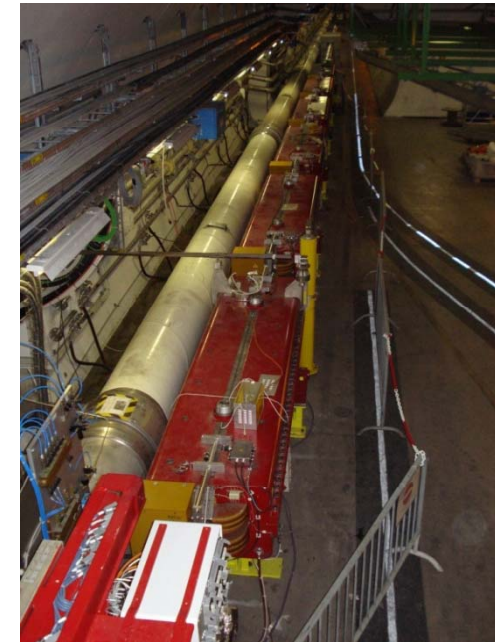
Re-cabling of RQT4.R3 -RQT5.R3

The commissioning of the two magnets showed the impossibility to keep the nominal current in the circuits due to the increase of T of DC cables and magnets. This effect produces a significant variation of the resistance of the circuits with the consequence that the PC is not longer able to provide the nominal current
