## VACUUM SYSTEM – HOW TO GET READY FOR BEAM ?

V. Baglin, CERN, Geneva, Switzerland

On behalf of the team in charge of cleaning the beam vacuum in sector 3-4

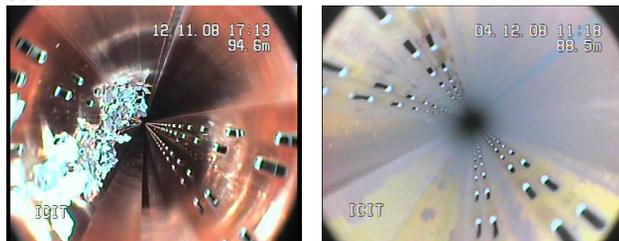
The beam tubes were polluted by interconnects and soot debris and super insulation debris. Electron microscopy Analysis of the soot was performed. This analysis revealed that the composition of the soot corresponded to that melted in the interconnection *i.e.* copper and stainless-steel. The soot size ranges from less than 1  $\mu\text{m}$  to 80  $\mu\text{m}$  [1]. Figure 1 shows examples of beam screens polluted with super insulation debris or soot.

Figure 1: Left, example of A10L4.V2 beam screen polluted with super insulation debris. Right, example of Q19R3.V2 beam screen polluted with soot.

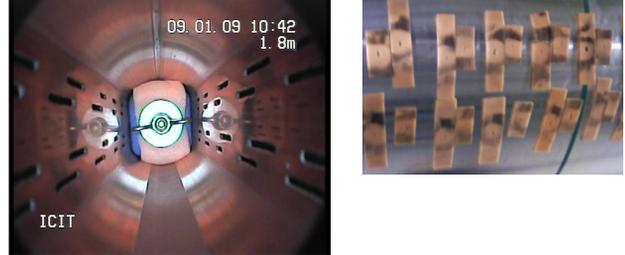
Figure 2: Foam-plug inserted inside. Left, cleaning of the horizontal parts of the beam screen C19R3.V2. Right, result of the cleaning with the wet foam.

*situ*. The process is based on a plug onto which foam is fixed. The assembly is used to sweep the interior of the beam screen. Up to 50 passages were done with a foam-plug wetted with alcohol followed by up to 15 passages which were done with a dry foam-plug. Figure 2 shows a picture of the foam-plug inserted inside C19R3.V2 when cleaning the horizontal parts and the result of the cleaning with wet foam. It is worth mentioning that the passages with dry foam left the foam clean.

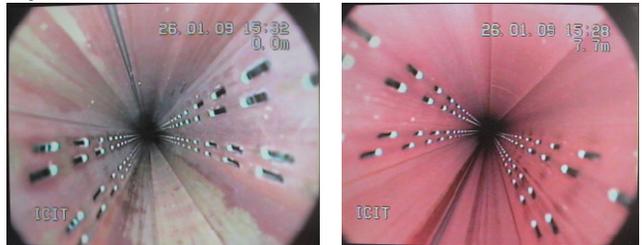
Figure 3: Left, example of results obtained after the soot removal of Q19R3.V2 (left) and A20R3.V2 (right).

It should be mentioned that the traces left behind this cleaning method are due to local oxidation of the beam screen surface. These traces, which are easily observable with grazing light, are a typical signature of residue which has been left after evaporation of a liquid. In our case, the traces are probably the result of the evaporation of an ice plug formed during the incident. The most affected beam screens by this phenomenon are C19R3.V2 and Q19R3.V2 located five half-cells ( $\sim 250$  m) from the incident point.

The result of this action gave pretty good results given the accessibility and the difficulty to remove the soot. As an example, Figure 3 shows the result obtained in Q19R3.V2 and A20R3.V2.

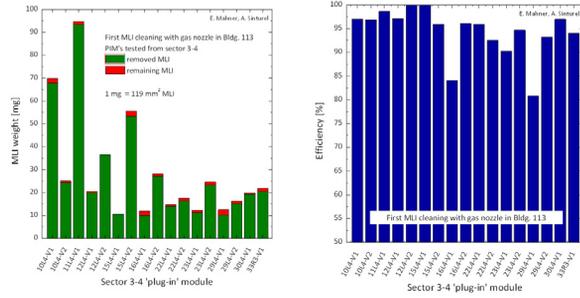
The system efficiency was evaluated in the laboratory on 17 PIM samples collected from the campaign of QQBI cutting in sector 3-4 [5]. Those samples originated from positions in Q10, Q11, Q12, Q15, Q16, Q22, Q23, Q29, Q30, and Q33 of sector 4 Left. The result of this campaign is shown in Figure 5. For the study, a PIM was connected between two dummy sets of beam screen / cold bore assembly to mimic a realistic situation. After only two passages of the nozzle, the average removal efficiency is about 95 %. After dismantling of the PIM for inspection, it appeared that the remaining debris were located in corners which are not in direct view of the beam aperture. It should be underline that no debris of super insulation were found inside the beam screen or in the coaxial space, therefore, once a debris is released in the beam aperture space, it is removed by the pumping system.

Figure 5: Results of the nozzle efficiency evaluation

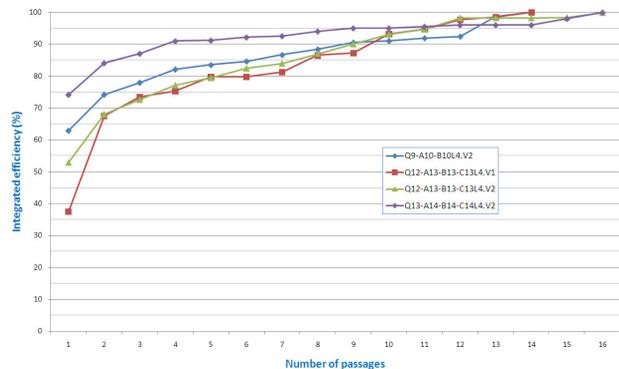
Of course, as far as the number of passage is increasing, the number of collected debris decreases. Figure 6 shows the evolution of the integrated cleaning efficiency of the nozzle system measured in sector 3-4. The result of this study shows that after 10 passages, 90 to 95 % of the super insulation debris has been removed from the beam tube. It is worth mentioning that during the study, about 700 to 1 000 debris of about 1 to 2 mm<sup>2</sup> were collected at the level of the filter. Therefore, if one would have reduced himself to 10 passages, one would have left about 50 super insulation debris *i.e.* about 1 debris per meter of beam tube.

Figure 6: Integrated efficiency of the nozzle system as a function of the number of passages.

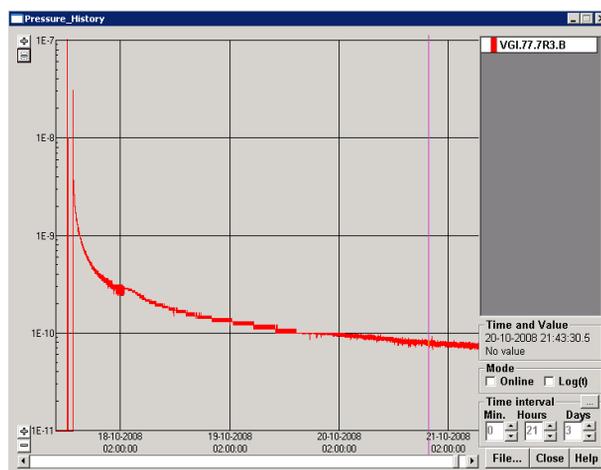
As shown in Figure 7, after evacuation by a turbomolecular pump, the room temperature vacuum sector previously held at 1 mbar was pump down back to its nominal pressure of about  $6 \cdot 10^{-11}$  mbar after only three days of pumping confirming the fact that these sectors were vented with pure helium (helium does not interact and does not saturate the NEG surfaces)!

Figure 6: Recovery of the total pressure in sector A7R3.B after only three days of pump down.
