MAXIMUM CREDIBLE INCIDENTS

J. Strait, Fermilab, Batavia, IL 60510, U.S.A.

Abstract

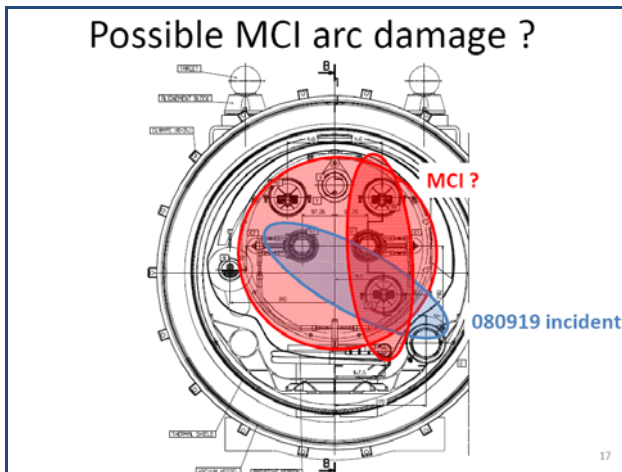
An incident resulting from an electrical fault in the main dipole bus, which generates an electrical arc and in turn ruptures the helium vessel, as happened on 19 September, is probably THE Maximum Credible Incident involving a hardware failure, since it involves: the electrical system with the largest stored energy – the whole dipole circuit; and the largest single volume of helium in the tunnel – one cryogenic system sub-sector, which is up to 300 m long. An event of this type could be worse than that on 19 September, if the electrical arc, originating in the dipole bus, were to breach one or both of the (powered) quadrupole bus lines (Fig 1[1]). In this case, the additional 43 MJ from the quadrupole system would be available to form electrical arcs. More important, however, is that with two or more of interconnect pipes broken, the flow of helium into the cryostat would be up to twice as large as in the sector 34 incident. This defines the new “Maximum Credible Incident”[1]. Minimizing the probability of such an event, and minimizing the collateral damage should one

Figure 1: The Maximum Credible Incident, resulting in twice the helium flow rate into the cryostat relative to the 19 September 2008 incident.

To minimize the probability of this sort of event, two main actions are being undertaken. First, a new bus quench detection system[7] is being installed, which will reduce the threshold for detecting a bus fault from 1 V to 0.3 mV. This system will be able to detect any resistive sections of the bus before a thermal runaway can result in the opening of the bus[8]. In particular, had it been in place on 19 September, it would have safely shut down the power system and the incident would not have occurred. Second, a new set of procedures and measurement techniques have been developed, utilizing the existing quench protection system, the new bus fault detection system, and the cryogenic system, to systematically survey the machine for anomalous resistances. The sensitivity is at the 10 n Ω level for splices inside the main magnets, and <1 n Ω for the main bus bars[9]. This will allow faulty joints to be identified during the hardware (re)commissioning phase, such that they can be corrected before running the machine.

Thus, despite the improvements in bus fault detection, it is essential to take further actions to minimize the extent of the damage if another MCI were to occur. Two main improvements are being undertaken, to vastly increase the pressure relief capacity on the main magnet cryostats[11] and to strengthen the anchoring to the ground of the SSS with vacuum barriers[12]. Several additional possible improvements, including enhanced pressure relief on the beam vacuum system and a more sophisticated system response to bus faults, are discussed in [13].

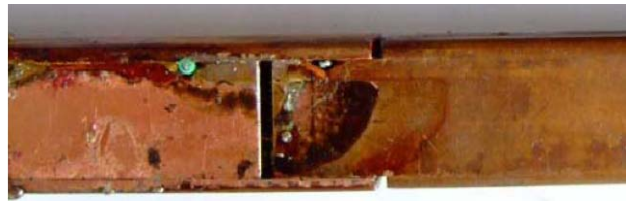
While these measures will drastically reduce the probability of a 19 September type event, they cannot absolutely eliminate the possibility. A bus failure could occur without being detected in time, even by the new bus detection system, if a bus cable segment were to suddenly quench (e.g. due to beam loss) at a point where there is both a discontinuity in the copper stabilizer (see Fig. 2[10]) and poor thermal contact between the superconducting cable and the stabilizer[8]. Gaps of the sort shown in Fig. 2 are not uncommon in the machine, due to component tolerances. A joint made without additional solder may have good electrical contact between the two superconducting cables, due to the pre-tinning of the wires, but the electrical and thermal contact between the cable and copper and across the copper-to-copper joints may be poor. It cannot be ruled out that this configuration occurs at least once among the many thousand high-current bus splices in the LHC.

Figure 2: An intentionally poorly made bus joint, illustrating the possibility of a gap in the copper stabilizer.

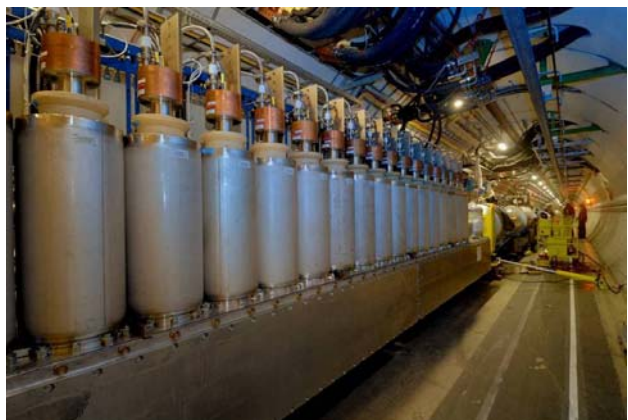
The sector 34 incident, or one like it, could have resulted in even more significant damage had it occurred in a dispersion suppressor (DS) sub-sector, since the DFBA shares a common insulating vacuum space with it. Were an MCI to occur in the future in one of the eight DS subsector which will have only the intermediate pressure relief installed, the peak pressure in the DFBA cryostat could still reach 2.5-3 bar. The DFBA (see Fig. 3) has a square cross-section cryostat, making it vulnerable to damage due to high internal pressure. Another likely failure mode would be the collapse of the chimneys for the HTS leads. In addition, the existing anchors to the floor may not be adequate in all cases to restrain the 2.5-3 bar pressure forces. Since each DFBA is unique in its design, there are no spares[14]. Therefore, damage to a DFBA would result in long down time for repair or replacement.

Figure 3: A DFBA.

An electrical fault, resulting in an electrical arc, that occurred *inside* a DFBA would certainly result in serious damage to the DFBA. Potentially all of the magnet circuits could be involved in such an incident. There is a “bottleneck” between the DFBA and the adjacent magnet cryostat, which makes pressure relief from the DFBA to the main cryostats relatively ineffective. If adequate pressure relief were provided on the DFBA cryostat, the extent of the pressure-induced damage could be reduced, maximizing the number of components that could be re-used for rebuilding the DFBA. To minimize the down time resulting from such an event, it is important to have an adequate pool of spares for all critical DFBA parts.

- Adding DN200 ports to all DS, even in the sectors not currently planned to be warmed up.
- Ensuring adequate pressure relief on all standalone, semi-standalone, and triplet magnets.
- Improving the pressure relief on the DFBs themselves.
- Ensuring that the anchoring to floor is adequate.
- Changing the response of the quench protection system (QPS) to a bus fault inside a DFBA or DS:
 - o Open the DS quench valves early (to limit the pressure, and therefore the flow into the cryostat).
 - o For a DFBA fault, do not open dump switch adjacent to it, (to limit the voltage across the electrical fault).
 - o Fire many quench heaters away from DFBA/DS (to limit the energy available to the electrical arc).

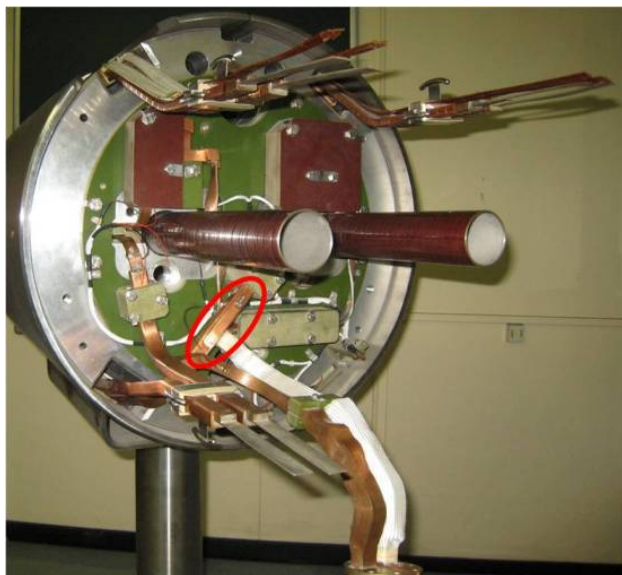
A circumstance that could credibly result in the failure of the diode bypass mechanism is the following. In addition to the inter-aperture and two inter-pole splices in the end of a dipole, there is a splice between one of the magnet leads and the bus bar that passes through the magnet. This splice overlaps with one of the T-joints to the bypass diode, as shown in Fig. 4. This splice, in contrast to the others in the end of a magnet, is not clamped inside an insulating box. Thus, it is at greater risk than the others of opening if it is not well made. Since at least two unsoldered splices have been found in magnet ends, it is possible that one of these more vulnerable splices is also unsoldered somewhere in the machine. Were one of these splices to spontaneously open, it is conceivable that the ensuing electrical arc could break the bus connection to the diode, with results equivalent to an interconnect bus rupture. The only defense against such a risk, beyond the measures already taken against a 19 September scale incident, is to systematically measure the resistance of this splice in

Figure 4: The connection end of a dipole, with the vulnerable splice indicated.

each dipole in the machine, to ensure that they are all well made. Any dipole that is found to have a faulty joint at this point should be replaced prior to running. The configuration of the joints to the diodes in the main quadrupoles needs to be examined to determine if a risk of this sort exists in them, as well.

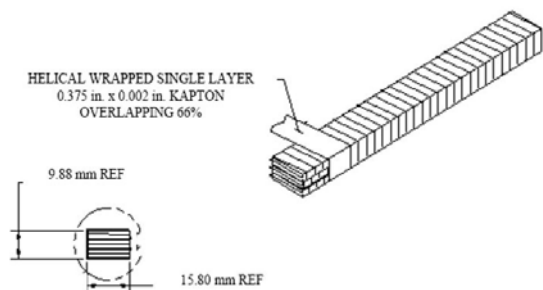
The inner triplet bus (Figs. 6 and 7) consists of a 13 kA superconducting cable, soldered to an all copper cable of the same geometry. These buses have been designed and tested[15] so that quenches in them will propagate and therefore be detected by the QPS, and so that they have the capability to safely carry the full current during the quench detection and current decay periods. The splice configuration at the Q1-Q2 and Q2-Q3 interconnects (Fig. 7) is complex, following the complexity of the powering scheme.

The risk of an inner triplet bus failure is low, but the consequences would be substantial. The splices are inside thin-walled (0.25 mm) bellows, which are vulnerable to puncture/rupture in case of an electrical arc. Although the circuit is segmented, so as to limit the stored energy involved in a quench to the individual magnet, a splice fault would involve two of the three circuits. Thus, most of the stored energy in the triplet system (Q1+Q2 or Q2+Q3) would be involved. Scaling from the size of the hole that was made in the beam tube, following a turn-to-turn short in an early SSC dipole test[16], where the stored magnetic energy was ~0.26 MJ and the quench protection was similar to that in the triplet, it is clear that an electrical arc at an inner triplet interconnect could fully rupture the interconnect bellows. This would result in a flow area similar to that in the dipole-dipole interconnect involved in the 19 September event. Due to the limited helium volume of the inner triplet (180 kg, including the D1), it is unlikely that a peak flow as large as 20 kg would result. However, the existing cryostat relief system consists only of three 67 mm ports, one each on the DFBX and on the Q3-Q2 and Q2-Q1 interconnects. Its capacity, on the order of 1 kg/s, would certainly be inadequate for such an event.

Figure 6: Inner triplet (Q2) bus assembly. Three bus bars are utilized, one to make the series connection between the Q2a and Q2b, one to carry the Q1 current, and one to return the combined Q1-Q2 current.

- Enhance the cryostat pressure relief, for example by adding a DN200 port at each interconnect. This should be done now, before there is any substantial irradiation of the triplets.
- Improve the anchoring of the triplets to the ground.
- Enhance the beam tube pressure relief in this area.
- Prompt opening of the quench valves would reduce the pressurization of the beam tube in case it is punctured.
- Unfortunately, even fast acting vacuum sector valves would not be fast enough to protect against consequences of a punctured beam tube in the triplet.

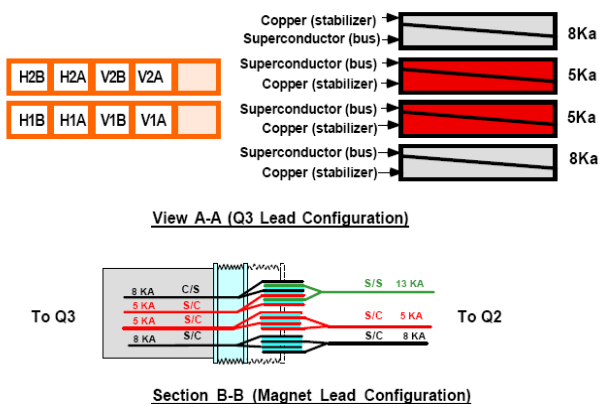
Figure 7: Inner triple bus and splice configuration at the Q2-Q3 interconnect.

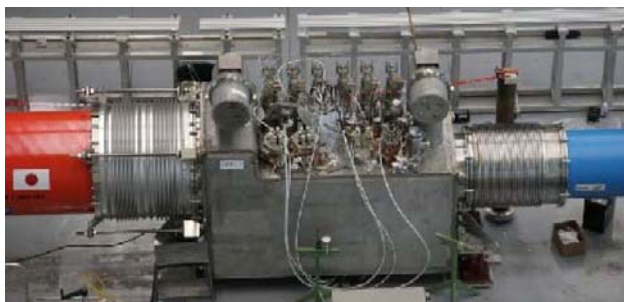
- The jacks that support the quadrupoles would fail for a cryostat pressure ≥ 1.5 bar.
- The D1 could also be pushed off its stands.
- The DFBX (Fig. 8) is vulnerable to damage similar to the DFBA's.

The consequences would be serious, since there is only one spare of each type of magnet for the inner triplets (including the D1), and essentially no chance to make additional ones. There are no spare DFBXs.

Figure 8: A DFBX.

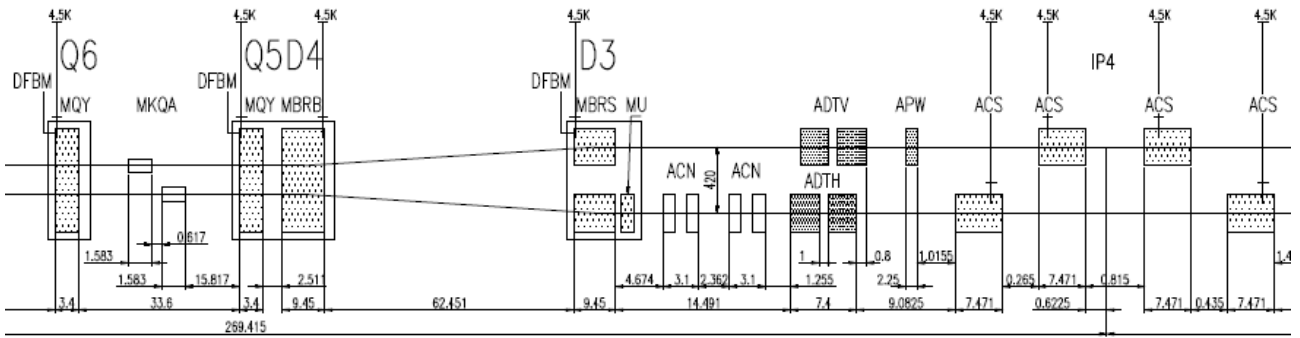
The most significant risk from these magnets is their potential to damage adjacent sensitive equipment. The D3, for example, is only about 30 m from the main RF system, and the D4-Q5 pair is only about 100 m away (Fig. 9). An electrical arc in one of these, that punctured the beam tube, would contaminate the superconducting RF cavities, requiring that they be removed from the machine for reconditioning or replacement. Since there is only one spare cryomodule, this could result in extensive down time. Similar measures to those proposed for the inner triplet could reduce the quantity of contamination. However, given how exquisitely sensitive SCRF cavities are to dust, the cavities would still, at minimum, have to be removed for cleaning and reconditioning. The only defense is to have an adequate number of spare RF cryomodules.

Figure 9: IR4, showing the distance between the SCRF cavities and the adjacent superconducting magnets.

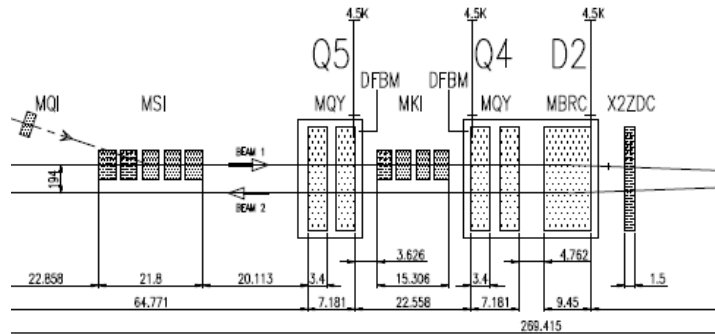
Similarly, the Q5 and the Q4-D2 pair are on either side of the injection kickers at IR2 and IR8 (Fig. 10). A failure in one of these magnets would contaminate the kickers, requiring their removal for reconditioning or replacement. As with the SCRF cavities, the a crucial line of defense is to have an adequate number of spare kickers.

Figure 10: The injection region at IR2, showing the distance between the kickers and the adjacent superconducting magnets.
