MAGNET REPAIR FOR 3-4 SECTOR

Paolo Fessia, Michele Modena and Lucio Rossi[#]

CERN, TE department, CH-1211, Geneva 23.

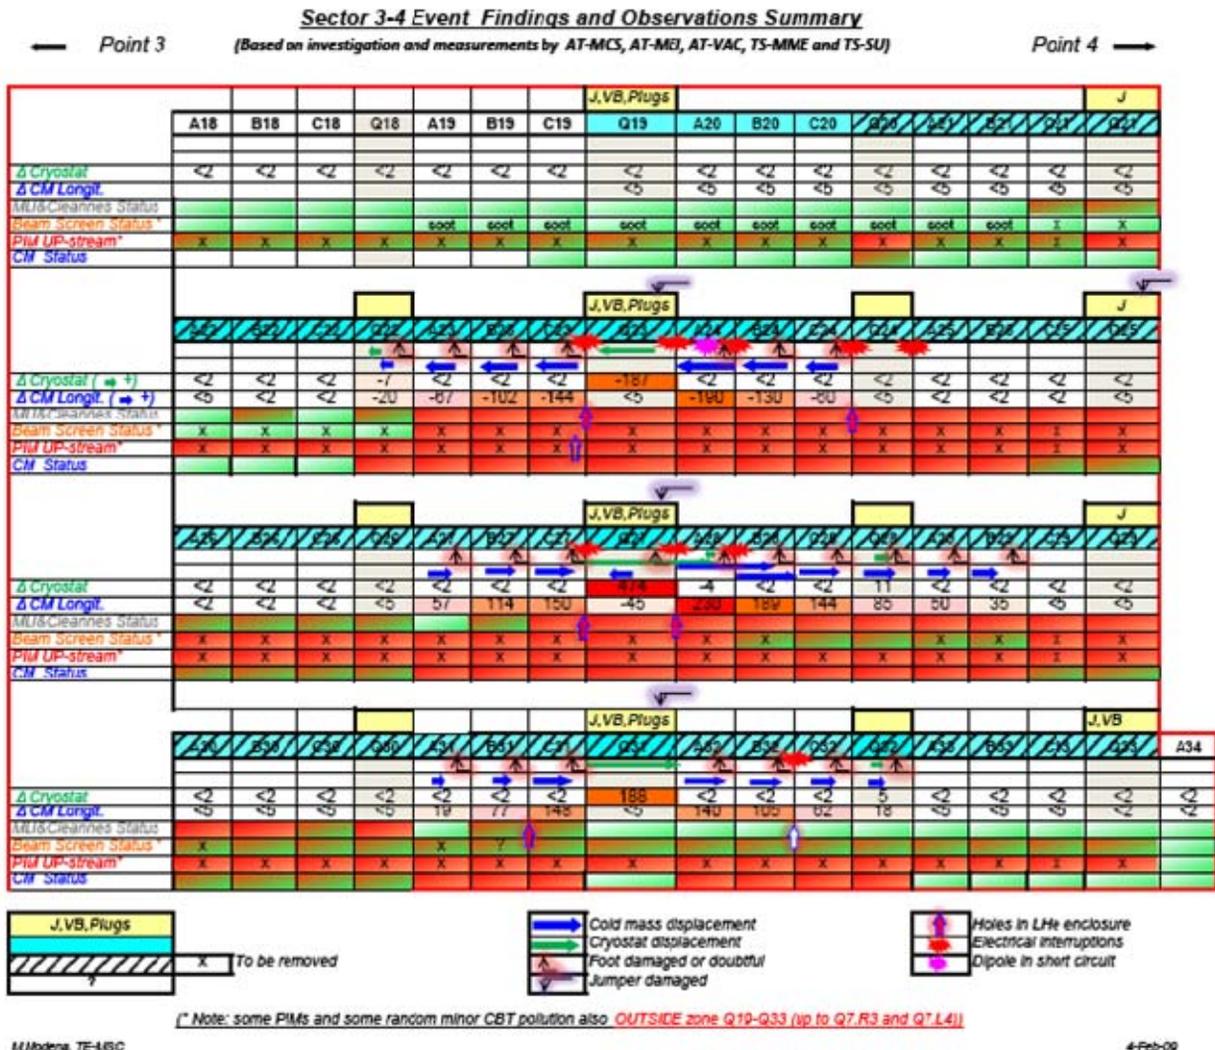
Figure 2: schematic with most of info on damaged magnets in sector 3-4. The D-zone is defined from Q19 to Q33. See text for details.

The damaged zone, D-zone, is between Q19 and Q33 and the map of damaged is synthetically described by the diagram in Fig. 2.

- 1) J means presence of Jumper, VB of the vacuum barrier, and plugs stays for the hydraulic restrictions for the HEII passage among cold masses.
- 2) The **primary event was the arc developed in the connections between C24 and Q24**. The

other electrical damages are induced by magnet displacement.

- 3) The color code try to give an idea of the damage, green indicating OK and red bad damage. A cold mass can be damaged electrically or mechanically (bus bar and end flanges) and also for reason of cleaning. In some cases; cold masses apparently OK were found badly contaminated by the soot.
- 4) The arrows are proportional to the displacement: the displacement of the cold mass is given with respect to its cryostat.
- 5) “elbow” arrows indicated damages on cold mass support, on QRL jumper.

There are 42 dipoles and 15 SSS in the D-zone, from Q19 till Q33. The magnet A34 was found with a damage wire inside the diode box, but this is probably not related to the incident. All magnets outside the D-zone were found electrically OK [4], not displaced and with no damage/dirtiness in the cold mass and in the cryostat.

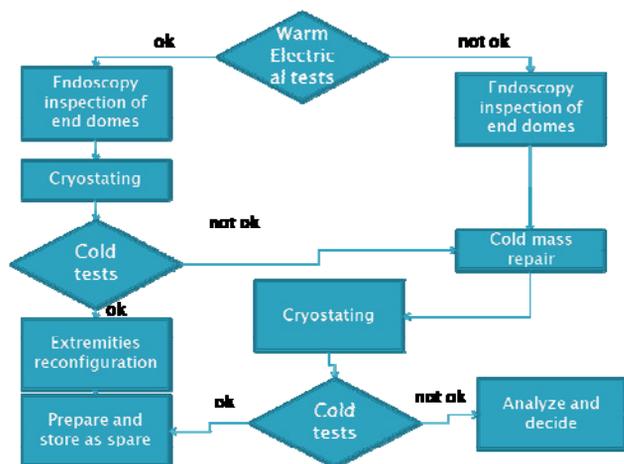
Figure 3: Flow chart of the repair and decision sequence for dipoles with minor damage (group B)

Group B) composed by magnets without apparent electrical fault and no displacement; the non-conformity regards mainly the presence of soot; 9 dipoles that will be treated starting from the ones farthest from the points of the arc, then going near to the source of damage. Careful inspection with eventual opening of the end covers to clean up will be carried out according to the scheme shown in Fig. 3.

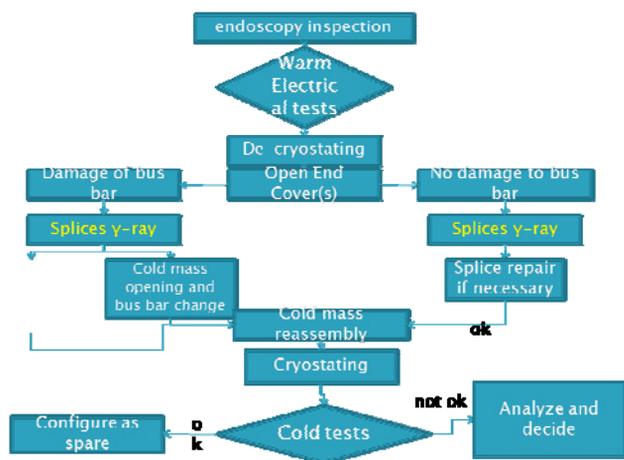
Figure 4: Flow chart of the repair and decision sequence for dipoles that displaced and with moderate damage (group C).

Group C) composed by 11 dipoles with displacement and OK upon electrical checks. These magnets as well will be treated from the less damaged to the most displaced. Careful attention will be put to the bus bars system violently solicited by large displacement. We think that all these magnets can be recovered without changing the bus bar because the point fix is much more robust than the connection itself, i.e. the this last as act as weak point. If this hypothesis will be true that means that bus bars can be put in conformity without opening the half shell, that requires much work, heavy tooling and considerable cost. The workflow of this group of magnets is reported in Fig 4.

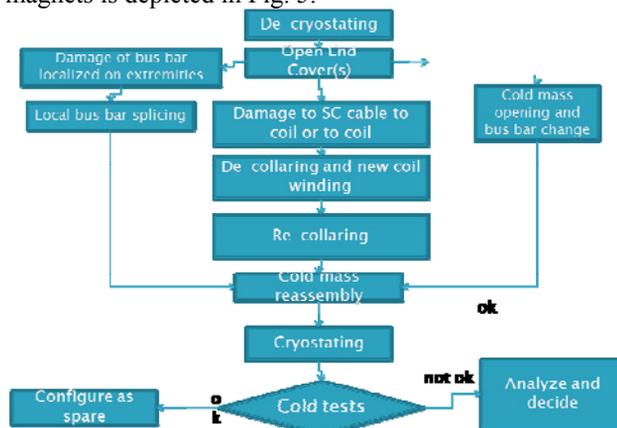
Figure 5: Flow chart of the repair and decision sequence for dipoles that displaced or not they have electrical faults, including arc originating the event (group D).

Group D) this is the group of electrically damaged magnets will be repaired as last. We have made the hypothesis, based on visual inspection and damage assessments that this subgroup may be divided into “easy” to repair, medium difficulty (i.e. when at least the coils can be recovered) and fully reconstructed. This last subgroup necessitate of the setting of the complete magnet facility and learning of long coil fabrication (something never done at CERN premises over the years

of LHC R&D and prototyping). The workflow for these magnets is depicted in Fig. 5.
