# Magnets repairs for 3-4 sector

P. Fessia, M. Modena and L. Rossi  
Technology Dept.– MSC group

### Sector 3-4 Event Findings and Observations Summary

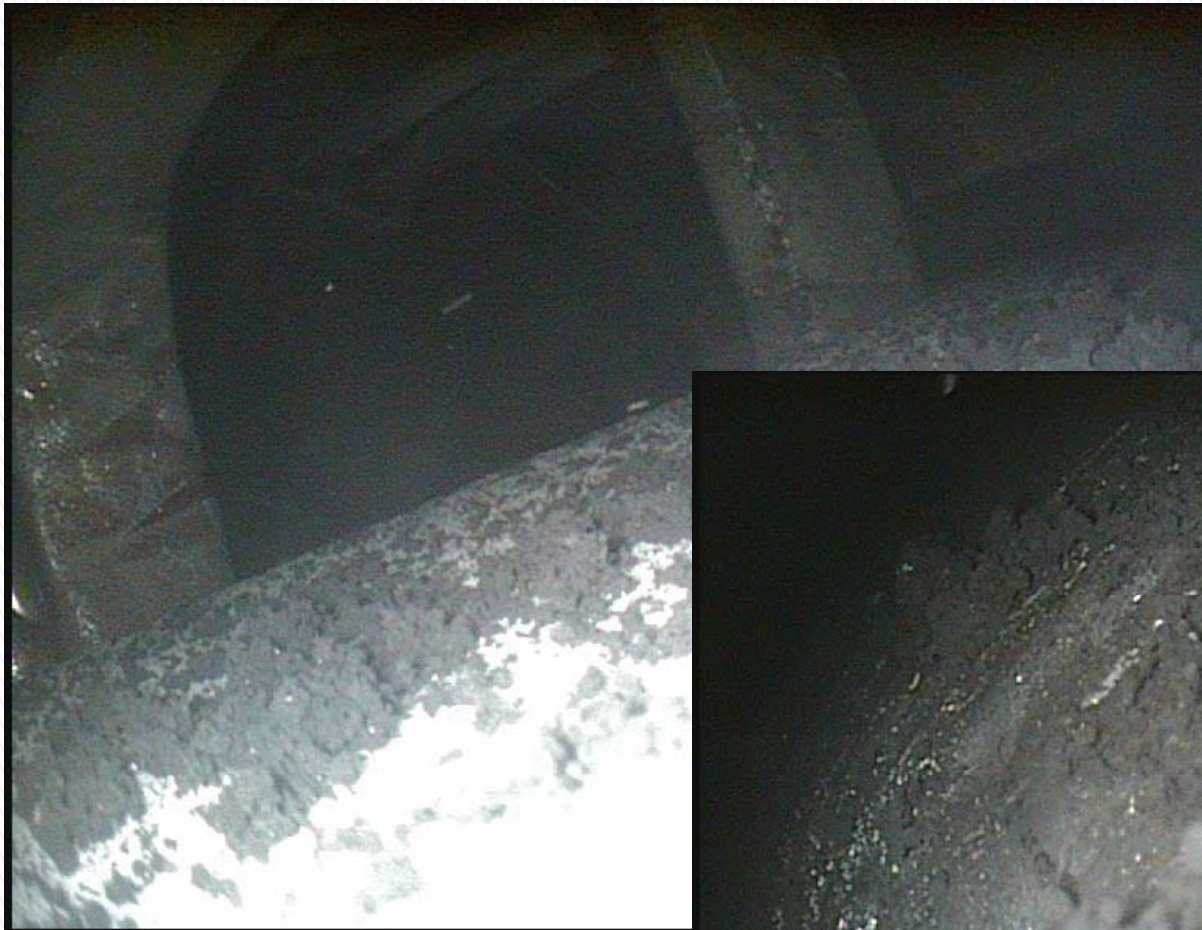
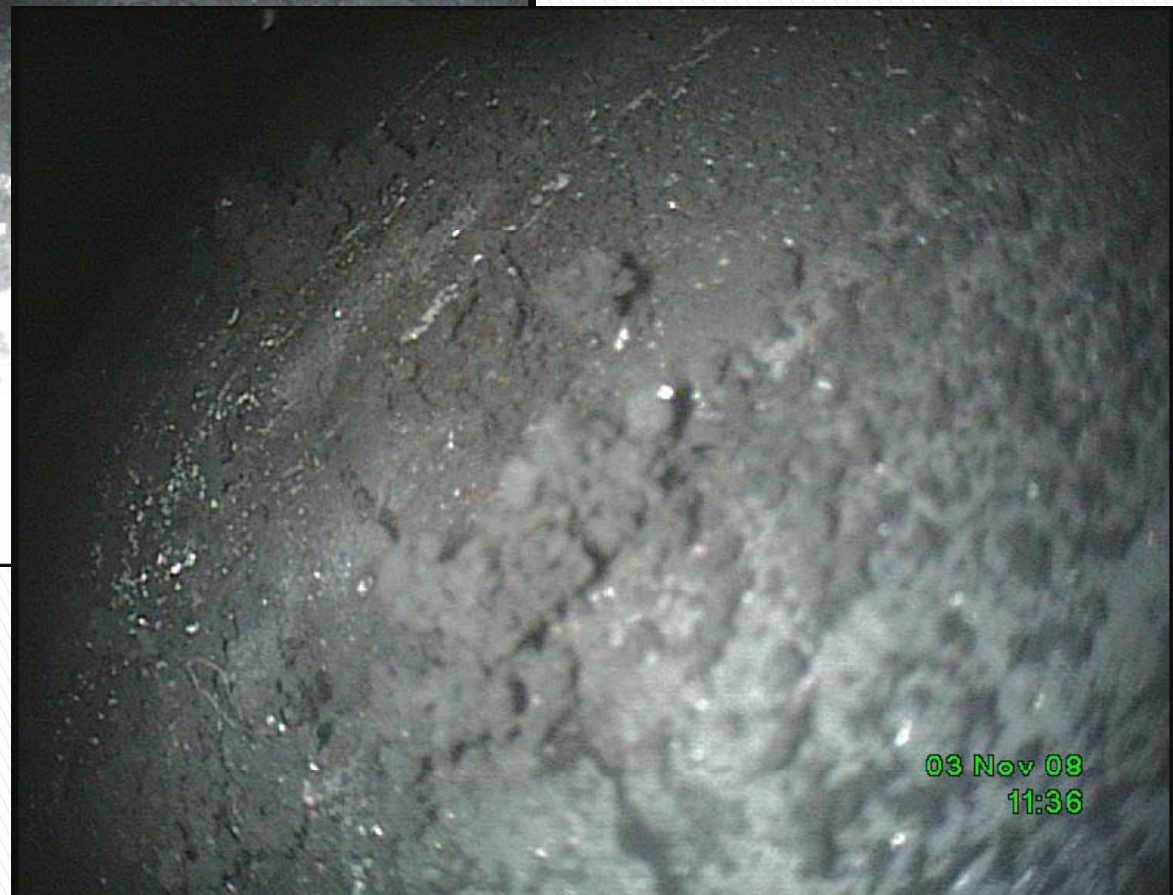
## Inspection of Q32.R3 (M 1-2 lines)

Serious contamination by soot. TS-MME analysis show a mix of copper and SS (not austenitic). Magnetic and elec. conducting; around-globular shapes; micrometric dimension for some amount.

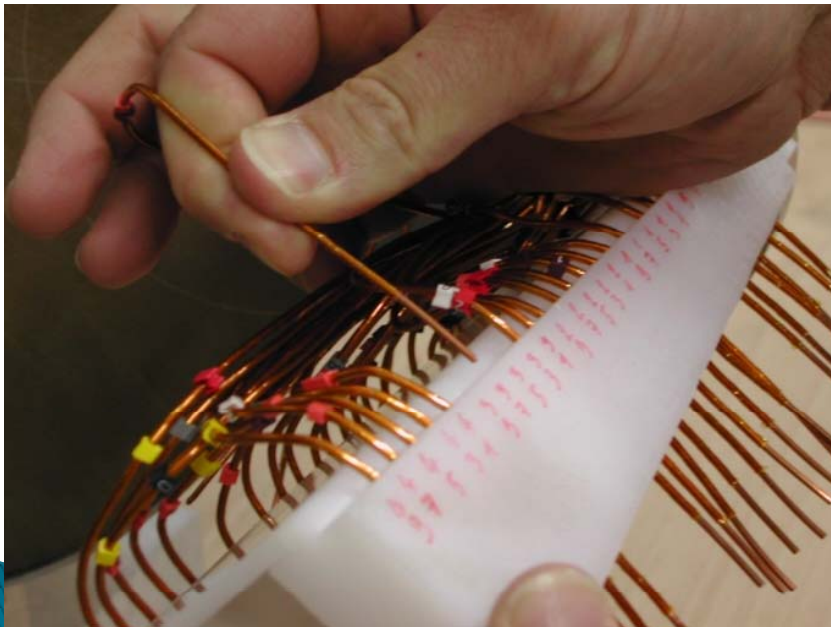
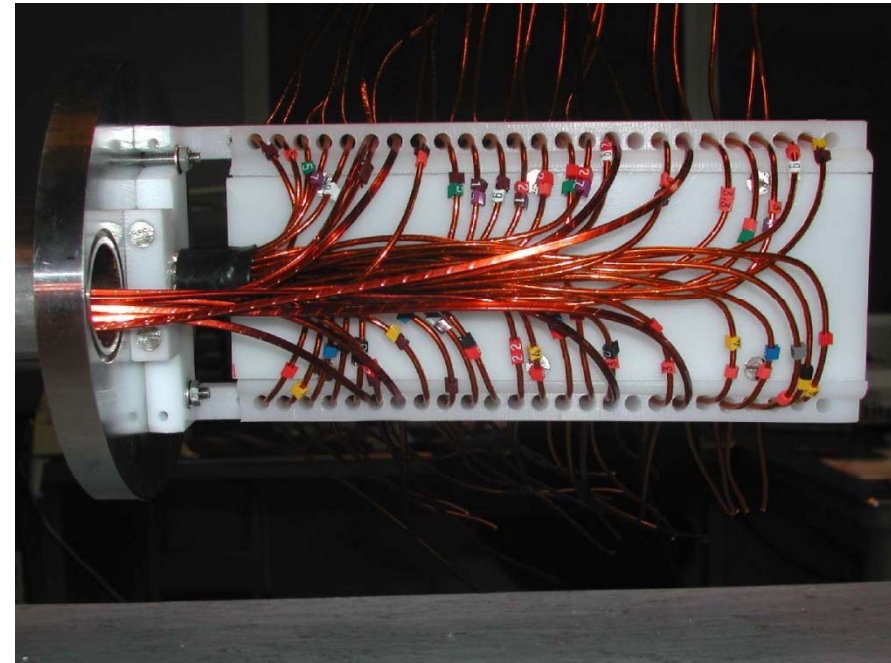
Impossibility to have an exact substitution for the SSS. We will loose correctors, because :

It is foreseen to loose 2 MQS/beam (out of 4 in sector 3-4) and 2 MO out of 13 in sector 3-4.

Not Standard modification will be necessary at the level of the “line-N” connection boxes to insulate the corrector BB not utilized and to bridge the corrector circuits connection to guarantee the continuity of them

All these modification are part of an ECR under preparation by MSC/Cryomagnet coordination with all concerned teams in the various departments.

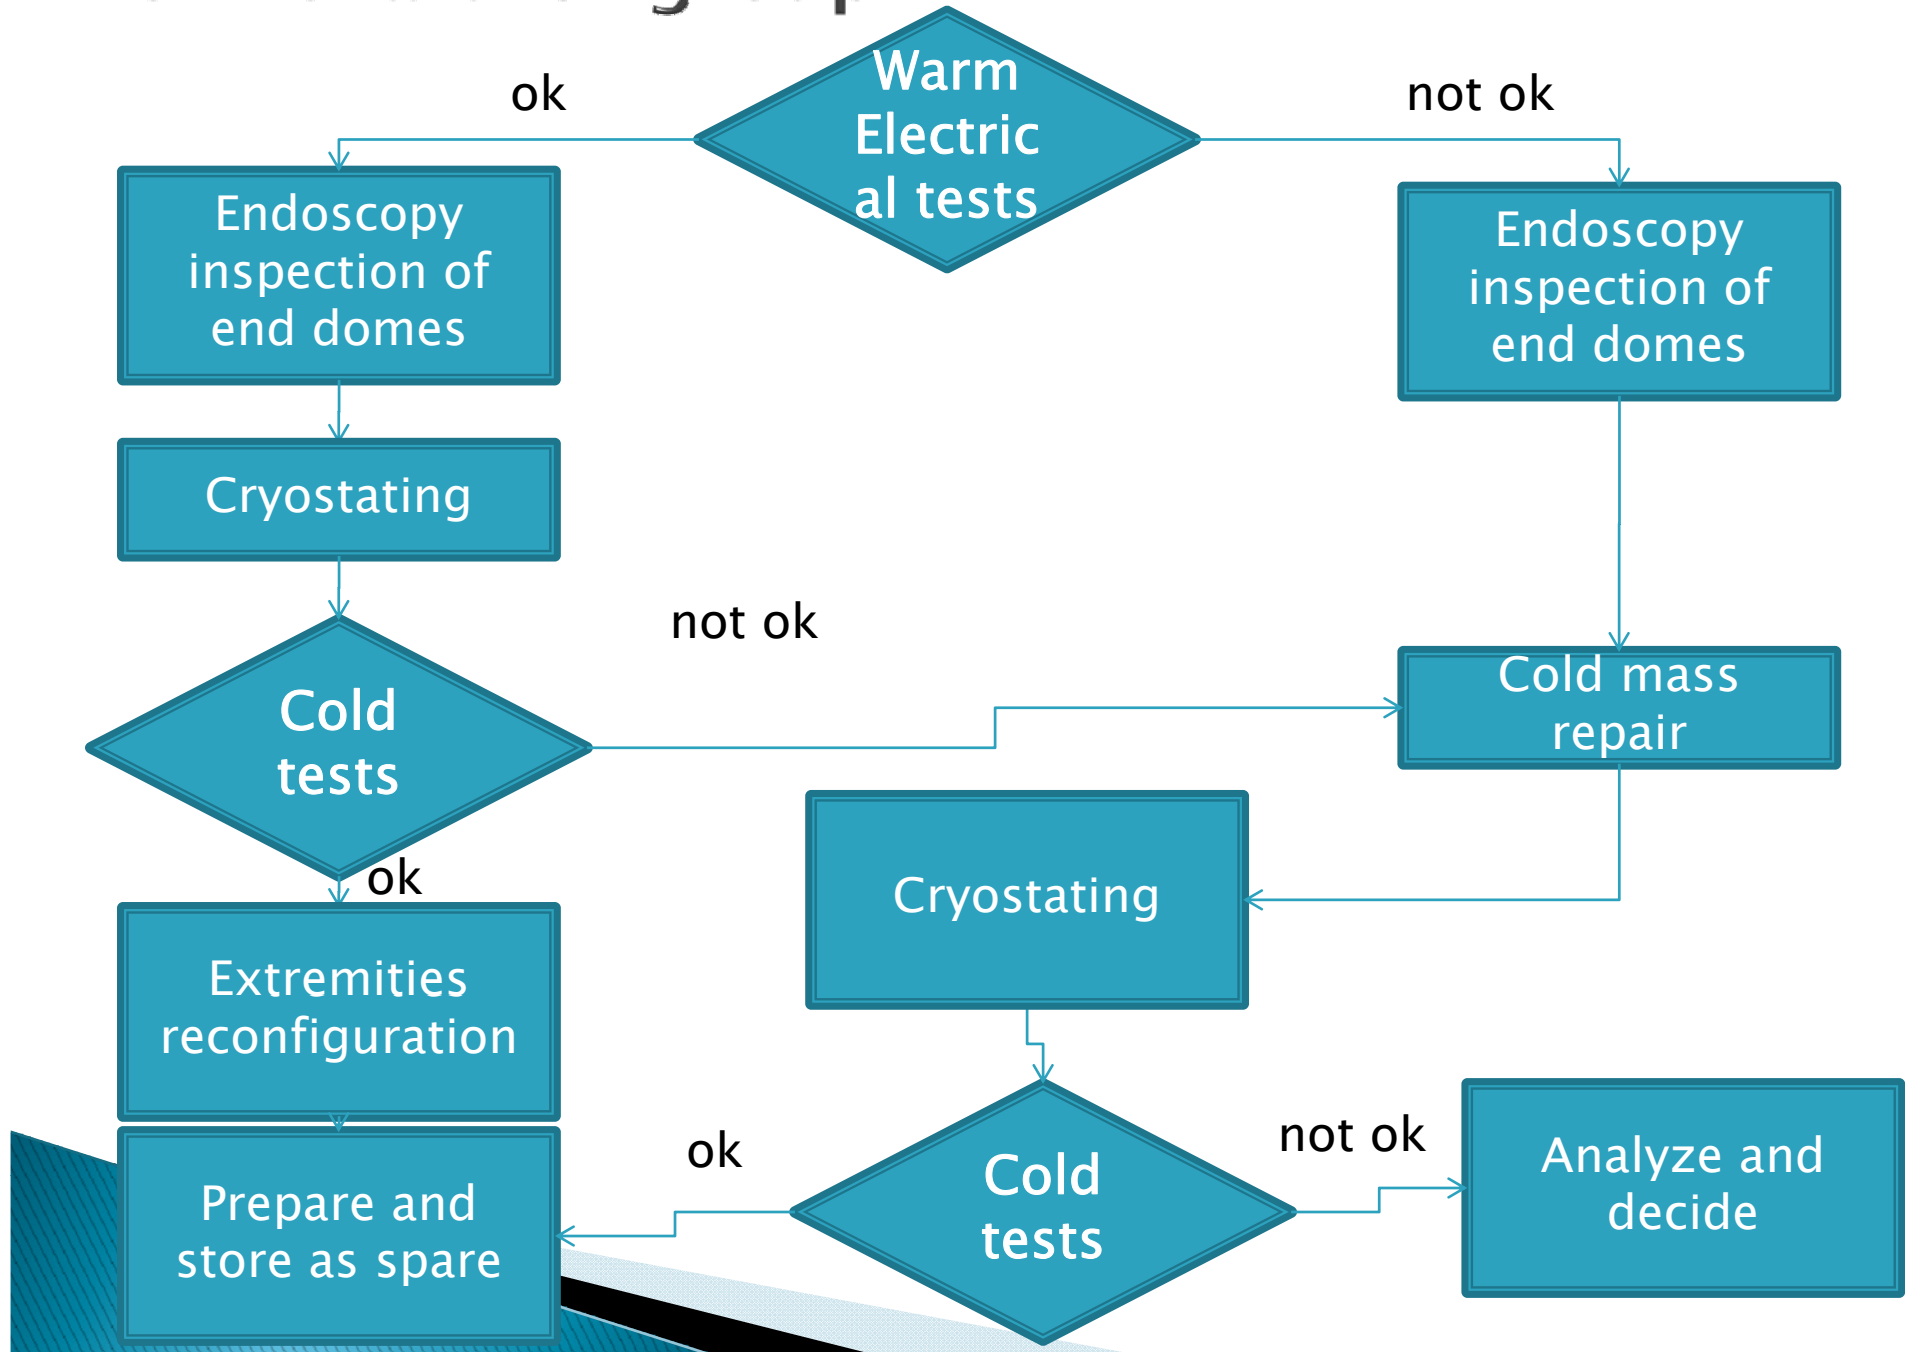
# Flow-chart for group B

# Group B: magnets without direct electrical damage, no measured displacement (9 units)

All de-cryostated to re-use components for cryostating new CMs.

Order of intervention:  
from farther from an electrical problem to nearer

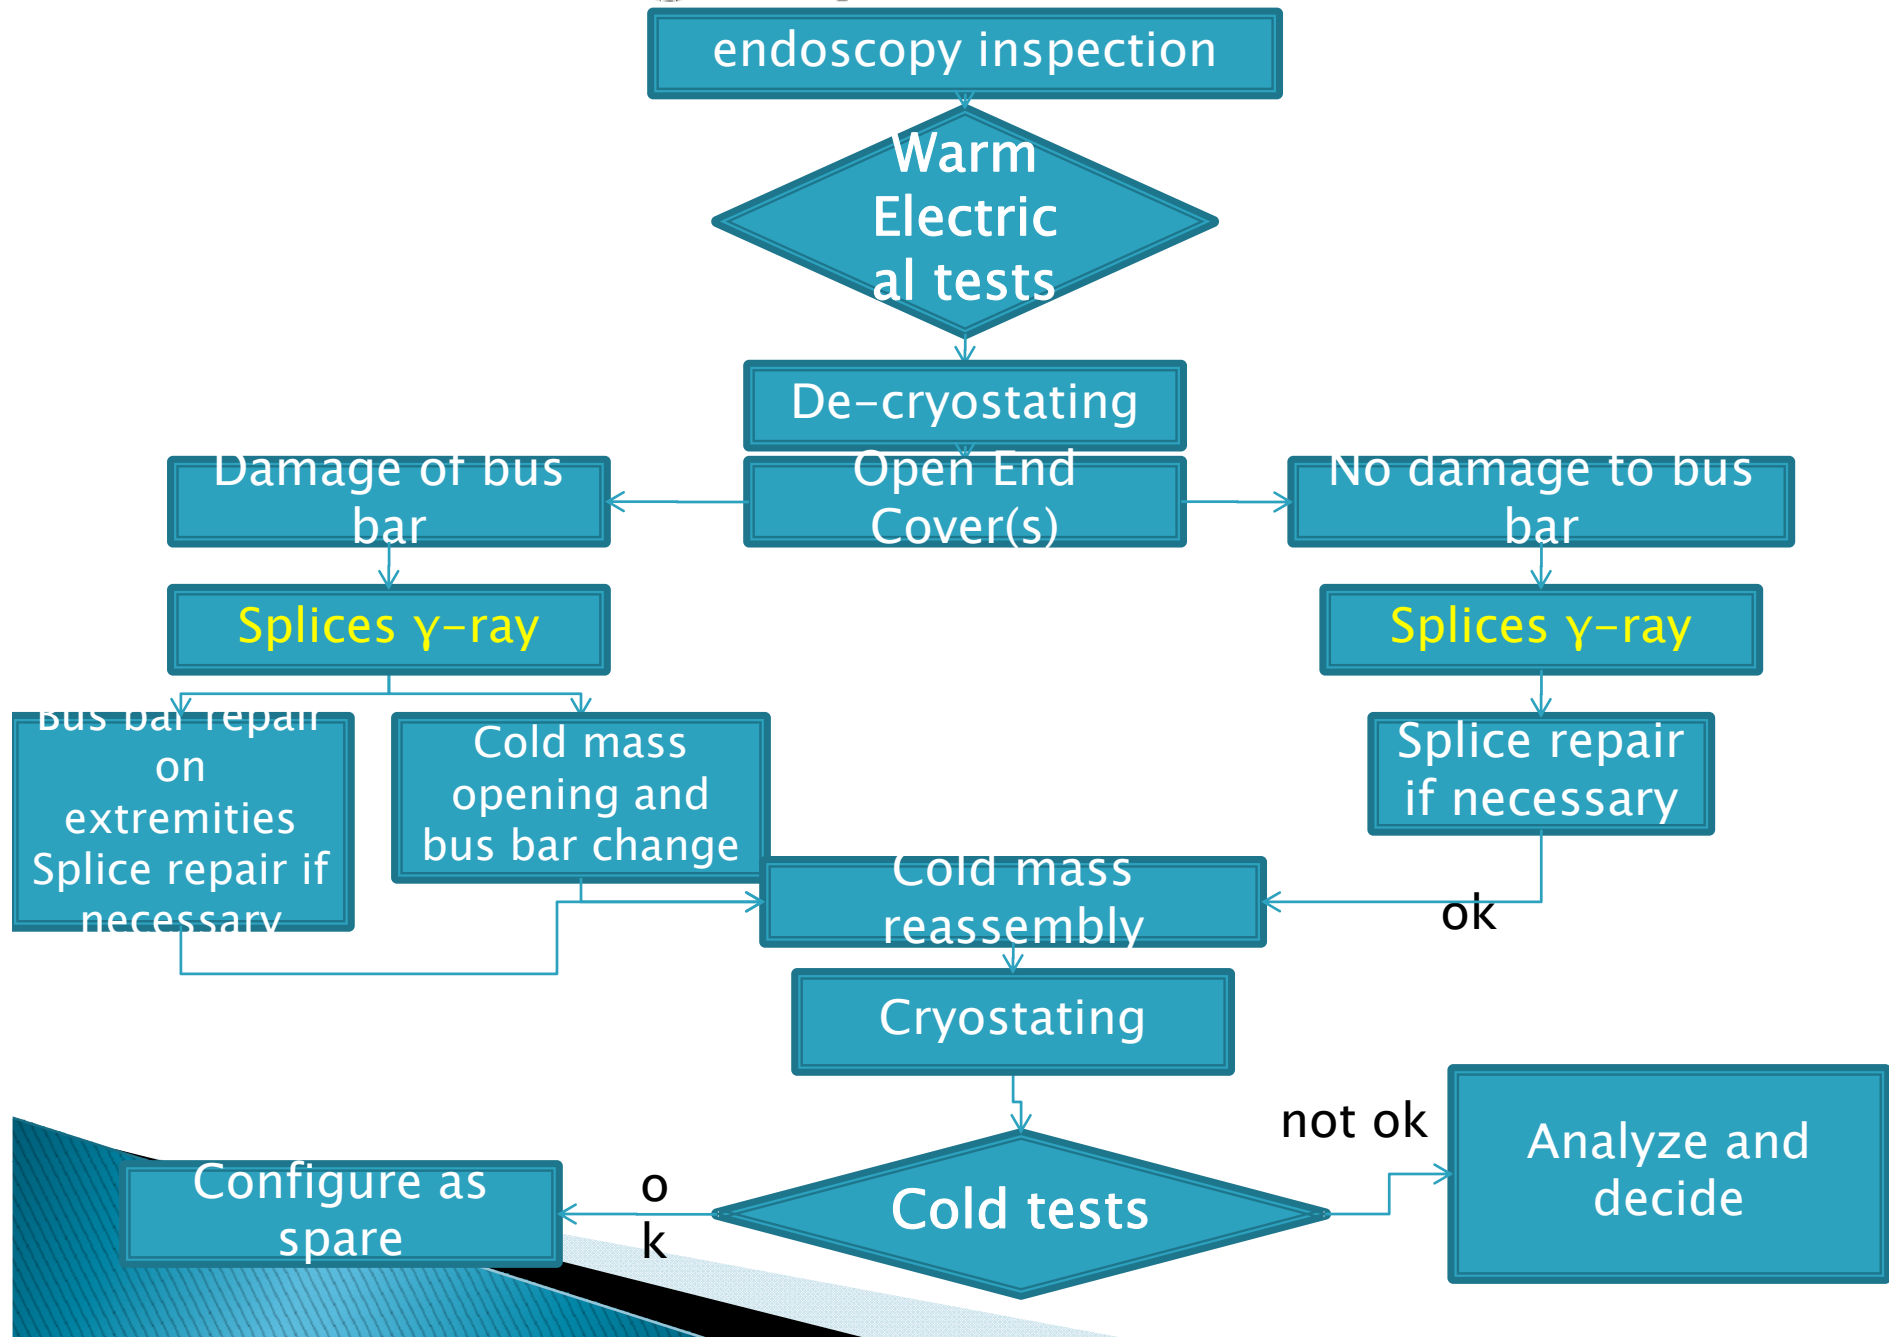
# Flow-chart for group C

# Group C: Dipoles without electrical damage, but displaced ( 11 units)

Order of intervention:  
from less displaced to  
more displaced,  
taking into account  
that a compression  
on lyras is less  
dangerous then a  
similar actions on  
CS side

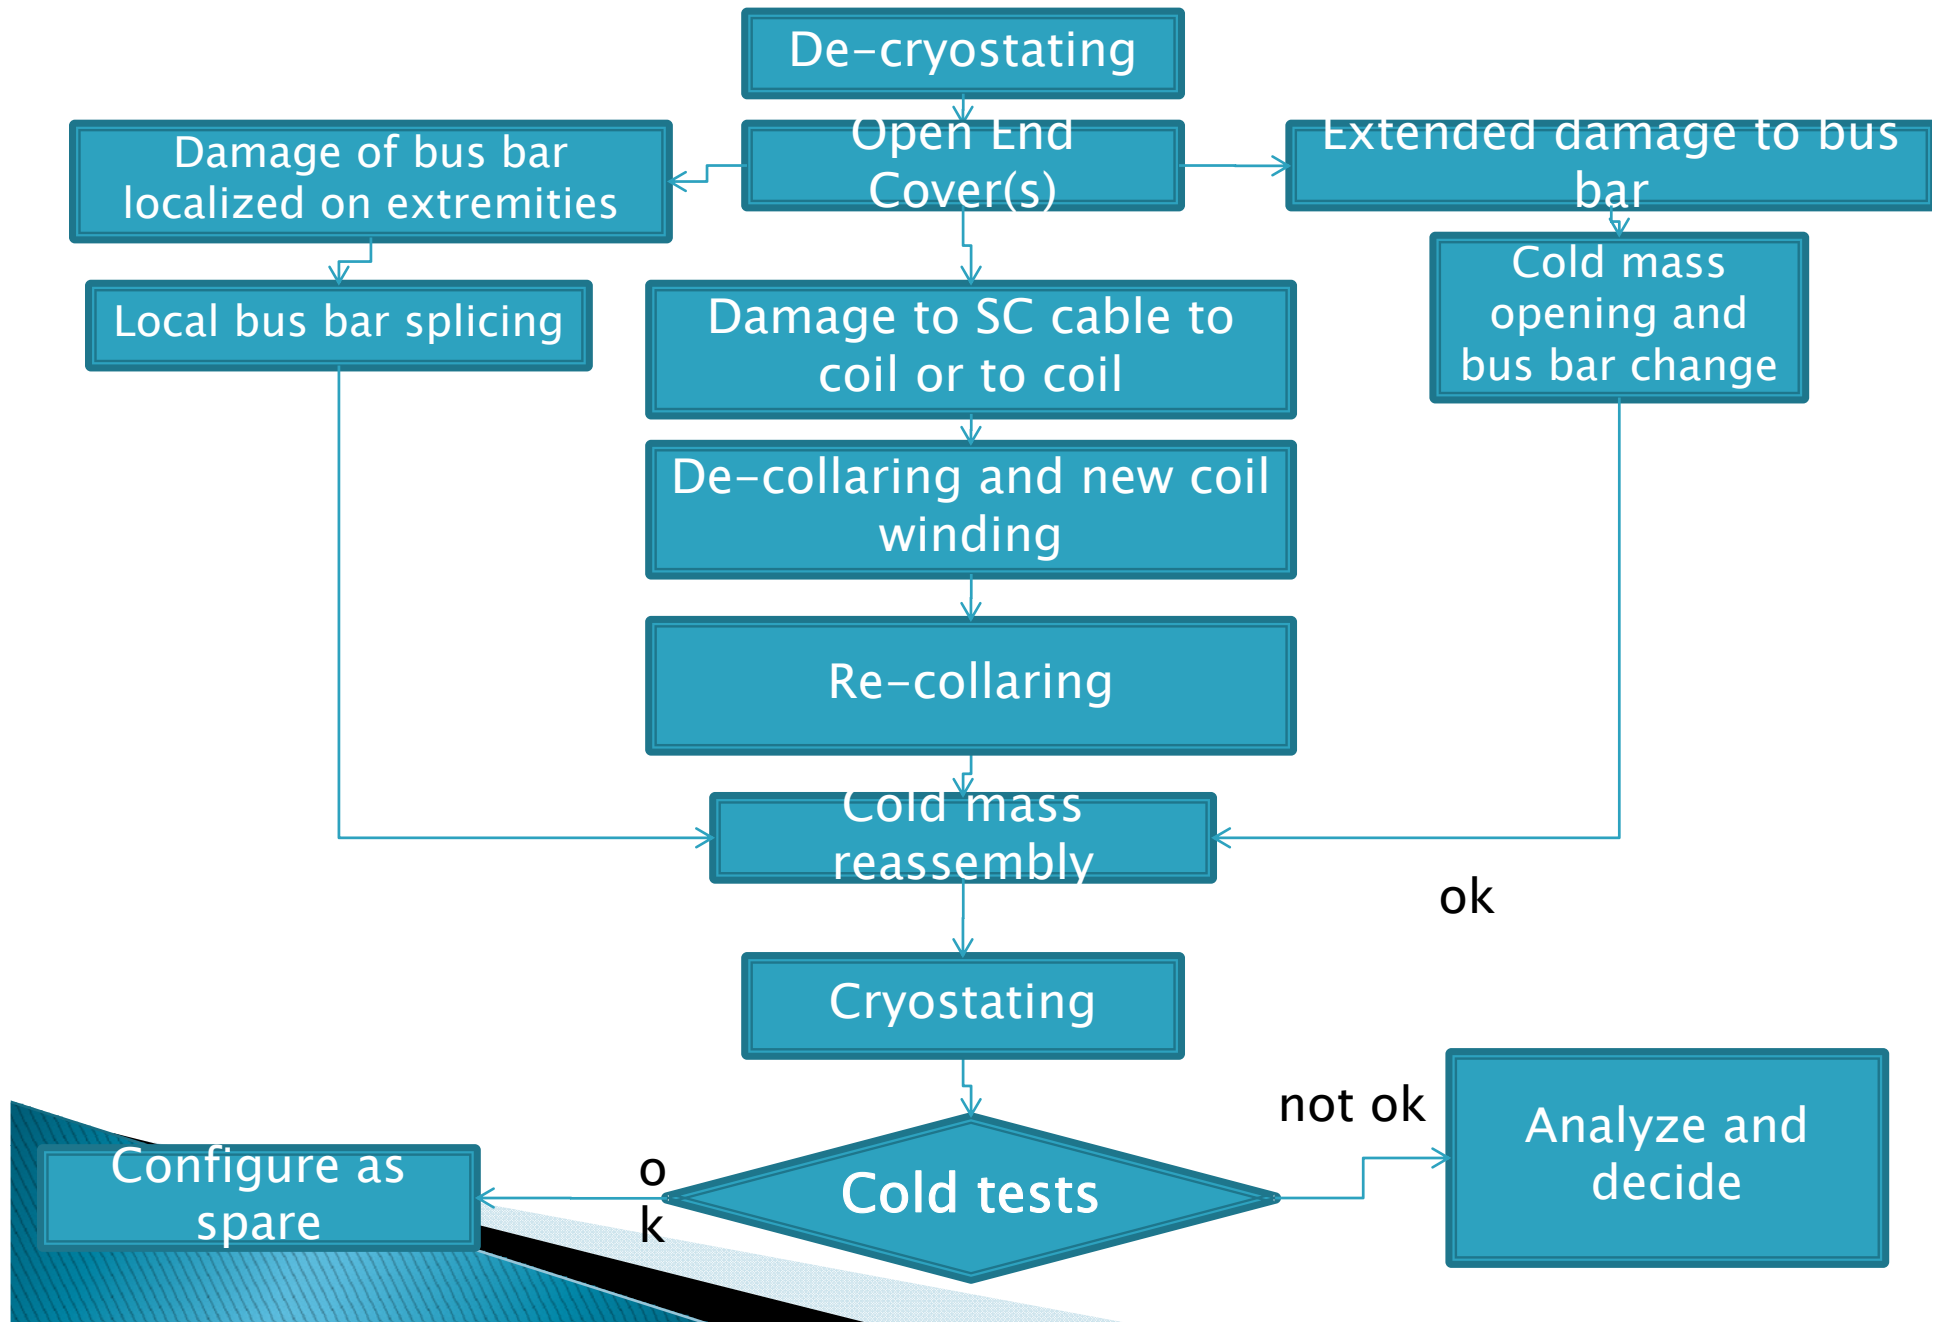
# Flow-chart for group C

# Group D: magnets with direct electrical damage (10 units)

Order of intervention from probably less damaged to more damaged.

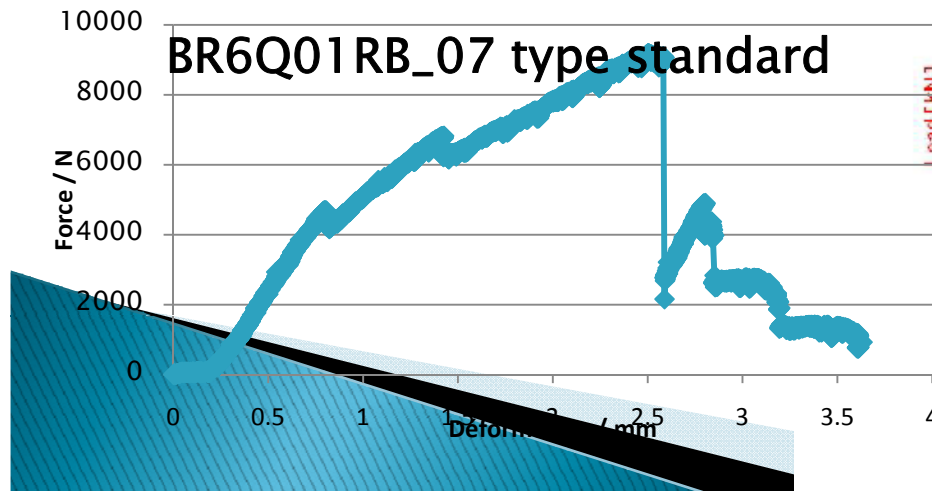
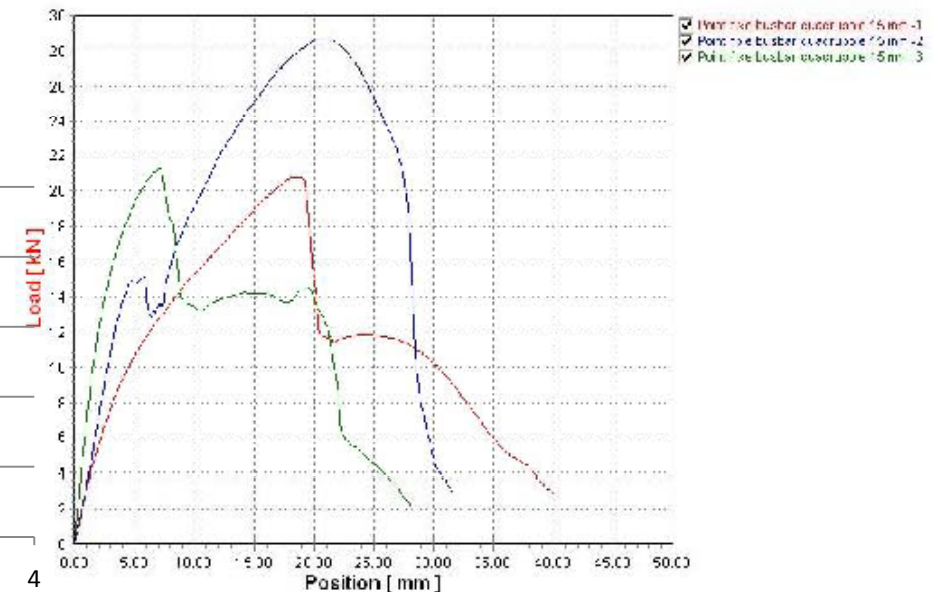
*Point fixe busbar quadrupole 15 mm-1-2-3*

Echantillon 1: rupture point fixe -sans cable supra-  
 Echantillon 2: rupture point fixe -avec cales vetronite et isolant-  
 Echantillon 3: rupture point fixe -avec isolant-

Of the 4 types of bus bar fixed points  
 The weakest is the quand in the SSS.  
 Tested: 20 kN tensile strength  
 Bus Bar interconnection rupture strength is  
 At max 13-14 kN.
