SUPERCONDUCTING ELECTRICAL CIRCUITS

K. H. Meß, CERN, Geneva, Switzerland

Abstract

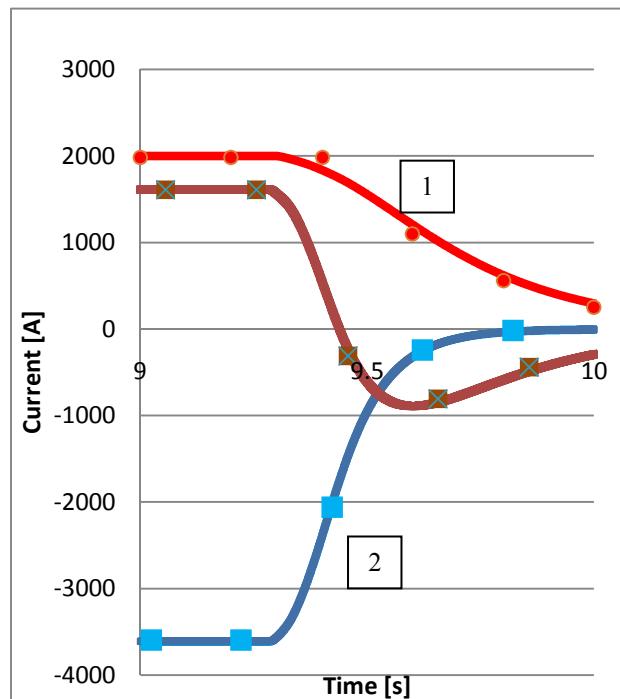
Fig 1: Current distribution between the three current leads feeding the Q6.R4

The plot shows in the upper curve (1) the current through the beam1 aperture of the Q6.R4 during a quench while powering asymmetrically. The lower curve (2) is

During the quench the current through the centre tap of the two magnets reverses the sign. This should never happen in a completely symmetric case. However, the difference in excitation caused a difference of resistance of the quenching apertures and different current decay times. The centre tap current had to change the sign once the current through the B2 aperture (lower) could not compensate or over-compensate the B1 current any more. Needless to say, this observation was completely harmless, but it paves the way for the next puzzle.

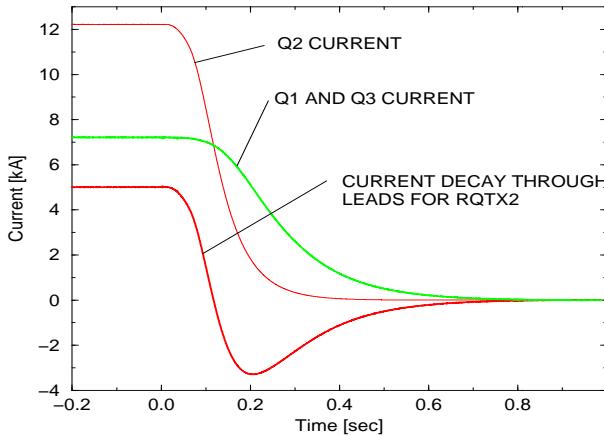
Figure 2 shows a similar case [8] for the inner triplet. Here two power converters (plus a trim converter) feed 3 magnetic circuits. The magnetic fields have to be calculated from the measured currents using the full information.

Fig 2: Current distribution of the inner triplet during a quench

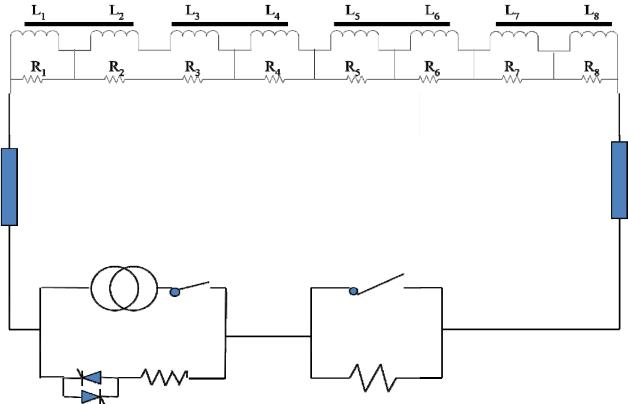
The undulators consist of 8 superconducting coils, which are pair-wise magnetically coupled. The coils are bridged by resistors, as shown in figure 3. The picture is taken from reference [10].

The internal resistors have a value of 0.15Ω , the extraction resistor has 0.8Ω . The undulator RU.R4 was very difficult for the power converter and the quench protection.

Fig 3: Sketch of an undulator [10]

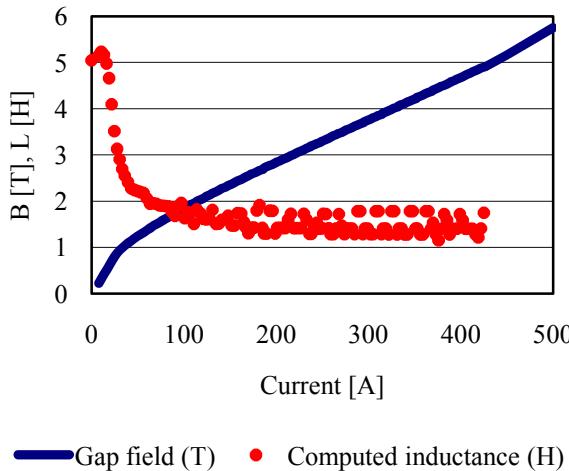
The reason was found in the saturation of the poles, which leads to the strong current dependence of the inductance, as shown in fig. 4 (from Reference [10]). Moreover, the undulator does not have a voltage tap in the centre (in fact, none at all). Hence the quench protection has to calculate from current measurements the first and second derivative of the current with respect to time in order to make a prediction about the expected inductive voltage. This process relies on current measurements and works only for low current changes. Consequently, only a dI/dt of 0.5 A/s was reached.

Fig 4 Nonlinear inductance of the RU.R4 as a function of current [10]

At present it is being discussed whether to replace the magnet with a proper spare unit with centre tap. That should solve the speed limitation. Alternatively, a second external dump resistor could be added to ramp down the magnet fast enough, if the speed is really required.

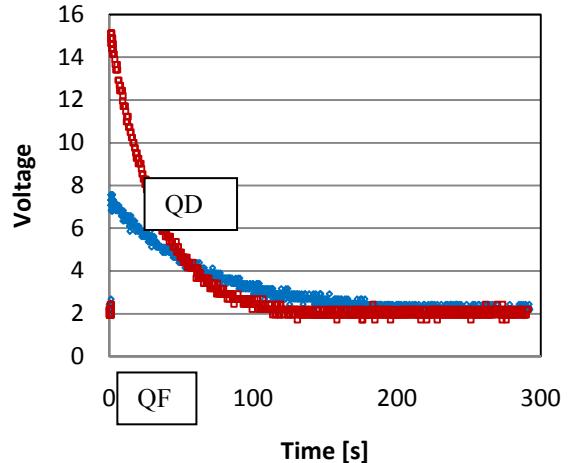
Sometimes a small failure can cause surprises. Right after the Christmas holidays in January 2008 the dump resistor for the QF45 failed. It failed after extensive testing in Protvino. Figure 6 shows the voltage over the dump resistors of the QF and, for comparison, the QD circuit in sector 45. The measurements describe very well exponential decays with different decay times. Clearly, the QF current (lower curve) decays much slower, indicating a much lower resistance.

The resistor was replaced and inspected. A fixation was broken during transport bringing parts of the resistor into contact with each other.

Figure 5: The voltage drop over the dump resistors during a 2 kA fast power abort of the RQ circuits

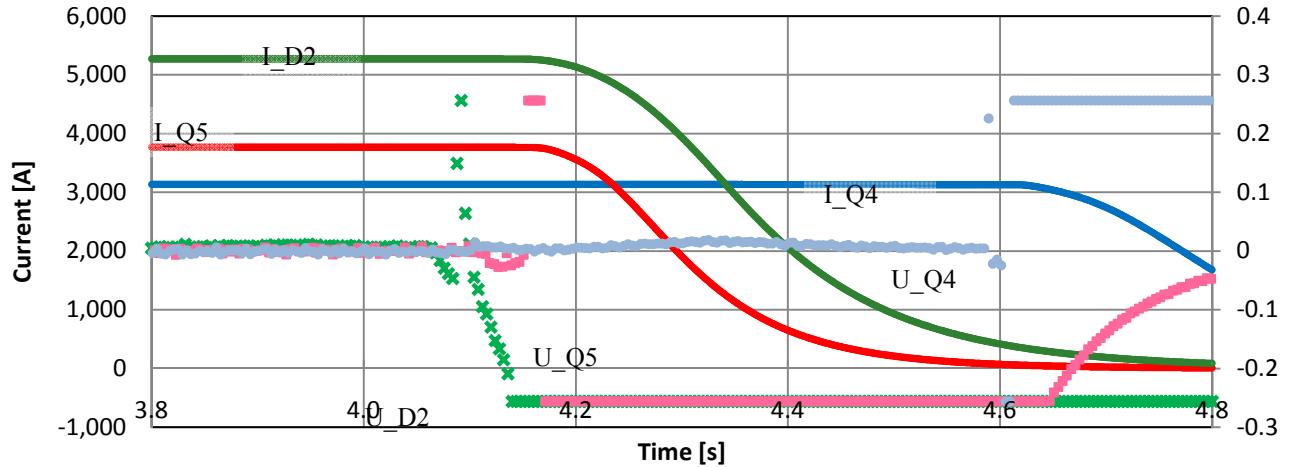
The historically first puzzle, the D3, Q4, Q5 problem caused a lot of discussions at that time. The D2.L8 was the first magnet to reach its design current in the LHC. The neighboring Q4 and Q5 quadrupoles did also very well, until they were powered simultaneously. Figure 6 shows the currents of the D2, the Q5 and the Q4. The symbols show the voltages, as seen by the quench protection (right scale). The dipole current and the Q5

current were rising, while the Q4 current was stable. Then the D2 quenched (green crosses), followed after 50 ms by the Q5 (light red dots). The Q4 followed about 500 ms later (light blue). One can also see that the resistance over Q4 actually started to rise around 100 ms after the Q5 quench, to calm down again and to take off suddenly. As this was the first incident of this kind and little was known about the stability of the equipment in general, discussions and additional tests went on for a while. It turned out that single magnets were always stable and it needed current changes in at least one magnet to

Figure 6: The coupling between D2, Q5 and Q4

reproduce the phenomenon. Then “shaking” was tried by varying the current in one magnet (Q4), while everything was still stable. This did the trick. The apparent coupling disappeared.

The most likely explanation is a movement of the bus cable inside the DFBM. Alternatively, it could be related to an incomplete filling. However the disappearance of the phenomenon was not correlated with an action of the cryo-control.

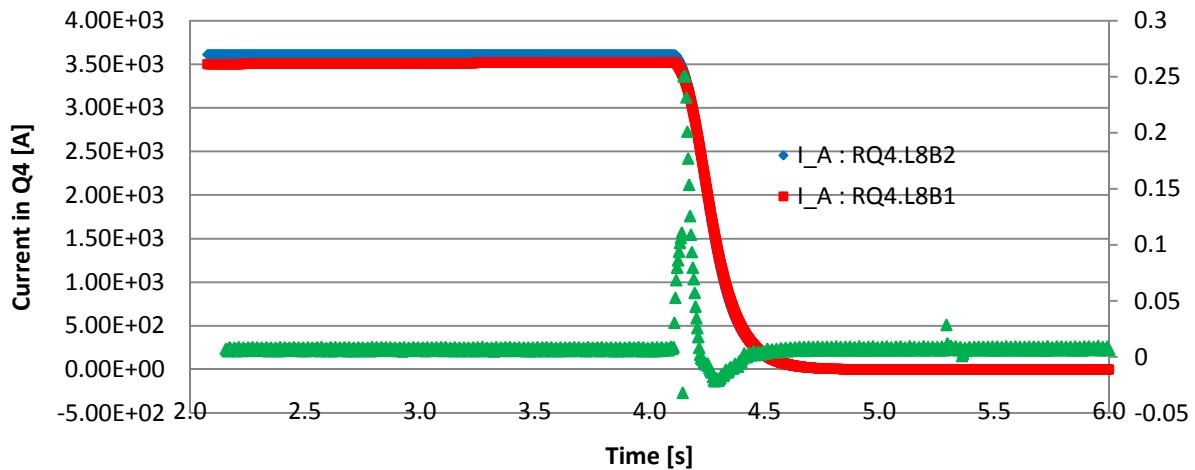
the Q4 was powered with the B2 aperture already at 3600 A. Around 4 seconds on the scale of figure 7 a quench happened and the current changed with more than 10^4 A/s. This induced a voltage of up to 0.25 V on the D2 dipole, which was not powered. If this would have been the case, again a multiple quench would have shown up.

Figure 7: Current of the quenching Q4.L8 and the voltage picked up by the quench protection for the D2 (right scale)

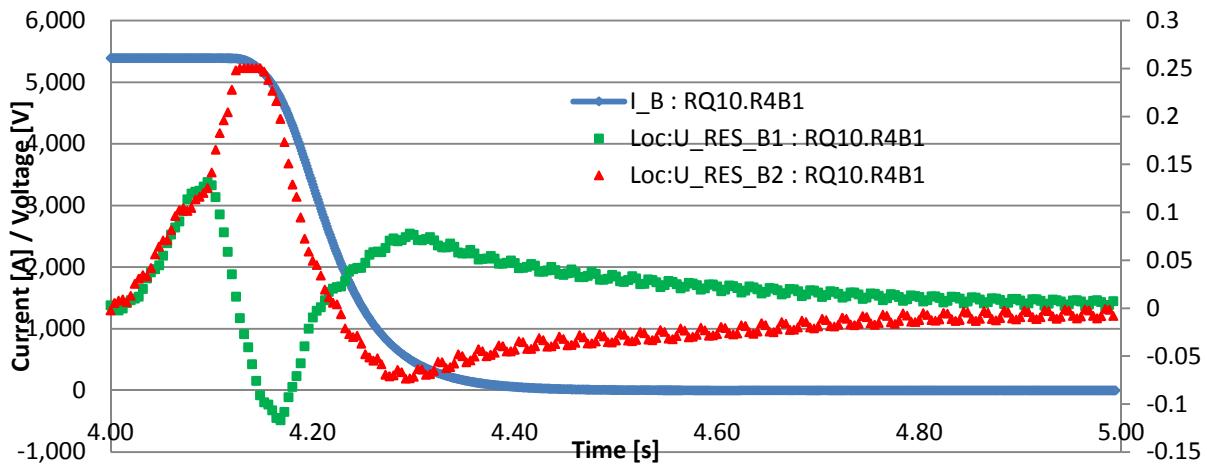
Note that there are several cases of a similar wiring mistake, as described in reference [12]. Table 2 is copied from this reference. The coupling will remain an issue with these circuits, as long as the problem is not fixed. This is demonstrated in figure 8, showing the same phenomenon in sector 3-4 between the Q9 and the Q10.

Figure 8: Current of the quenching Q10.R4 and the voltage picked up by the quench protection for the Q9.R4 (right scale)

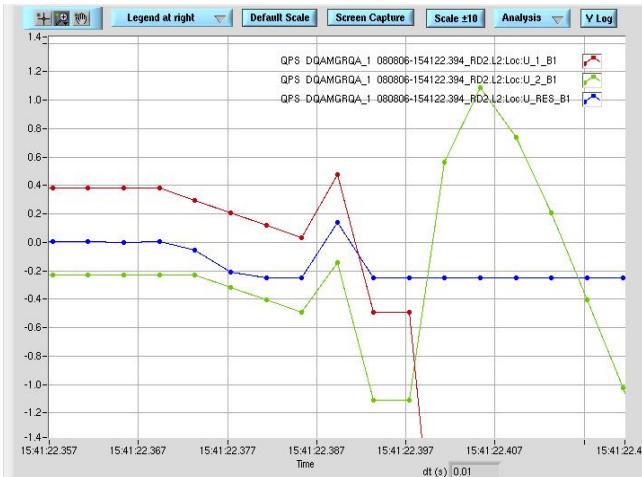
Figure 9 Voltages over the “detraining” RD2.L2

Figure 9 shows the voltages over the half-coils of aperture B1 of the D2.L2 during an apparent detraining quench on August 6th 2008. The magnet had been without problems at 6 kA before. Now it quenched at about 5.5 kA. Both half-coils (blue and red) seem to develop a resistance, which is reflected in the difference (blue) going rapidly into saturation. The logbook says “detraining ?”. The question mark is well deserved, because the Q4.L2 aperture 2 had been ramped up to nominal the day before, in between this quench and the previous successful 6 kA run. Table 2 reveals that the two magnets share cable 1 in the DFBMA.4L2. So, it is maybe not a mystery at all? The question has to be followed up.

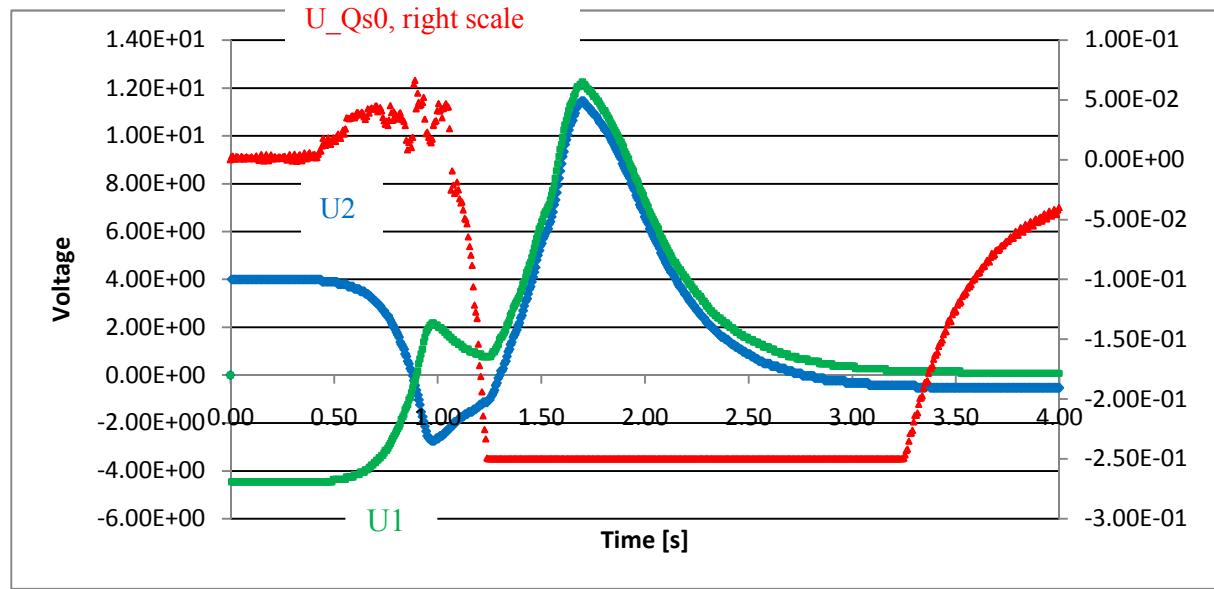
In June 2008, during the training campaign of the dipoles the dipole B16.R5 quenched due to the “hot” helium coming from the quenching neighbor. This is so far quite normal. In this case, however, a phenomenon showed up, which had been previously excluded on the basis of the string experience and theoretical assumptions.

The voltage traces of this event are shown in figure 10 [10]. The curves labeled U1 and U2 (green and blue, respectively) show the voltage over the respective aperture. Clearly something develops around 0.5 seconds. The quench grows, however, so symmetric that the difference U_Qs0 (red dots, right scale) stays within 100 mV. This threshold is reached 650 ms later. The total integral over the square of the current (MIITS) increased to 50 MA², corresponding to an adiabatic temperature of 600 K [14].

Figure 10 Voltage traces from the B16.R5 (6.6.08). The quench develops very symmetric and is discovered 650ms later [13].

The extension of the quench protection, necessary to detect early faults in the main busses makes it also possible to compare two electrically adjacent magnets [15]. This solution is currently being implemented. It requires, however, a large quantity of additional cables, which spread high voltages all around the LHC and which increase the risk of complicated earth faults.

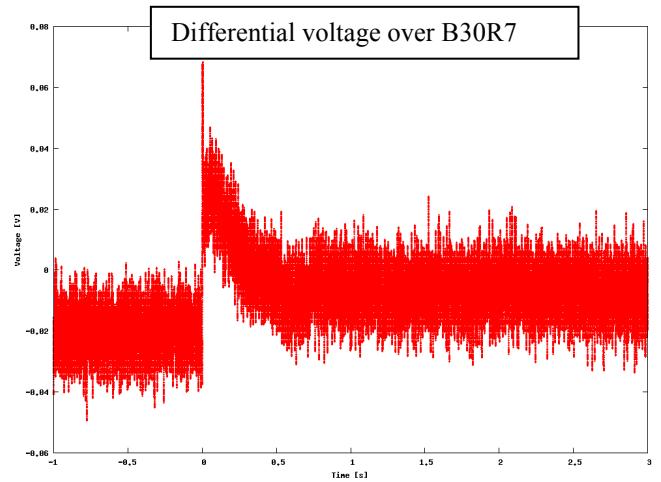
Figure 11: The differential voltage over B30R7 during a 3 kA energy extraction. Vertical scale: 0.02 V/div; Horizontal scale: 0.5 s/div

The effect [17] was first observed in MB B30.R7 (MB 1007) during a fast discharge at $7000\text{A} \Rightarrow \frac{dI}{dt} = -70\text{A/s}$. The event is shown in figure 11. The voltage difference between the two apertures is clearly incompatible with a quench. The voltage increased with dI/dt and exceeded 100mV [18]. Figure 12 shows the differential voltages over the two apertures. There was no unbalance between upper and lower poles. Magnetic measurement in SM18 had also shown a different dynamic behaviour of the aperture with an unusually high sextupole in one aperture and no particular asymmetry between upper and lower poles [19]. It was therefore concluded [20] that the contact resistances in the two apertures, and hence the eddy currents, are quite different. However no particular problem for the safety was envisaged and the quench

detection threshold was raised to 250 mV. This decision seems discussable and potentially dangerous in view of the symmetric quench issue (see above).

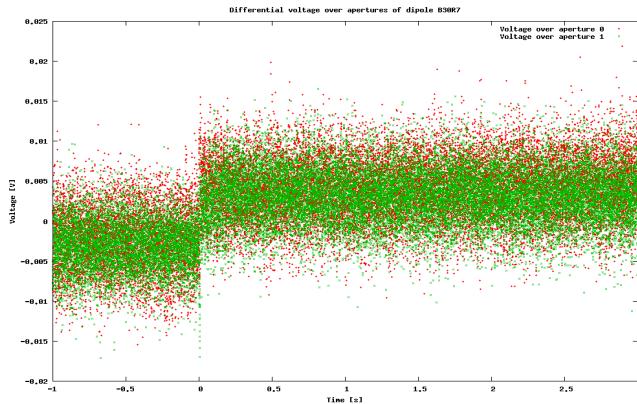
Figure 12: The differential voltages over the two apertures of B30R7. Scales: 0.005 V/div and 0.5 s.

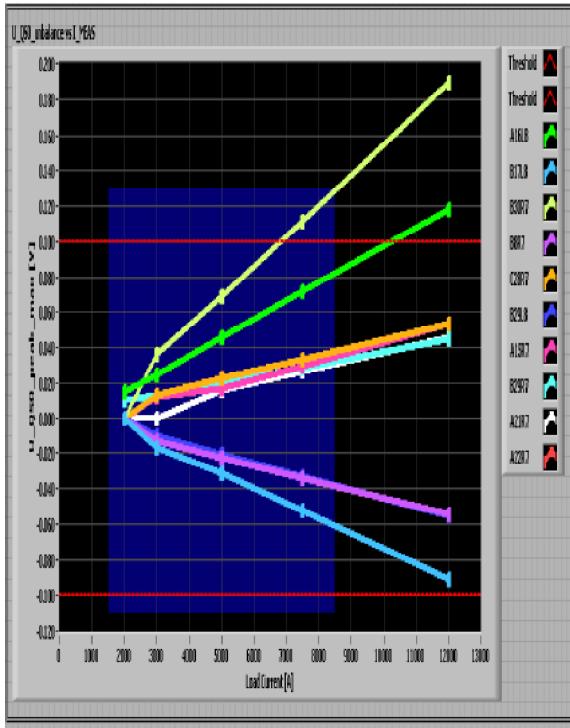
Figure 13: Sensitivity of dipoles in sector 78.

The plot shows the observed peak voltages as a function of current. The red horizontal lines correspond to the quench protection threshold. The yellow line on top belongs to the B30.R7. As useful as this tool is for the original purpose, it turned out even more important for the search of abnormal splices.

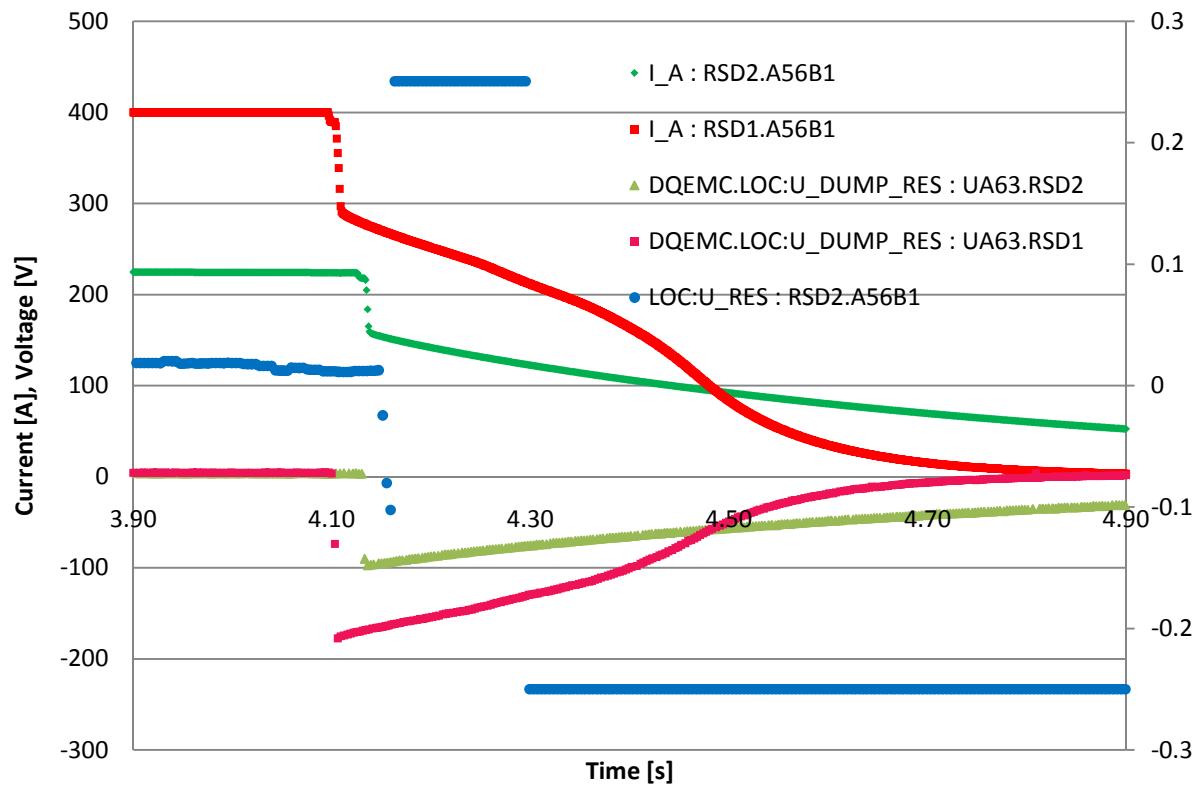
Figure 14 shows the current in RSD1.A56B1 and RSD2.A56B1 (red and green) respectively. In blue (right scale) the resistive voltage of the RSD2 is plotted. The curves starting from below are the voltages over the external dump resistors. The sextupole correctors, like many others, are protected by internal resistors and by external dump resistors [22].

A quench happens in RSD1, while the current in RSD2 is slowly ramped down. The current in RSD1 drops rapidly by more than 100 A. The mechanism is well explained in reference [23]. The current diverts in part into the local bypass resistor (150 mΩ each, 1.8 Ω total), which are mounted on the magnets. This happens in a very short time. The enormous change in current (amounting to almost 18 kA/s in fig. 14) is “seen” by the adjacent circuit. The blue symbols indicate the (calculated) resistive voltage, which reaches easily the quench detection threshold. The switch of RSD2 is being opened and the current is being redistributed.

Note the acceleration of the current decay in the RSD1 after about 300 ms. The bypass resistors act as quench heaters and quench all magnets of the circuit.

Figure 14: Coupling between RSD1.A56B1 and RSD2.A56B1

Many cases of coupling have been observed, more or less accidentally, because no procedure was set up to test for this phenomenon. It is highly recommended to systematically include this in the next hardware commissioning procedures!

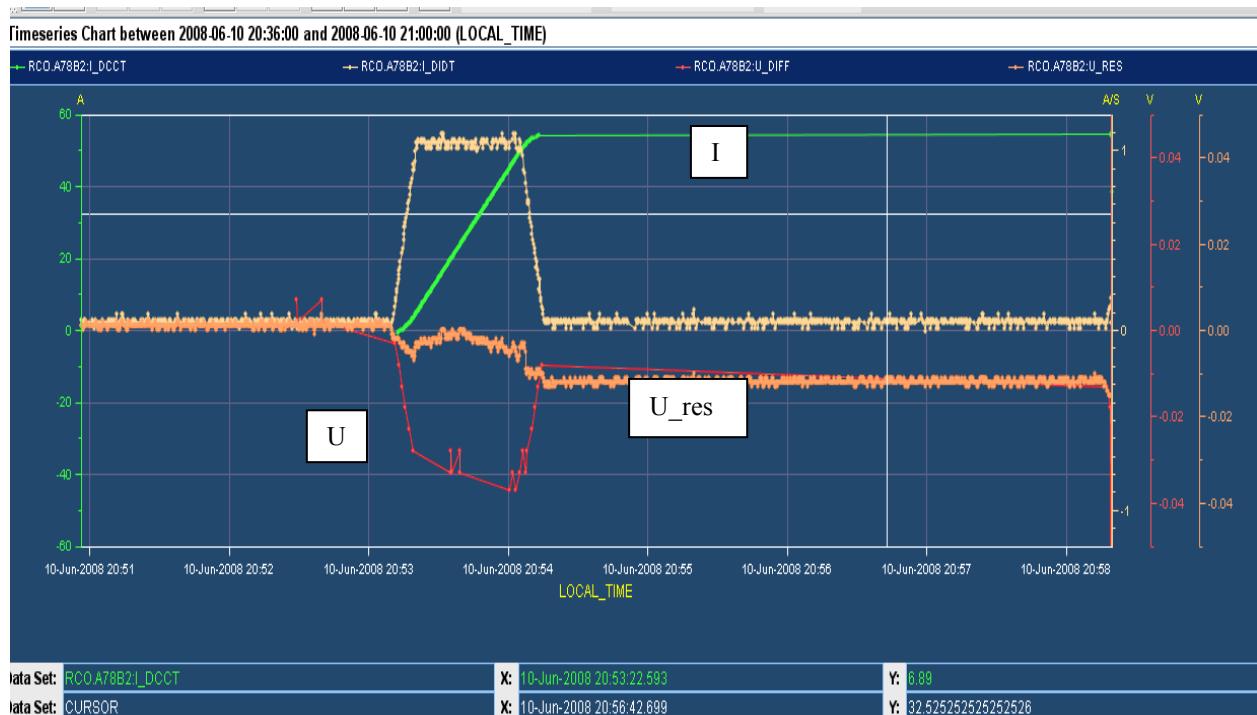
Figure 15: Voltage (red), resistive voltage (orange) and current (green) of the RCO.A78B2. The resistive voltage rises with current and explodes after ~ 4 m.

Figure 15 [26] shows in green the current applied to the RCO.A78B2 as a function of time. The red curve, the total voltage, should be reflection of the yellow curve, which indicates the current change. It is however rising, while the current change is constant. Subtracting the inductive part one arrives at the orange curve, which is the resistive voltage. It is clearly rising with current and it explodes after about 4 minutes.

The observation is best explained by the presence of a bad joint. The spool corrector circuit RCO.A78B2 is maybe not really needed for the LHC operation, because the corrector strength of the other 7 sectors should be sufficient.

A resistance of $0.3 \text{ m}\Omega$ can be calculated from figure 15. This corresponds to an average joint resistance of $330 \text{ n}\Omega$, or, more likely, a bad splice with $0.27 \text{ m}\Omega$.

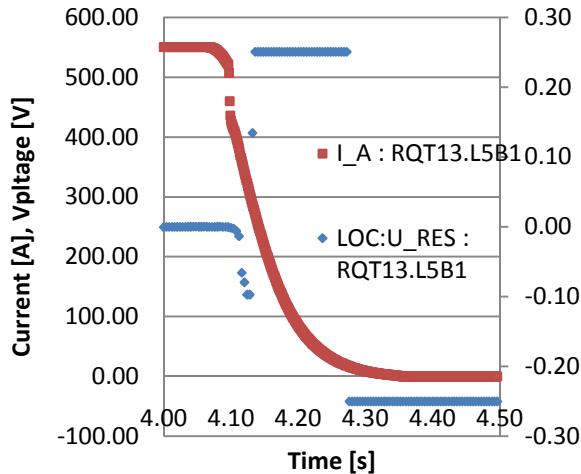
As to be expected, also the line N cable is holding some surprises. Figure 16 shows the current and resistive voltage of the RQT13.L5B1, as an example. The circuit quenched 28 s after having reached 550 A. The resistive voltage is detected after the current starts to drop. This is very likely a sign for an increasing resistance somewhere outside the coil.

Figure 16: Current and resistive voltage (right scale) for the RQT13.L5B1

It was decided to reduce to maximum current for these circuits, in order to progress with the hardware commissioning. This seems to be a quite questionable decision in view of the September experience. The circuits should be declared “out of order” to avoid damage.

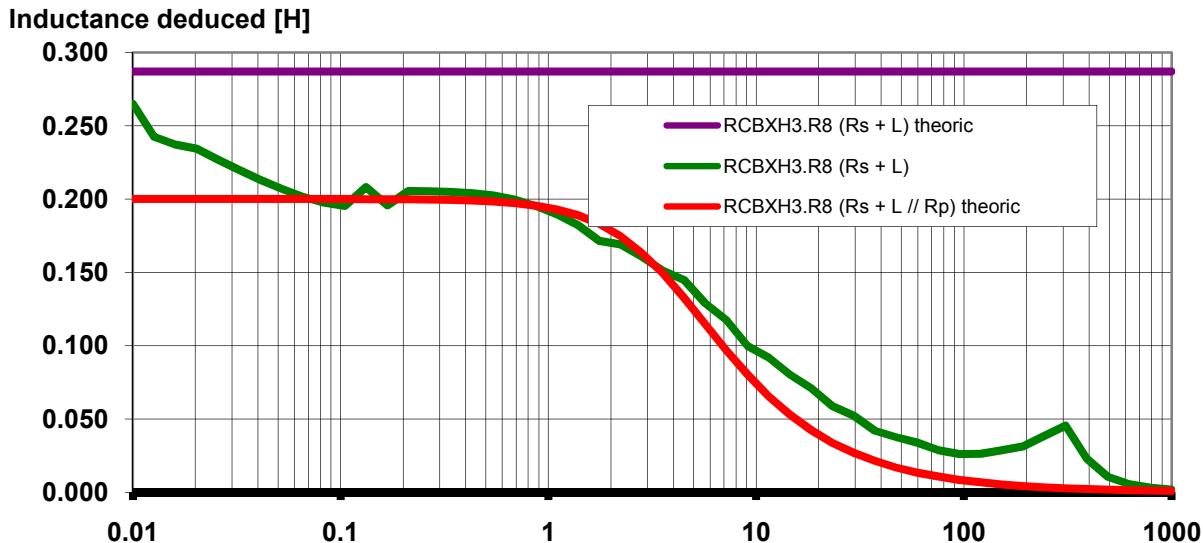
The model, underlying the regulation of the converter, was wrong. The (green) inductance (see figure 17) is far from the purple constant, which was the expectation. This magnet seems to have either an exceptionally low eddy current resistance or (equivalently) a parallel resistance of $\sim 10 \Omega$, or.

Figure 17: Inductance of the MCBXH3.R8 [31]

It was possible to get the magnet working with this assumption (lowest, red, curve)

At the time being, no information is available over the condition of the other, orthogonal, magnet of the same aperture. It might have been shorted and magnetic coupling could have induced the effect. Clearly, the experiment has to be repeated at the earliest possible occasion.

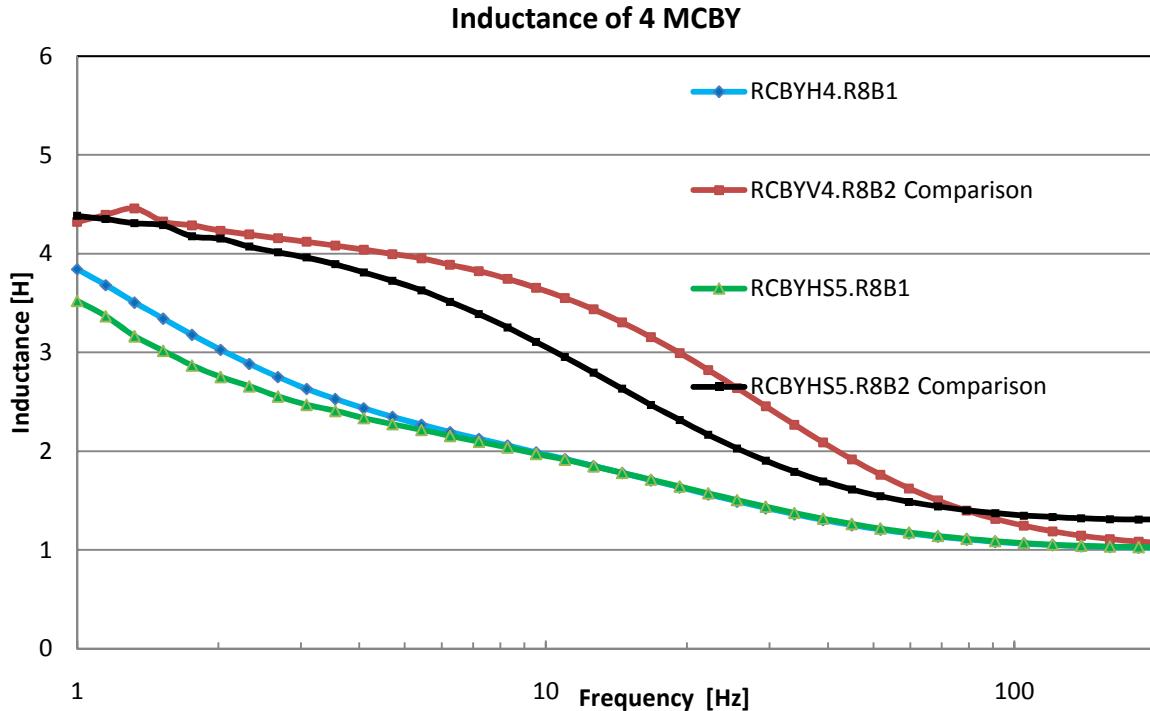
Figure 18 shows the inductances of 4 MCBY apertures [32]. The upper curves belong to “normally” behaving magnets. The lower curves, indicating lower inductance already at low frequencies, behave very strange. Special transfer functions are being employed. Nevertheless, the magnets have other shortcomings, which may or may not be related to the strange inductance.

It is not known, why some transfer functions are completely different. Up to now, no hint was found in the production data [33].

Figure 18: The inductances of 4 MCBY apertures [32]

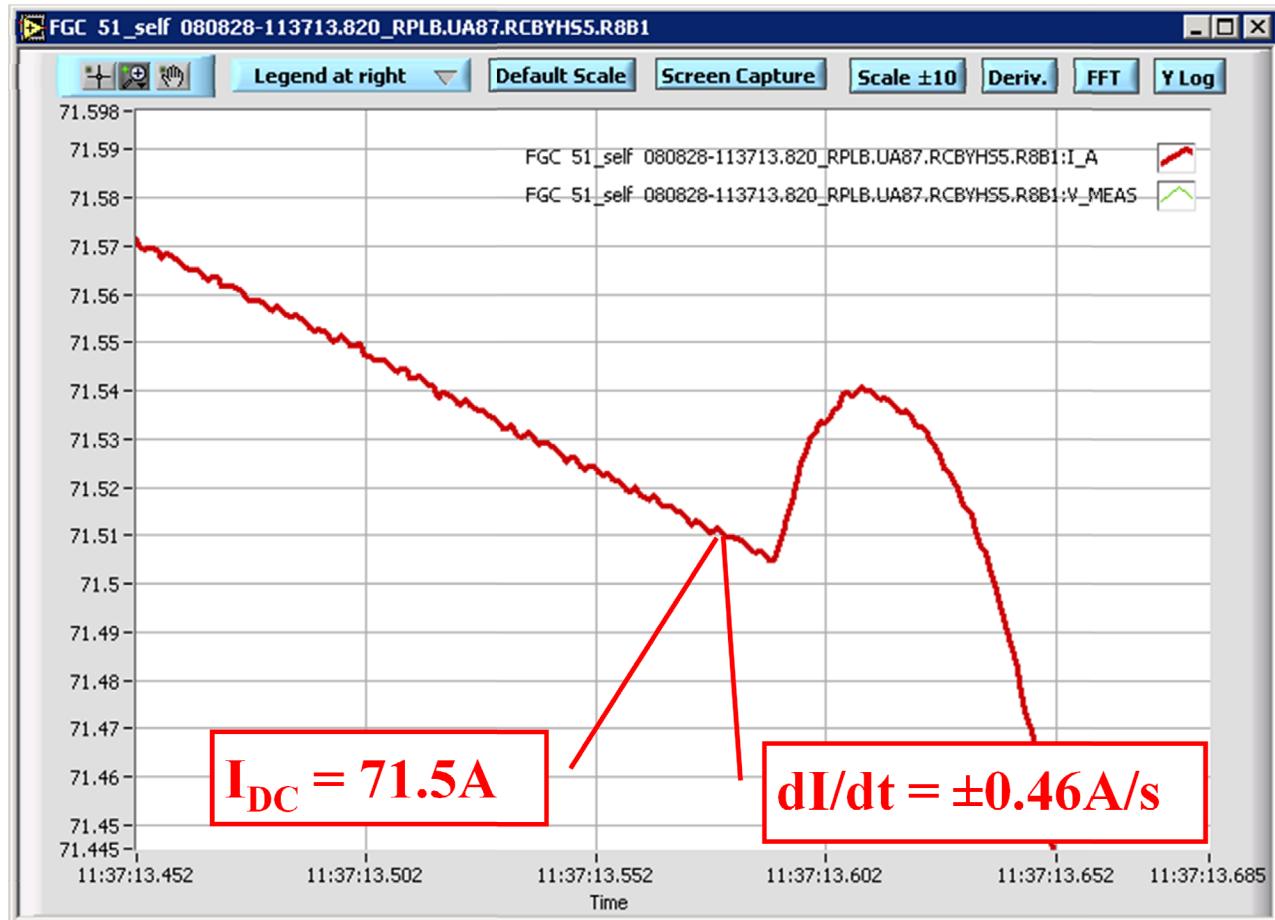
The most remarkable feature of this “quench”, however, is shown in figure 19 from reference [34].

The sudden bump confuses the power converter and is interpreted as abnormal situation, hence the switch off. But where does the energy to create the current bump come from? The current increases by ~ 50 mA, i.e. by 0.07%. The Inductance seems to shrink by 0.14%, assuming that the current is being driven up by the magnetic energy.

Figure 19: The current hunch

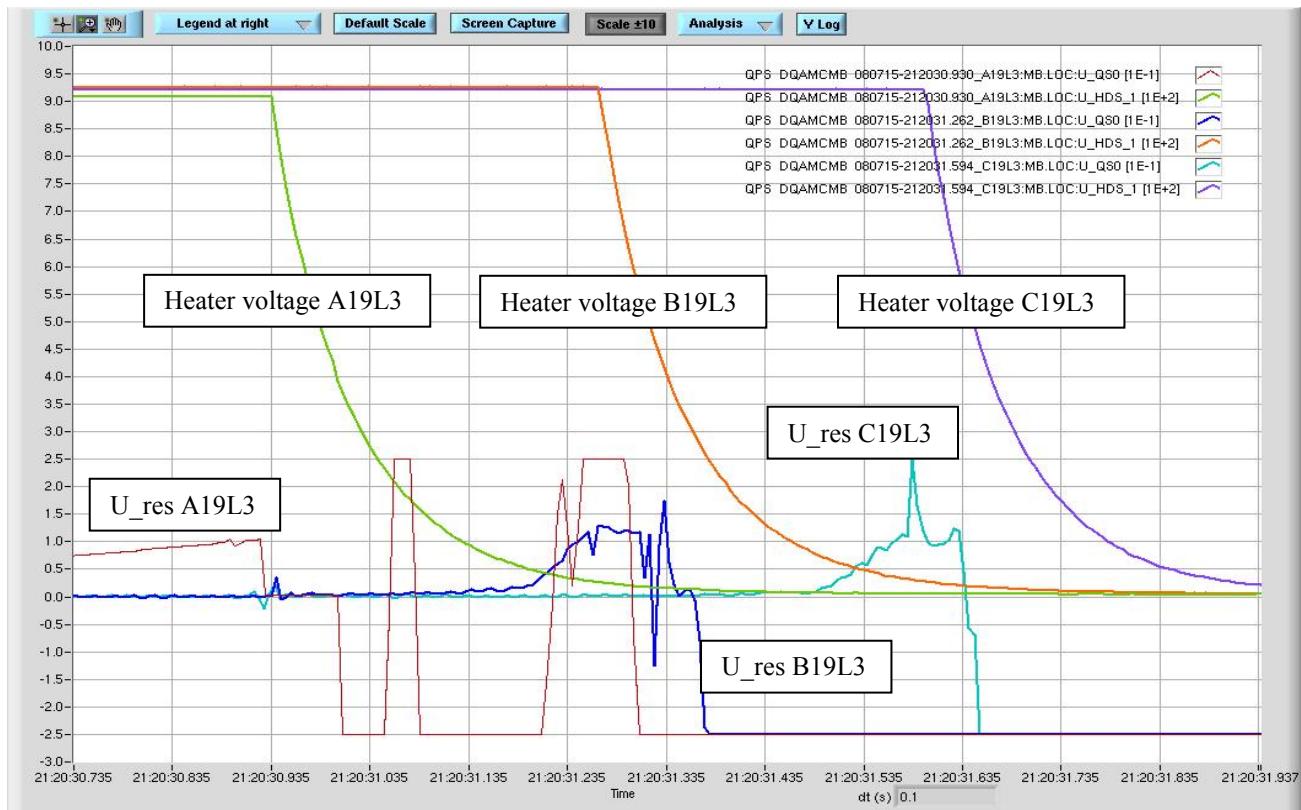
The plot in figure 20 shows an example of a quench propagation time of the order of 100 ms between the three magnets each. R. H. Flora found two other cases,

Figure 20: Three dipoles quenching at a very fast rate [35]

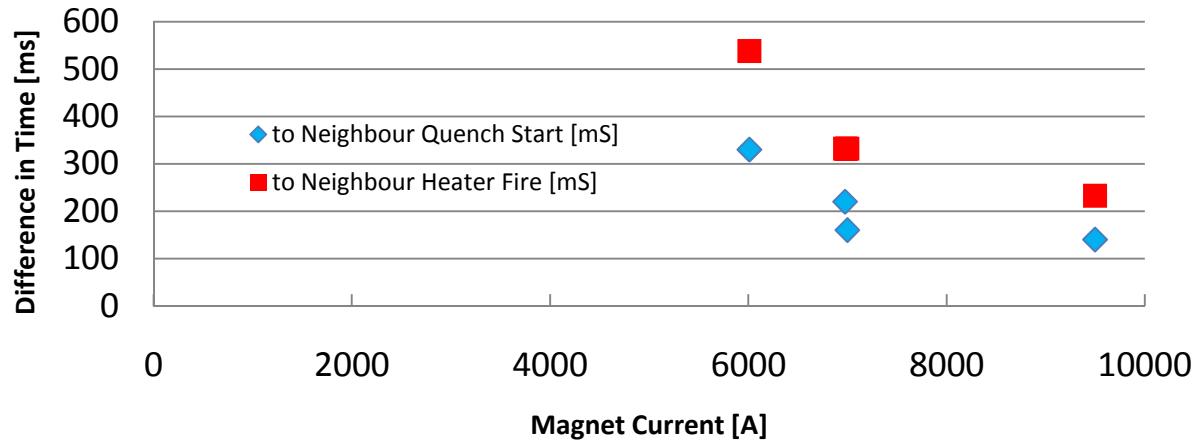
Fast Quench Propagation 4 cases found

involving only 2 magnets. The result is plotted in figure 21. No explanation has been found so far. It is also unclear, whether this phenomenon has anything to do with the exceptionally high quench propagation, observed during the incident/accident on September 19th [36, 37].

Figure 21: All fast quench propagation cases [35]
