CIBDS beam dump triggers due to glitches in BIS loop B1-A

diagnosis and mitigation measures

Stéphane Gabourin
TE/MPE-EP

MPP – 23th Oct 2015

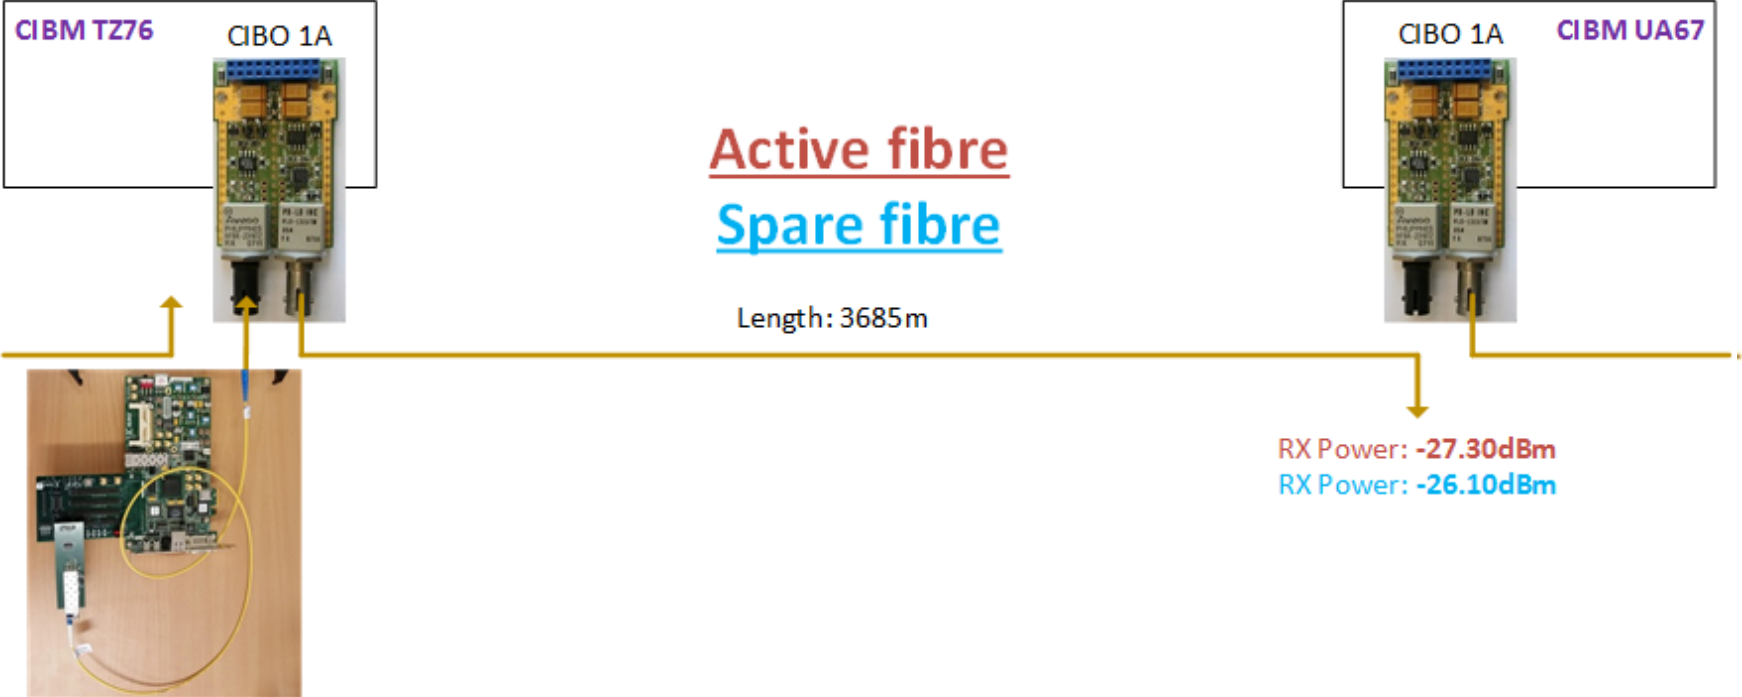
Action taken (19th October)

- Check the optical link during a (long enough) stop of the LHC
- Opportunity on Monday morning (loss of Cryo in Sect 1-2)
- On **Monday 19th**, the fibre between TZ76 and UA67 on Loop Beam-1 A was re-measured, including the CIBO in TZ76

- RX power measured higher by 1.2dB => Change the active fiber by spare fiber
- Check the 4 optical loops are properly re-close using the CIBG debug frequencies of 100-200 kHz (not possible to forget the LoopA freq generator...)

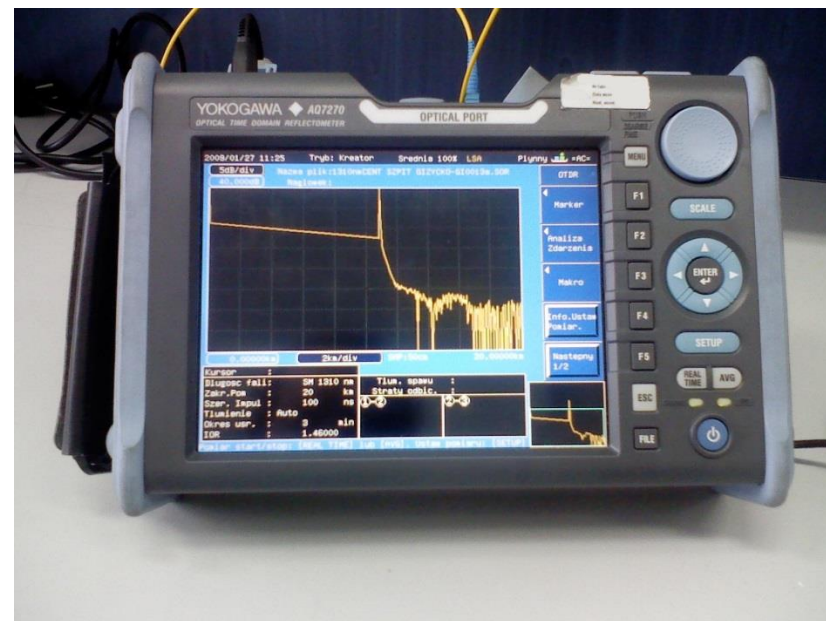
- EN/EL have replaced the 6 fibers between UA67 and TZ76 during LS1
- Ask EN/EL their fiber attenuation data
- Ask EN/EL to re-measure the fibers with professional equipment (OTDR), as we are using JDSU power source, power meter and attenuator.

⇒ Proposed by EN/EL for the EYTS
