HTS tape insulation

Nikolaj Zangenberg, Danish Technological Institute
Dec 1st, 2015

Study of defective coil from Danfysik HTS magnet

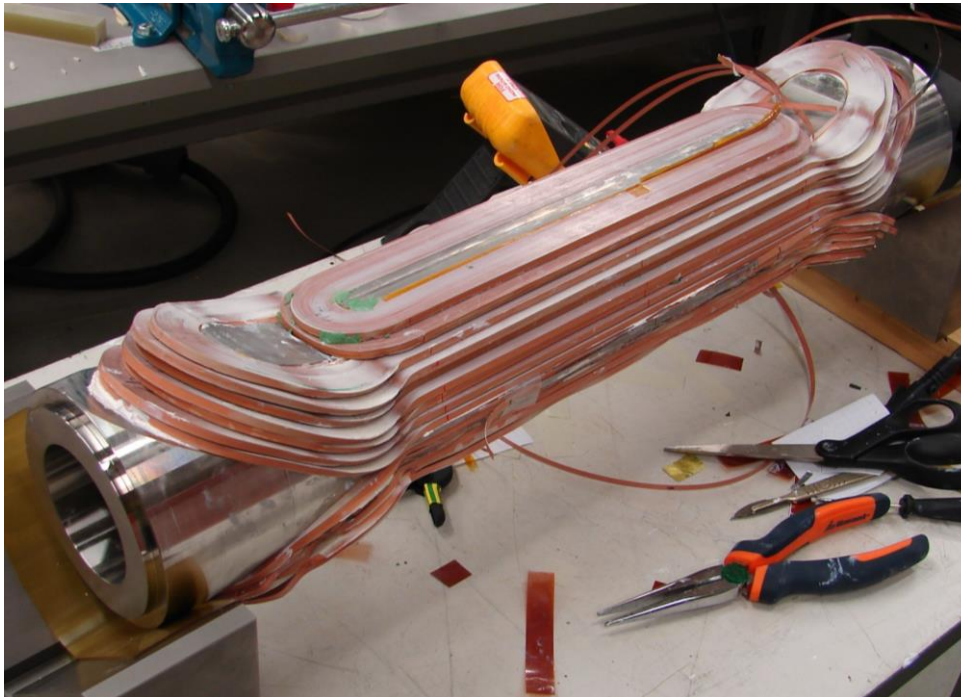
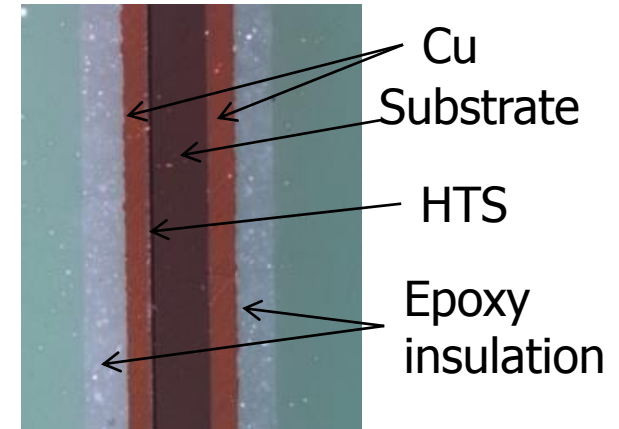
A few of the coils were not able to carry the designated current

Defective top coil made available for DTI in EuCARD2 project

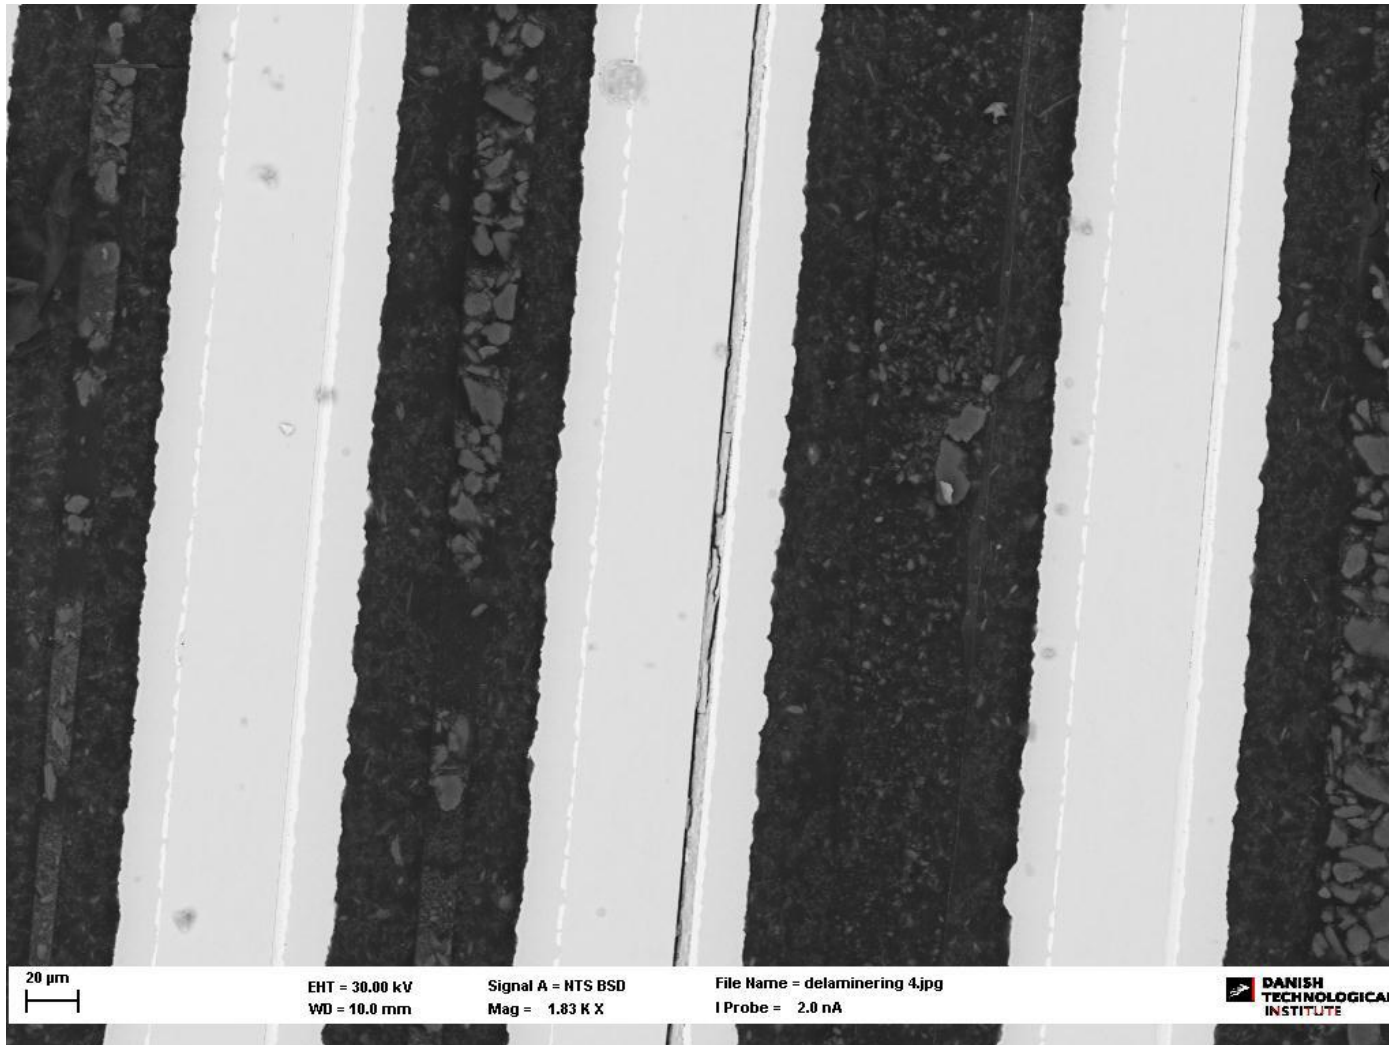
Example of delamination (electron microscopy)

Tape/coil delamination

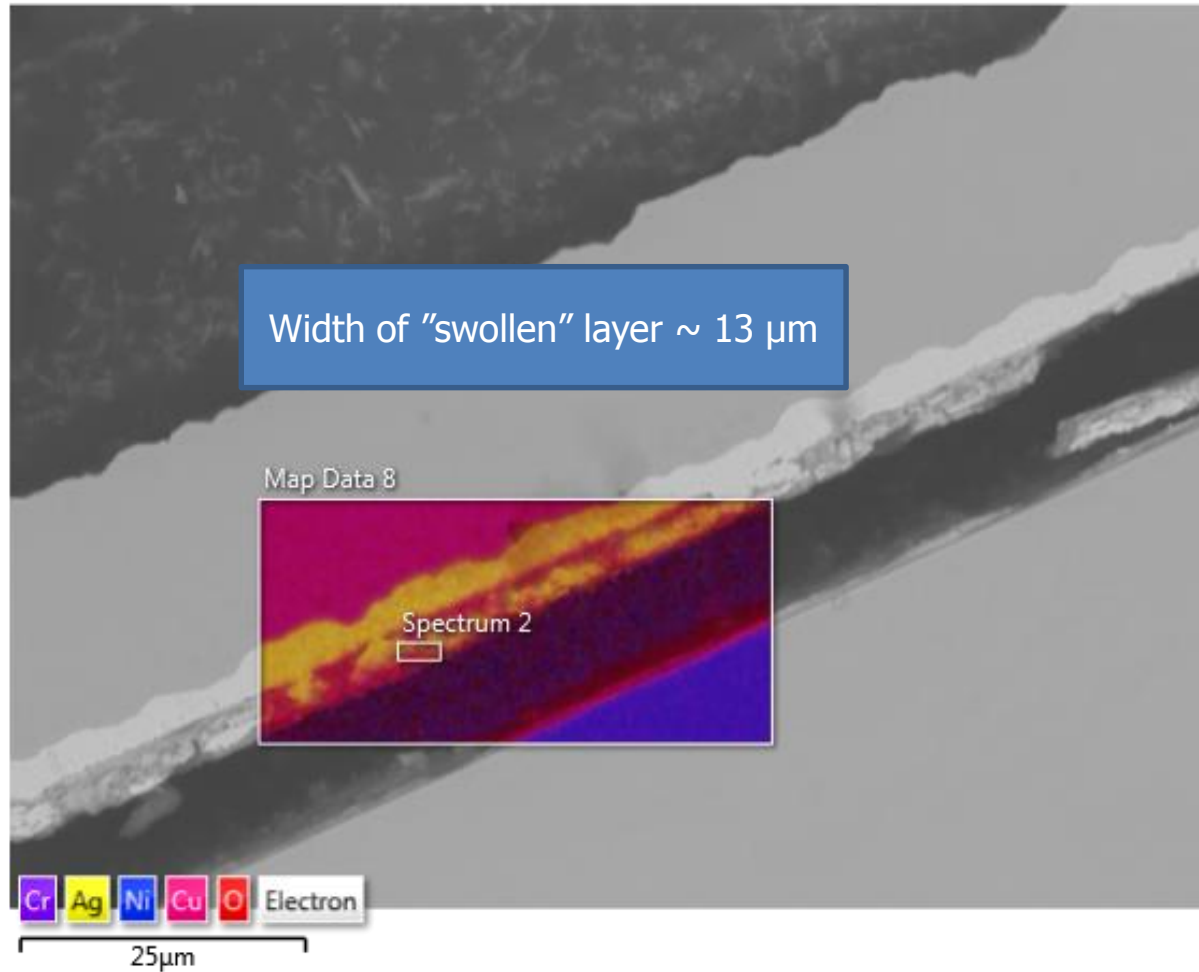
EDS Layered Image 8

Tape/coil delamination

Please note: The investigated tapes/coil are from 2011-2012.
Present day performance is not evaluated.

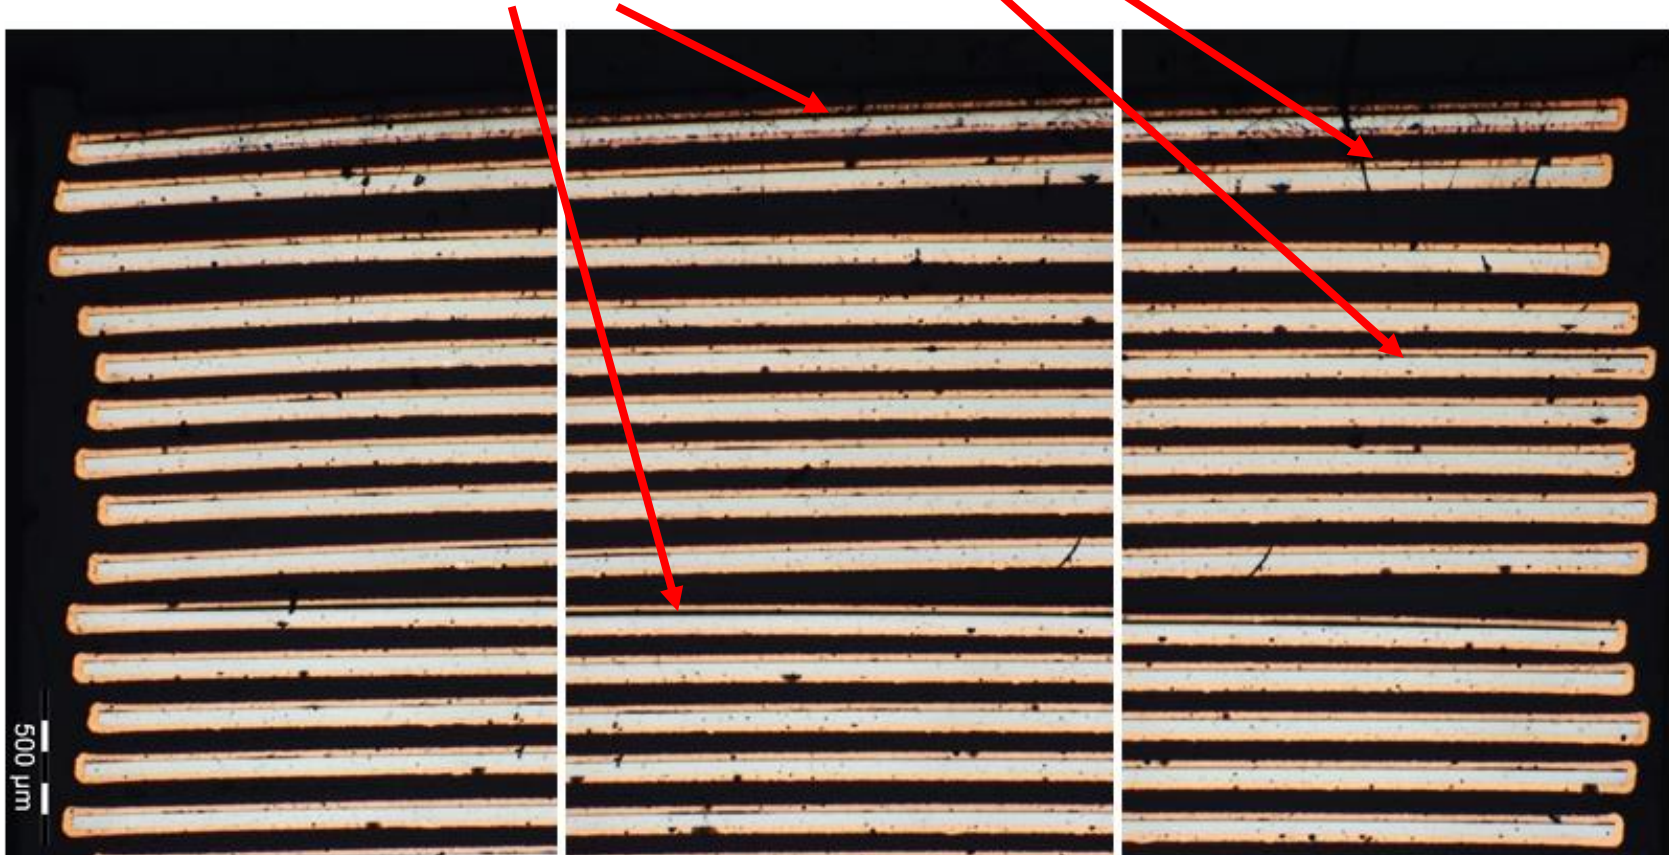
Coil defect registration

- A) defect (partial delamination)
- B) complete delamination

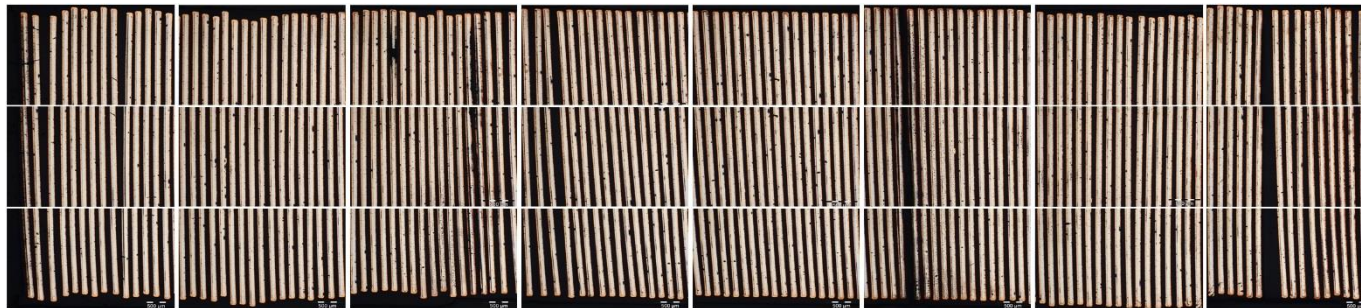
Coil section #1

Complete delaminations

Complete delaminations occur with some correlation between 1-2 and 3-4 (to a smaller extent). Serious conductor damage.

Damage may have been caused by outwards pressure on YBCO layer without mechanical backing from Hastelloy.

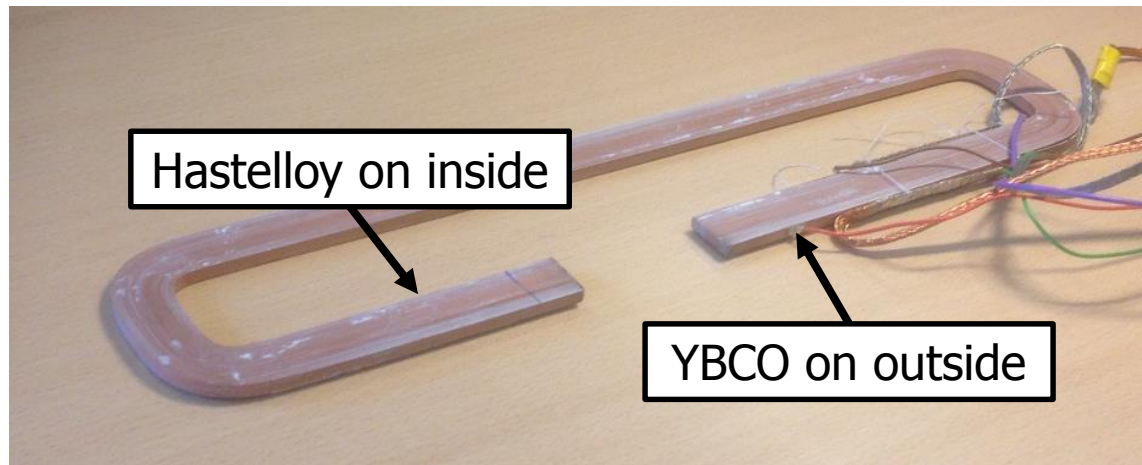
No correlation between partial delaminations in coil sections 1-2 and 3-4. Defect origin from section preparation cannot be excluded.
