Operation of Diamond Light Source SRF Cavities

Pengda Gu On behalf of the Diamond RF Group*

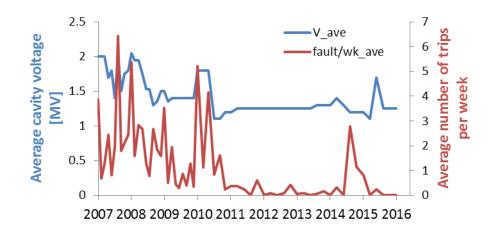
Managing cavity "fast vacuum" trips

Cavity 4 has the lowest threshold and operation suffered in 2014 before safe voltage was established Trips have been eliminated by operating cavities below threshold voltages

Reliable operating voltages	
Cavity 1	1.1 MV
Cavity 2	1.2 MV
Cavity 3	1.4 MV
Cavity 4	0.8 MV

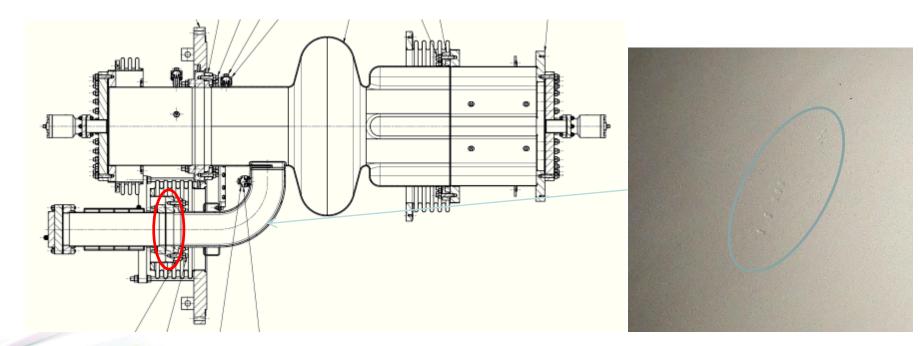
Investigation at RI

Leak rate 2x10⁻⁸mbar*l/s

Repair and modification: Add AB sensor along niobium waveguide bend. Add TSPs with isolation valve on RBT side. Modify helium fill tube to achieve more uniform cooling.

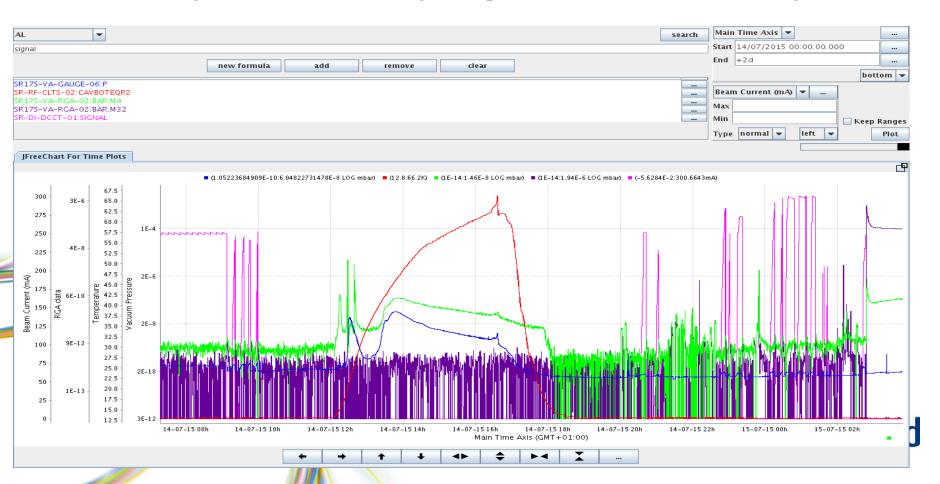
Cavity 4 RF Window Leak

Cavity 4 was rushed through the SAT to replace cavity 2 in September 2014.

It suffered many fast vacuum trips from the start.

Qext was pushed very low to $9x10^4$ by using stub 1&3 of the 3-stub tuner.

Stronger and more lasting out gas even at low power level when both stub 1&3 were pushed in. Pulse conditioning and beam conditioning were performed before it failed during beam test.

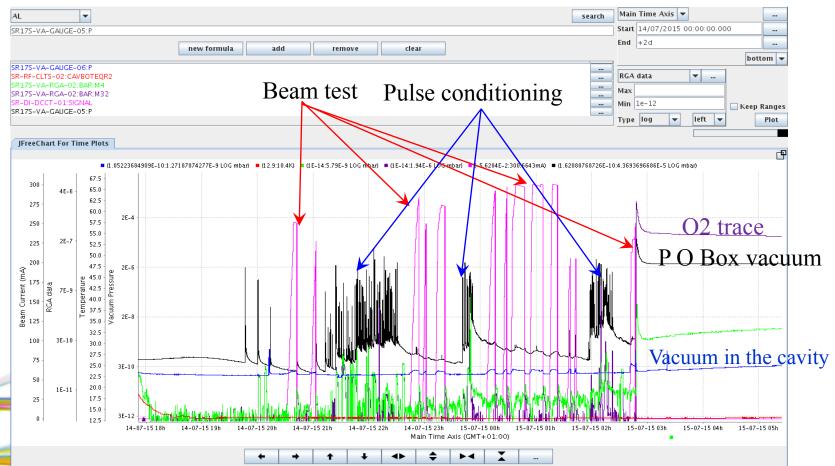
Cavity 4 RF Window Leak

Vacuum at valve box went up to 10⁻⁵mbar at pump out box. No big change inside the cavity.

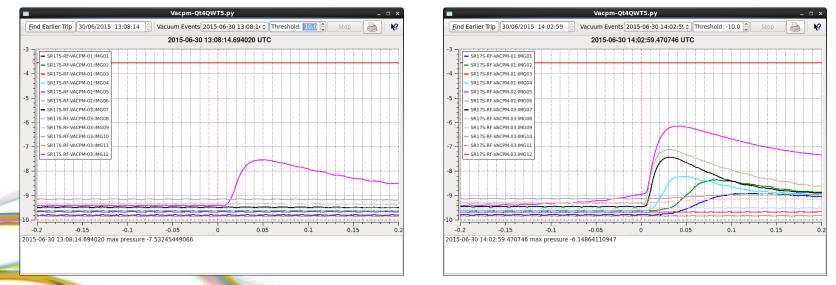
3-stub Tuner Position and Cavity Trips

- Cavity 4 trip problem was cured by reducing voltage from 1.0MV to 0.8MV
 - Some loss of beam lifetime but interlock levels were cleared
 - Required change in 3-stub tuner position to maintain good coupling
- As a test, a beam trip was provoked by overloading cavity with the two 3-stub tuner configurations
 - Followed same procedure in both cases

Pressure profiles correspond to standing wave pattern and do not signify different processes
