# Availability of PETRA III from the rf point of view

PETRA III Availability Review

DESY, May 26<sup>th</sup>-27<sup>th</sup> 2016

CWRF 2016, Genoble June 24th

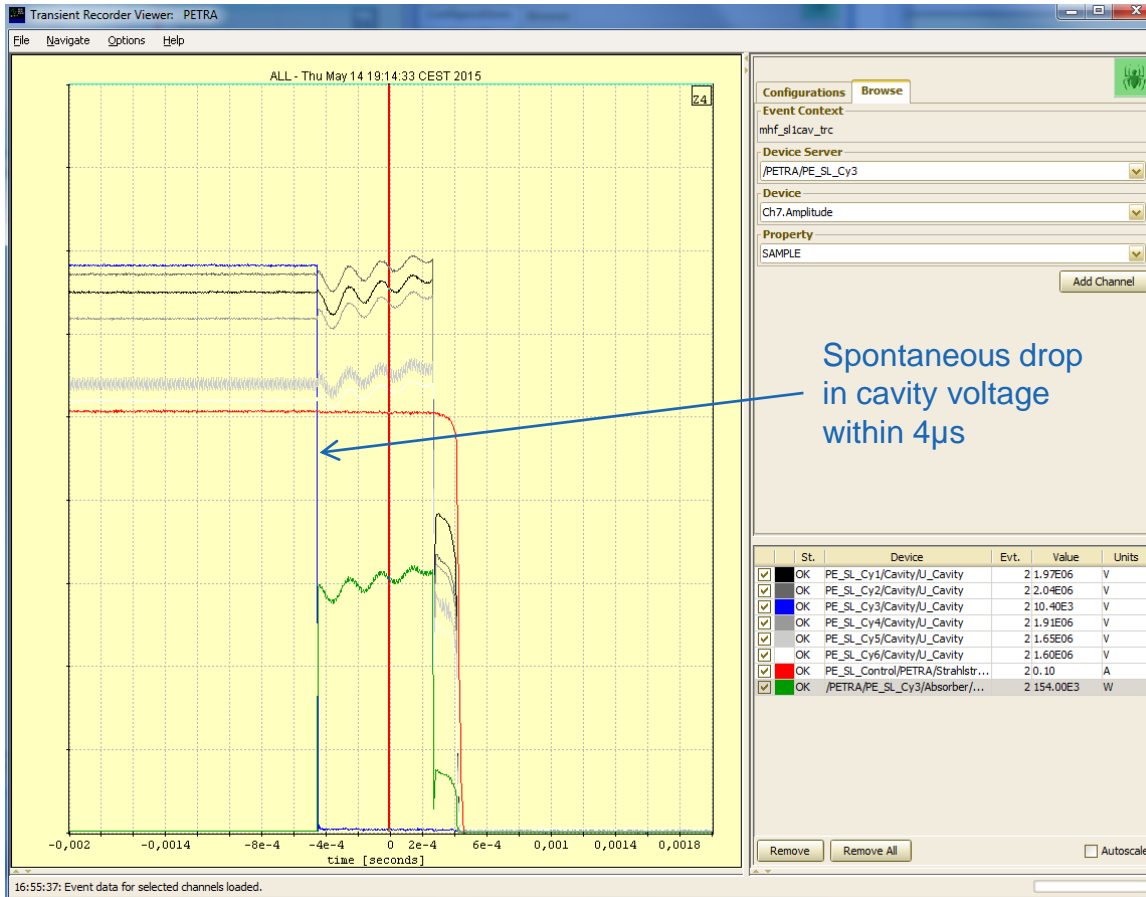
Typical signature of a  $\dot{r}$ -event, triggered by fast rising reflected cavity power

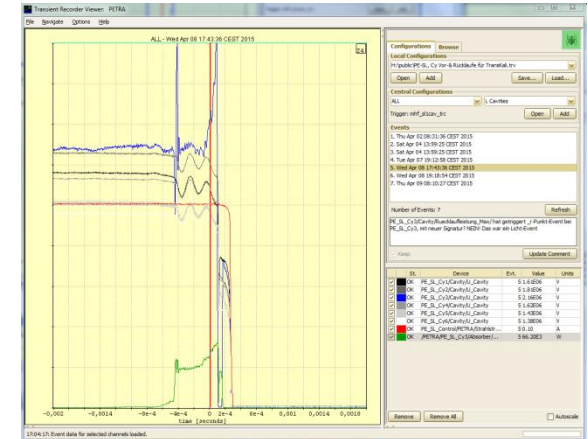
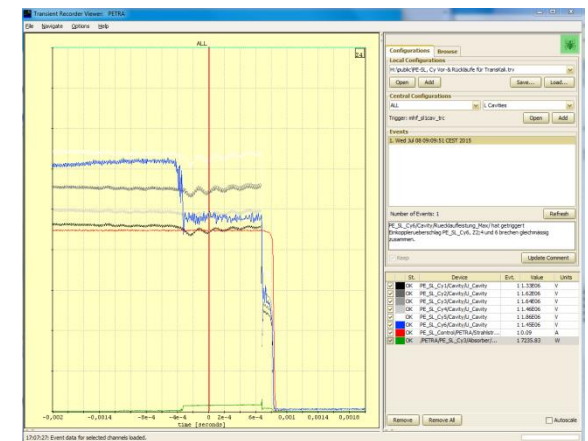
For comparison: Typical signatures of coupler arc events, detected by light.

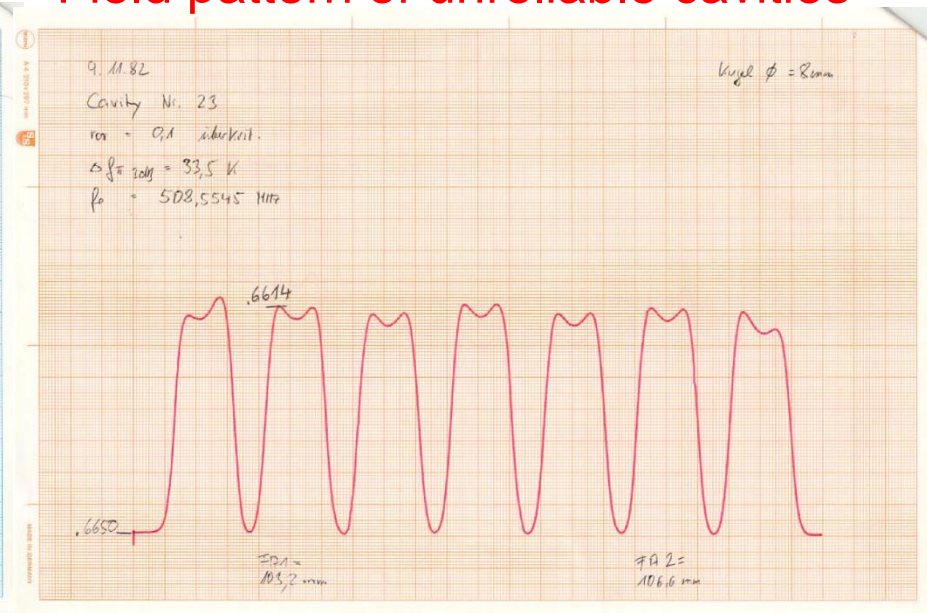
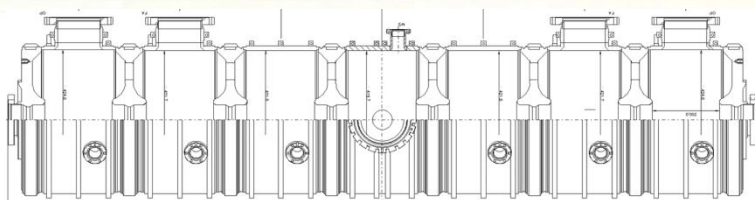
### Field pattern of unreliable cavities

The cavities with highest  $\dot{r}$ -event rate are characterized to have a homogeneous field distribution!

We do not know the mechanism yet.  
But the problem seems to be related to the plungers somehow

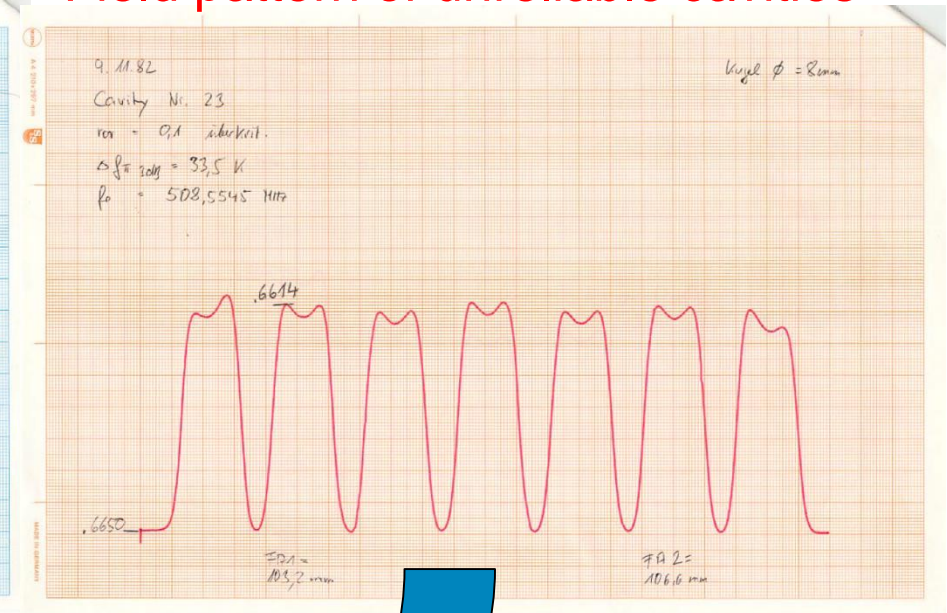
### Field pattern of unreliable cavities

Field pattern can be turned from **unreliable** to **reliable** by increasing the cavity temperature

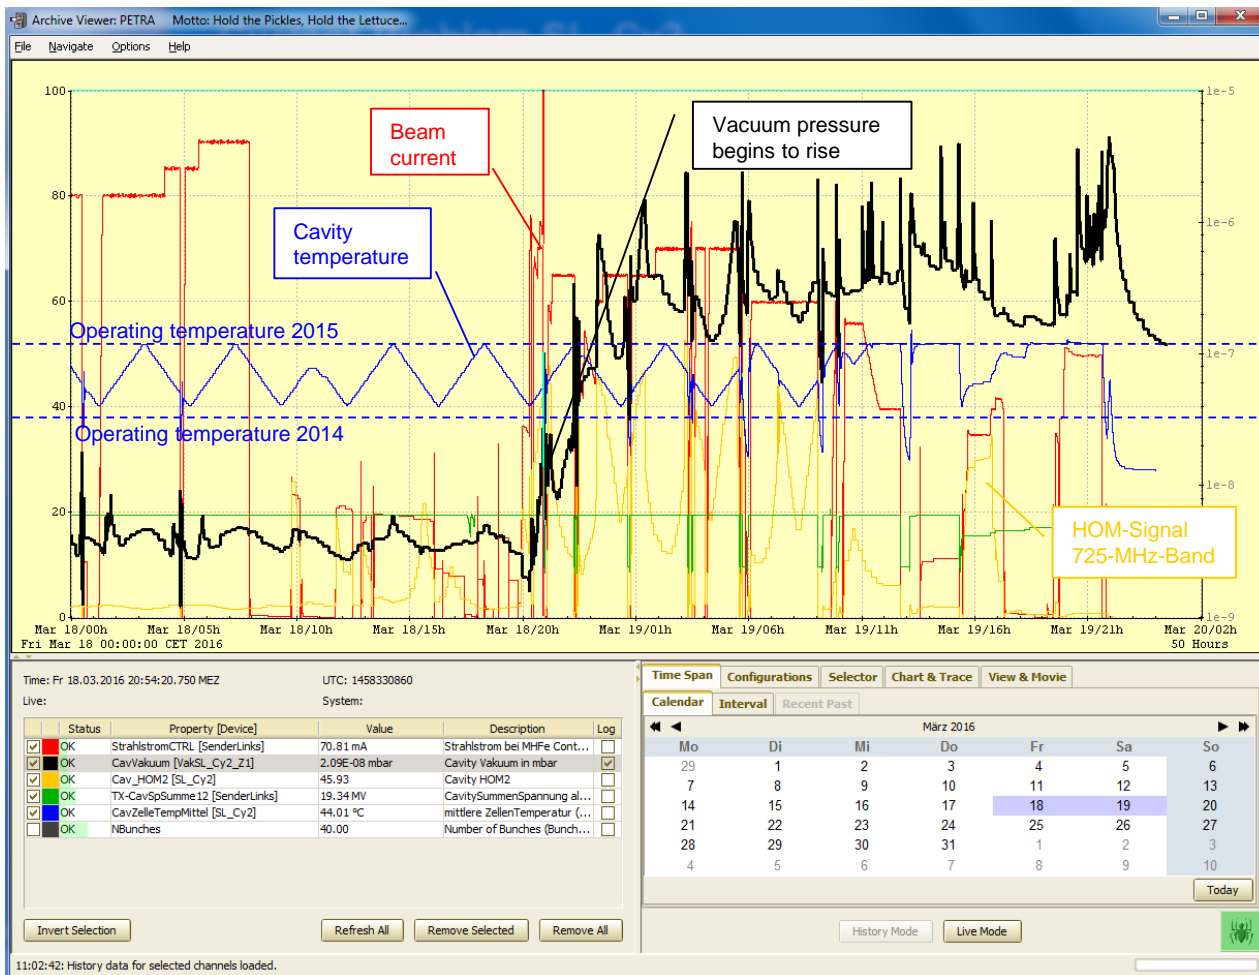
# Current Problem SL\_Cy2

A vacuum problem occurs 18 days before start of user operation

- Instead of the expected  $\dot{r}$ -events, we got plunger temperature and vacuum events.
- The vacuum behavior looked like a leakage. But no leakage could be found!
- A similar event has occurred at this Cavity already in 2012!
- In order to avoid venting the vacuum system the cavity was disconnected from rf system.

- > With some chance one plunger could be the culprit.
- > We plan to replace both plungers of this cavity during the service week in August.
- > Afterwards the cavity is reconnected to the RF system again.
- > Should turn out that not a plunger, but the cavity itself has a vacuum problem, it could be replaced at the next suitable service-break.

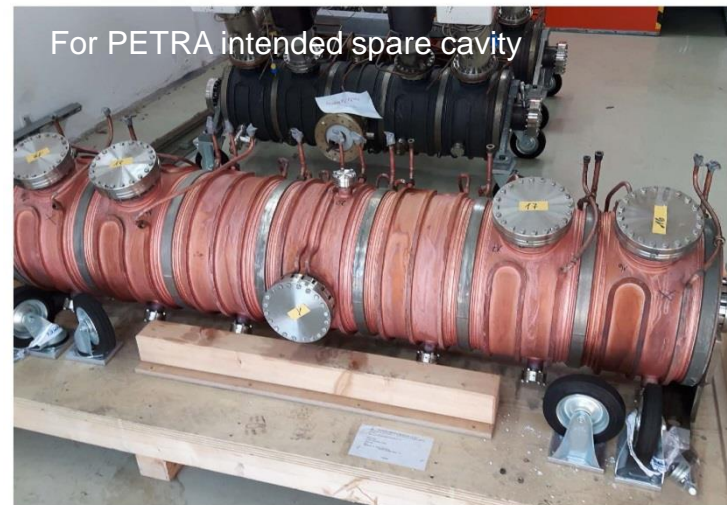
- Completion delayed due to higher priority of XFEL (plumbing & personal interlock)
- The chosen spare cavity was refurbished by electro polishing but must be complained
- Earliest completion date: July 2016 (depends on personal interlock)

For PETRA intended spare cavity

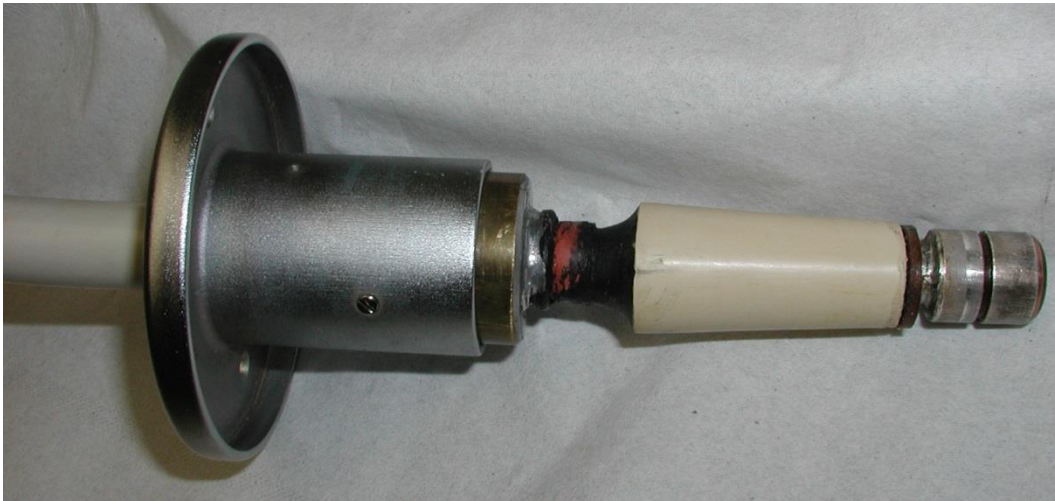
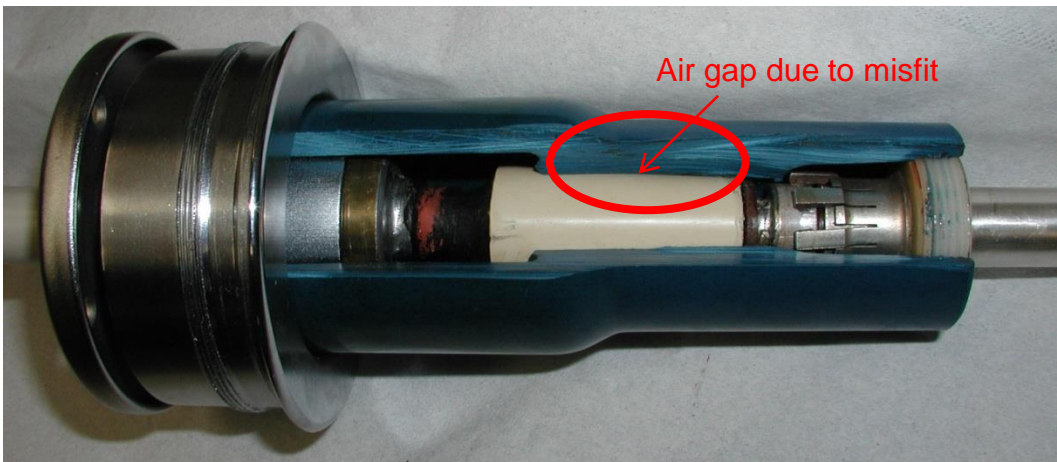
## Klystron HV Connectors, 22 hours downtime

**October 2011:** Repeated crowbar-ignitions. Subsequent (unsuccessful) Troubleshooting led to an integrated downtime of 22 h in one week.

Cause: Flashovers inside plug and female connectors.

Analysis had shown, that the plugs of the new HV cables, not exactly fit to the older female connectors of the klystrons.

The misfit led to field-increasing air gaps inside the plug-female sets.

After all 32 male-female sets were revised the failure no longer occurred.

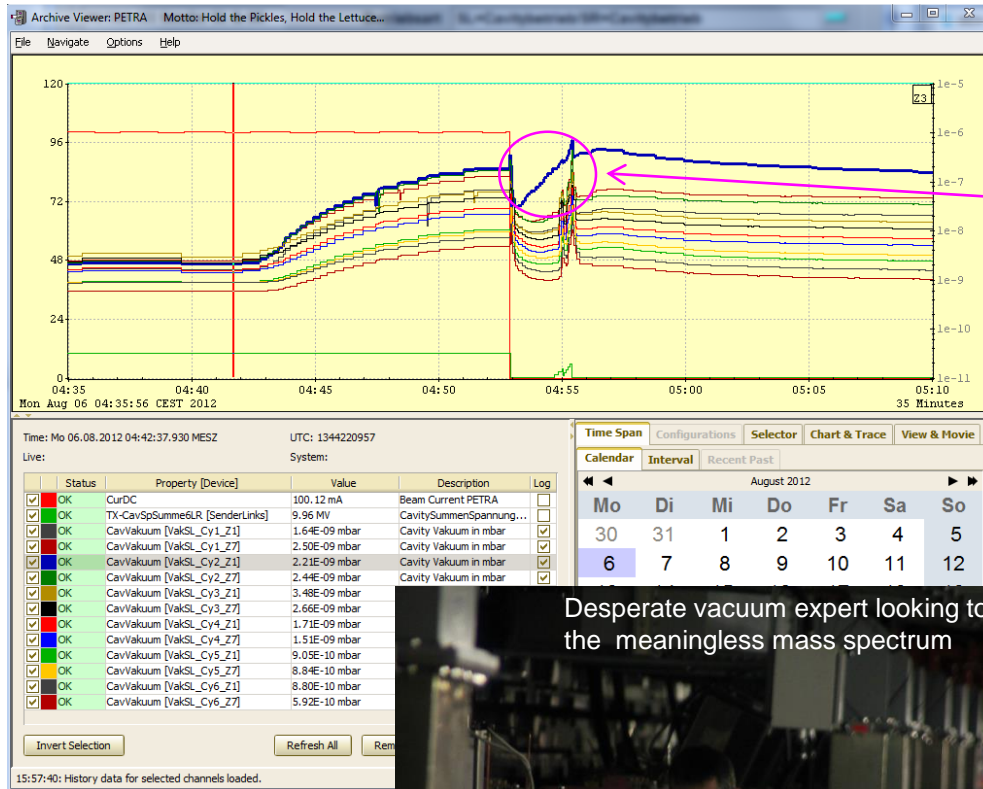
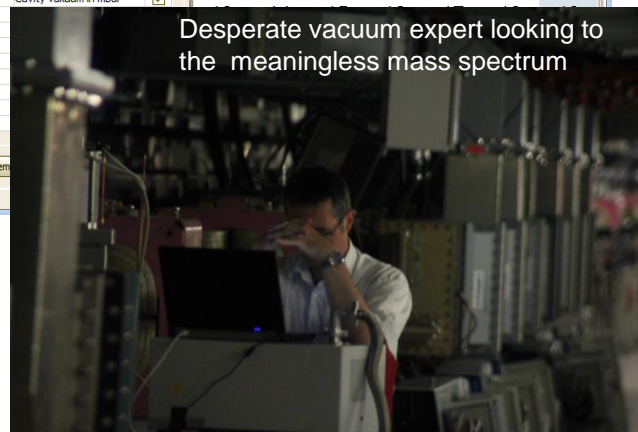
## Cavity Vacuum (SL\_Cy2), 56 hours downtime

August 2012: During the user-run the vacuum pressure began to increase. After 10 minutes the interlock shut off the transmitter.

Despite RF had been switched off, the pressure of one pump continued to rise!?

The vacuum experts could not find a leak.

The input coupler was vaguely suspected and has been changed – without real success.

For further leak detection cooling circuits were drained and dried – again experts could find no leak.

It worked. But the cause was not found until today.

Last desperate act: RF gently turned on and beam current slowly increased.

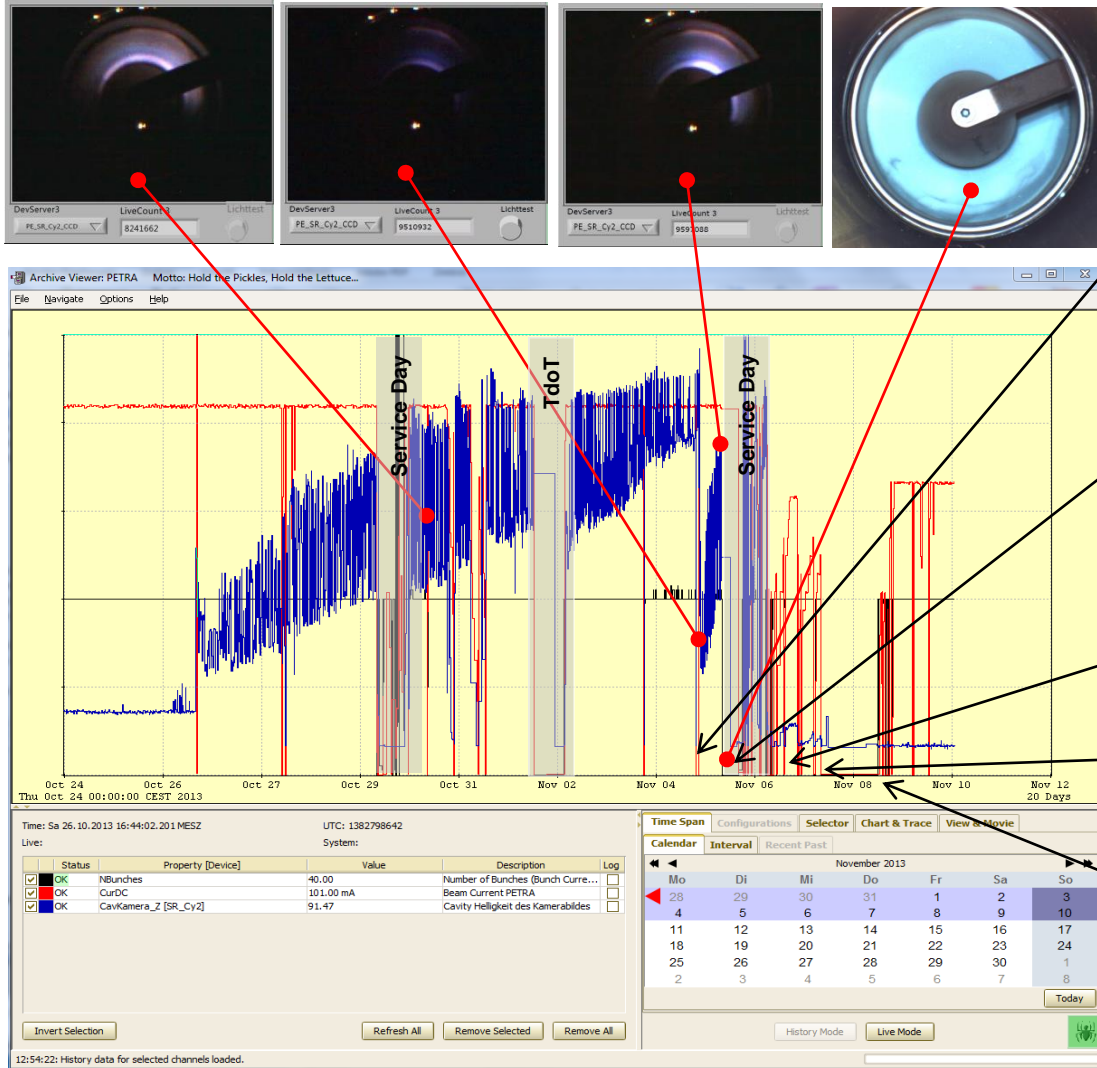
## Input Coupler SR\_Cy2, 58 hours downtime

2 x coupler arcing.

Visual coupler inspection showed grey smear on the ceramic. But this is not uncommon and must not be a problem

Lots of coupler arcing & vacuum events.

On Friday morning was decided to replace the coupler

On Saturday afternoon gently restart of beam operation
