CM 44

Hydrogen System

31/03/16

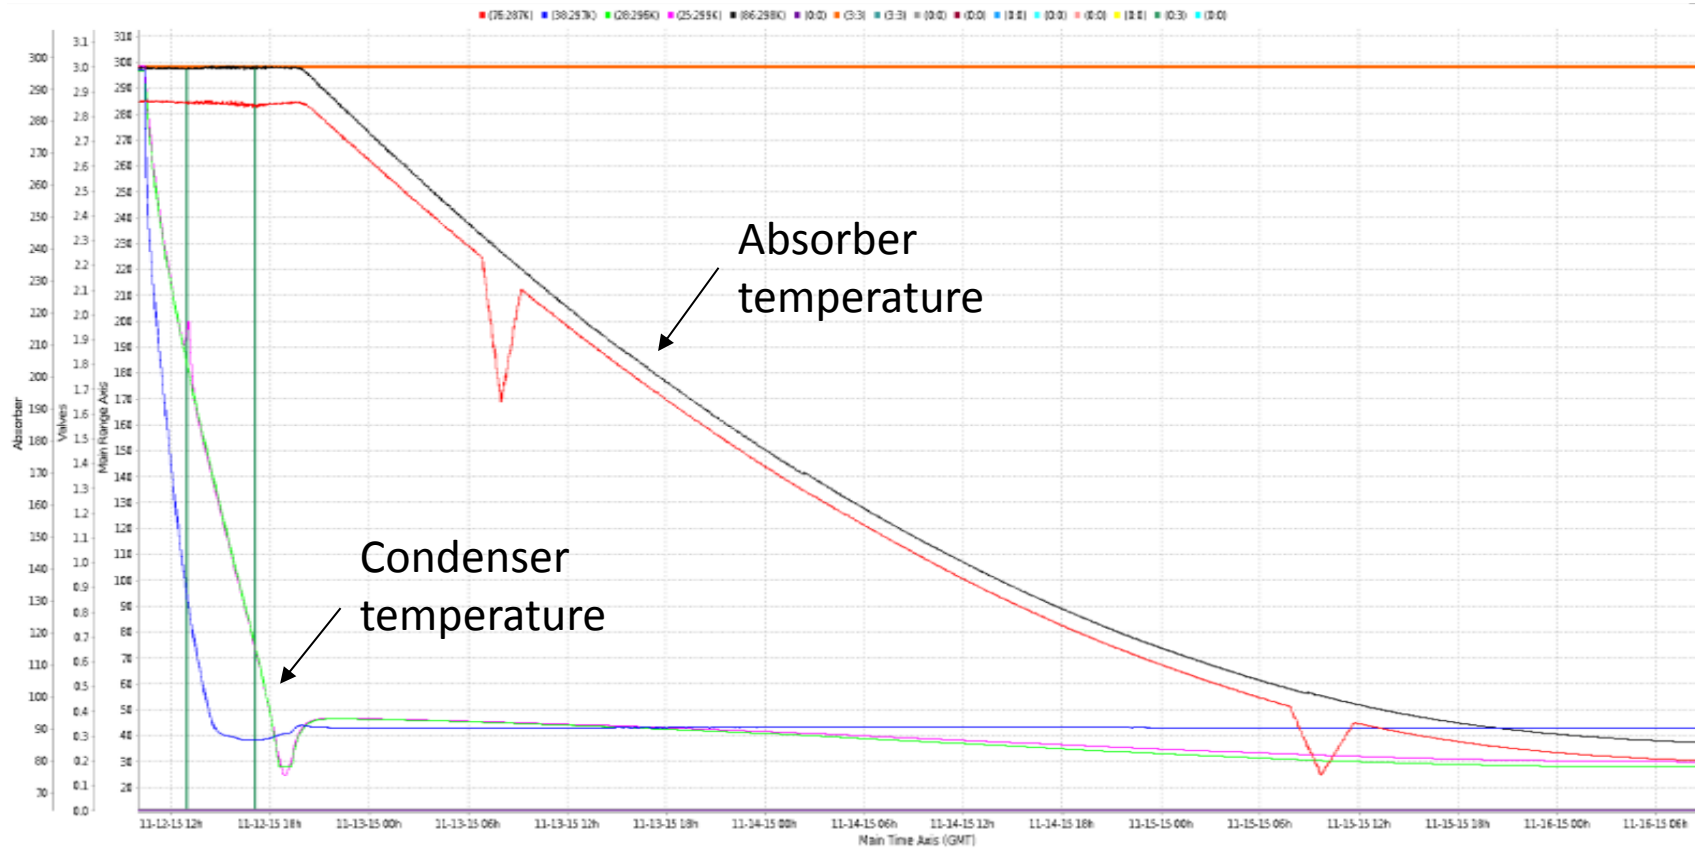
Cooldown problem

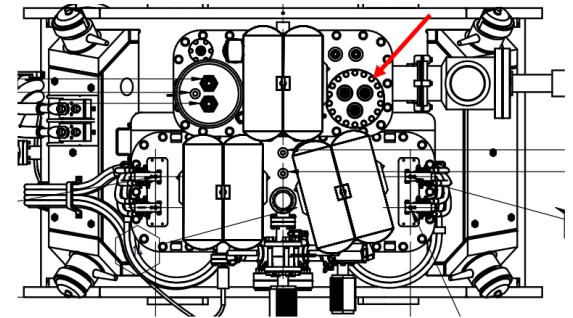
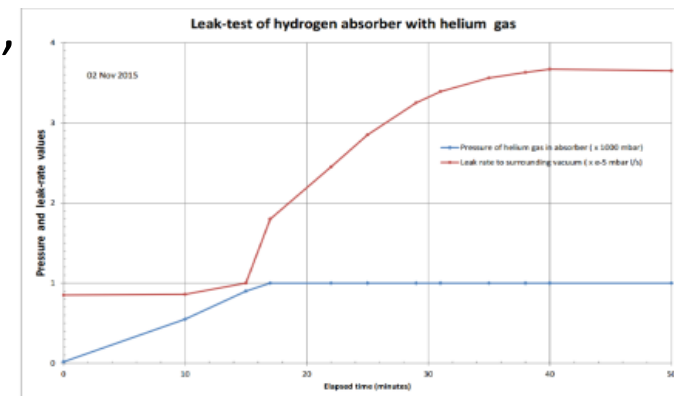
Two leaks invalidating the H2 safety case:

- Feedthrough on turret - 1×10^{-3} mbar.l/s
- Absorber circuit – initially 3.6×10^{-5} mbar.l/s, then after 2nd cooldown 1.2×10^{-3} mbar.l/s

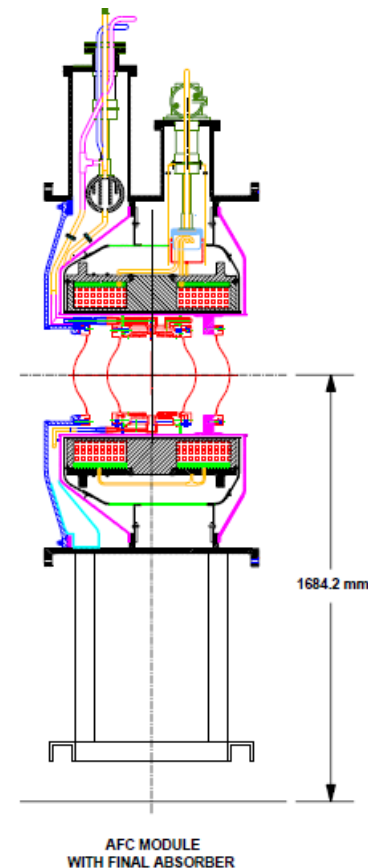
R9

- Working to improve the cooldown:
 - thermal model shows significant heat loads through radiation on absorber and conduction through cooling pipes (including LN2 pre-cooling pipes)
 - Glass fibre stand-off to prevent touch between top-hat and cooling pipes

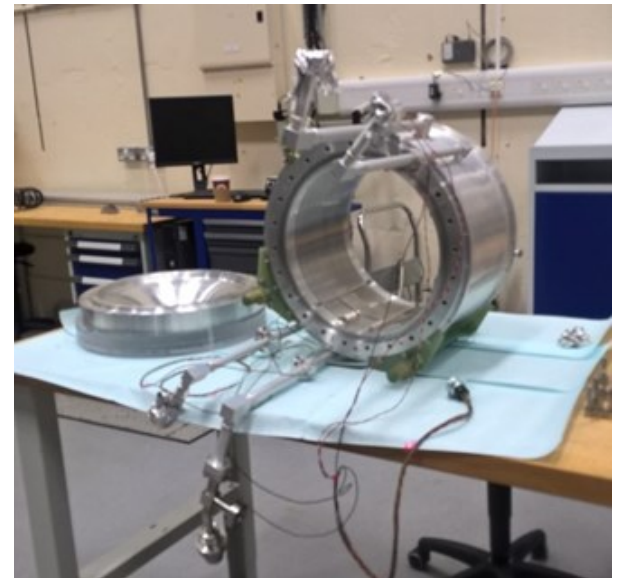
- Leak checked the absorber circuit with the cryostat open – identified leak location
- Removed windows to inspect the joint
- Leak check the windows themselves using rubber o-ring
