# Instrumentation Performance in the SPS in 2015 & Requirements for the Future

Serge Massot

On behalf of SPS Operation

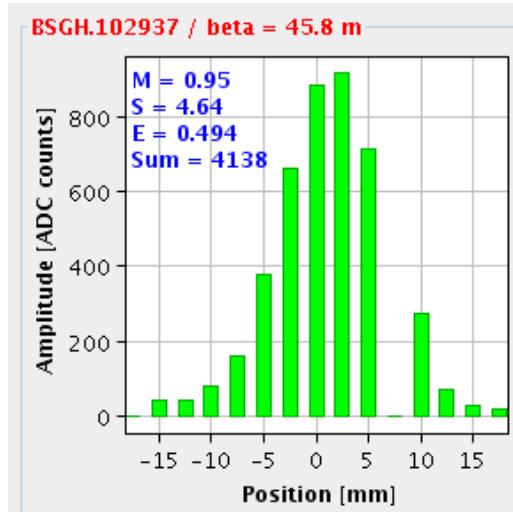
BSG.102937

- SEM (position and profile monitors)
  - SEM-grids in TT10 and TT20 have dysfunctional channels

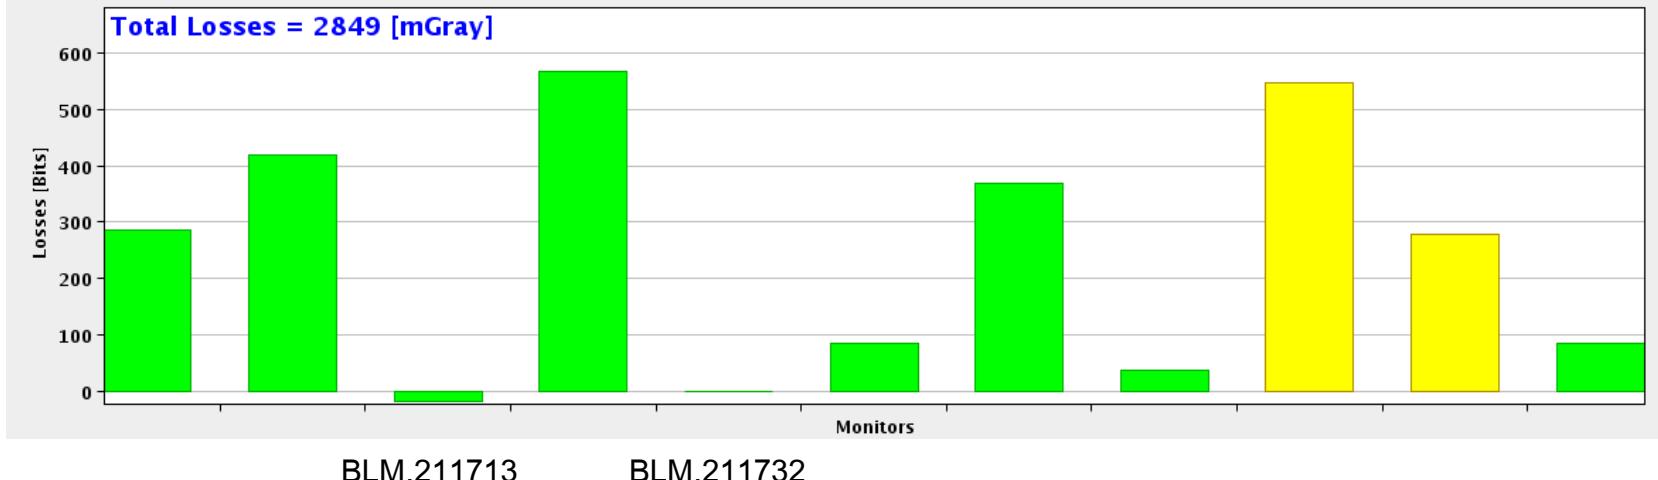
- SPS.BLM.21652.ZS2 and SPS.BLM.21674.ZS4 were out of order – no signal
  - All BLMs have been changed around the ZS – Efficiently
- NA:
  - TT20.BLM.211713 → Negative signal
  - TT20.BLM.211732 → No signal

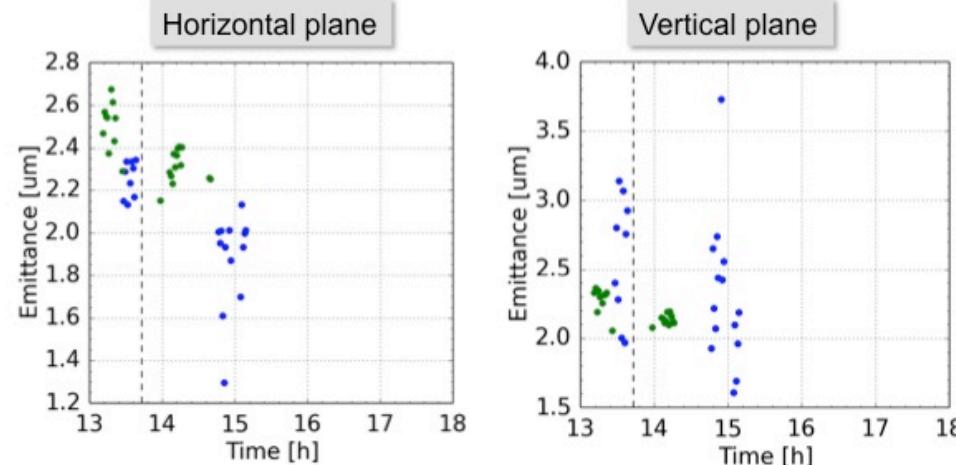
Qualification of beams at the SPS flattop not evident.

Emittance measurement not reliable.

Issue: absolute resolution of beam size similar at FB and FT.

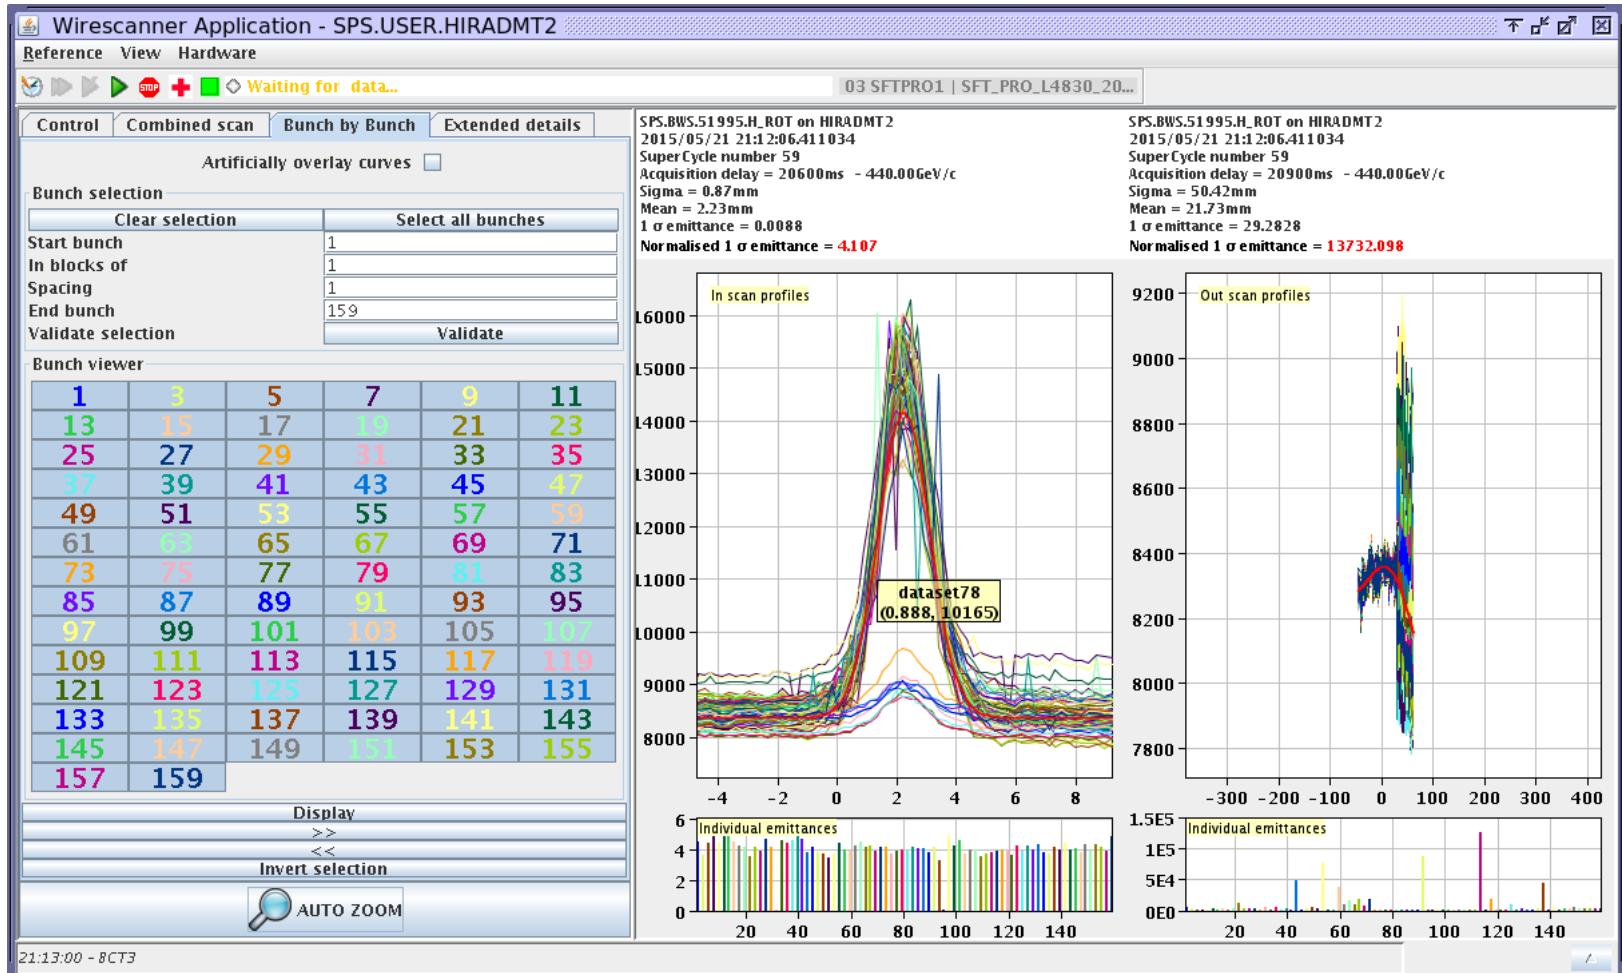
- Bunch by bunch measurements are now limited to 80 bunches:

- More modern electronics and front end without memory restrictions
  - to be able to measure bunch by bunch without limitations  
(now 80 bunches max.)
- New FESA class
  - less data treatment at application level (to be discussed with OP)
- Fitting/smoothing of the wire position readout data
- Prototype operational ASAP
