Problem(s) with the 80 MHz cavity in SS08

Tuner piston

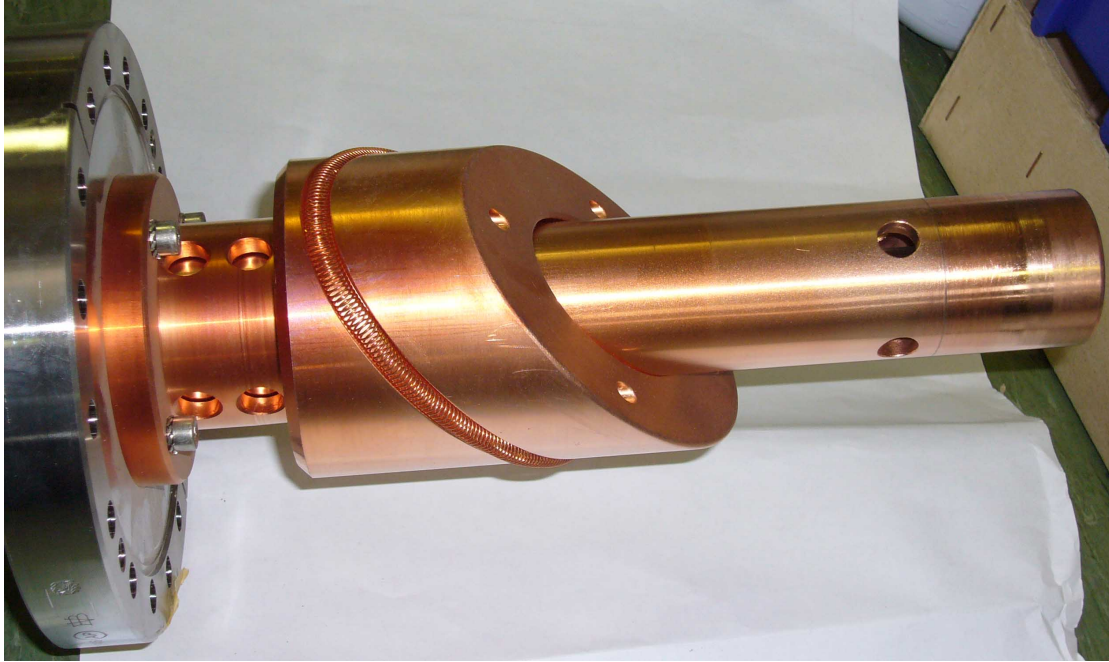
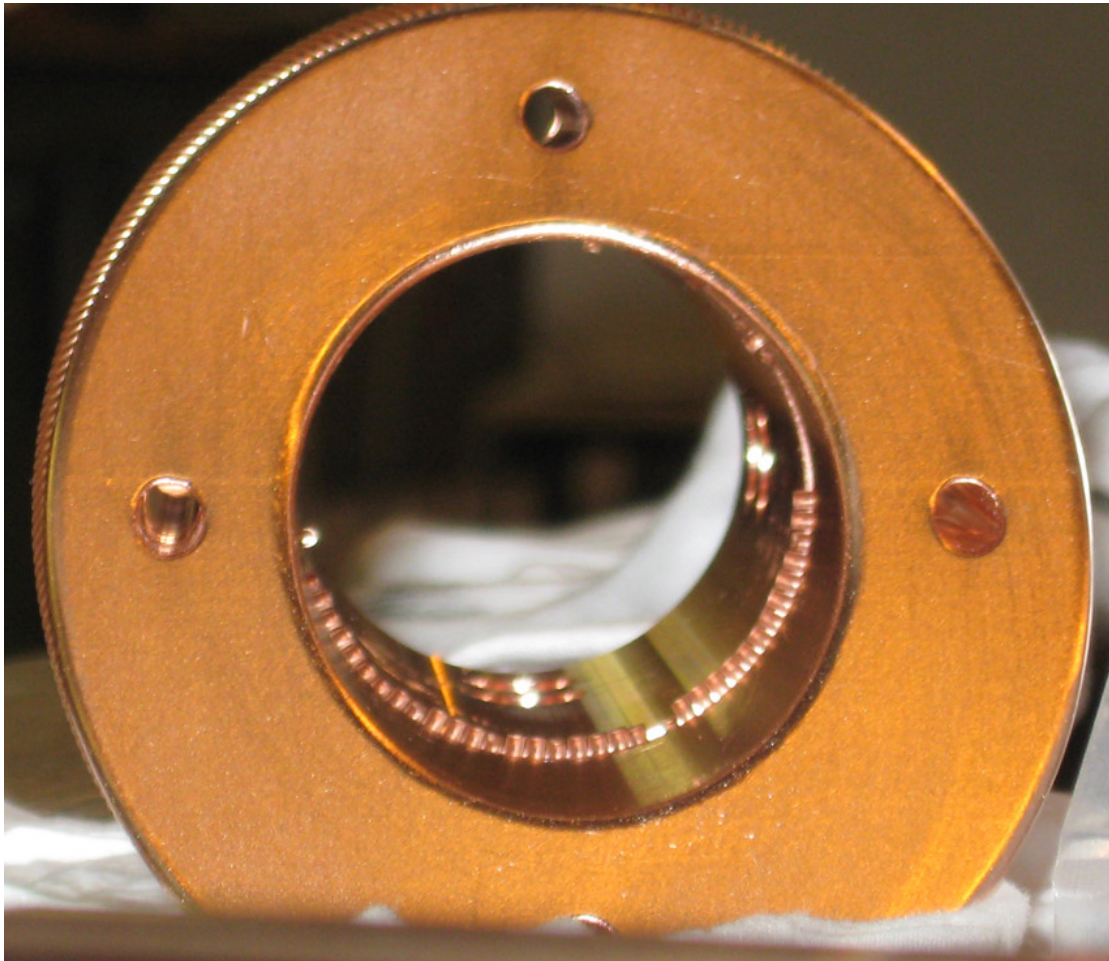
3 tuners modified and installed on cavities 08, 88 and 89.

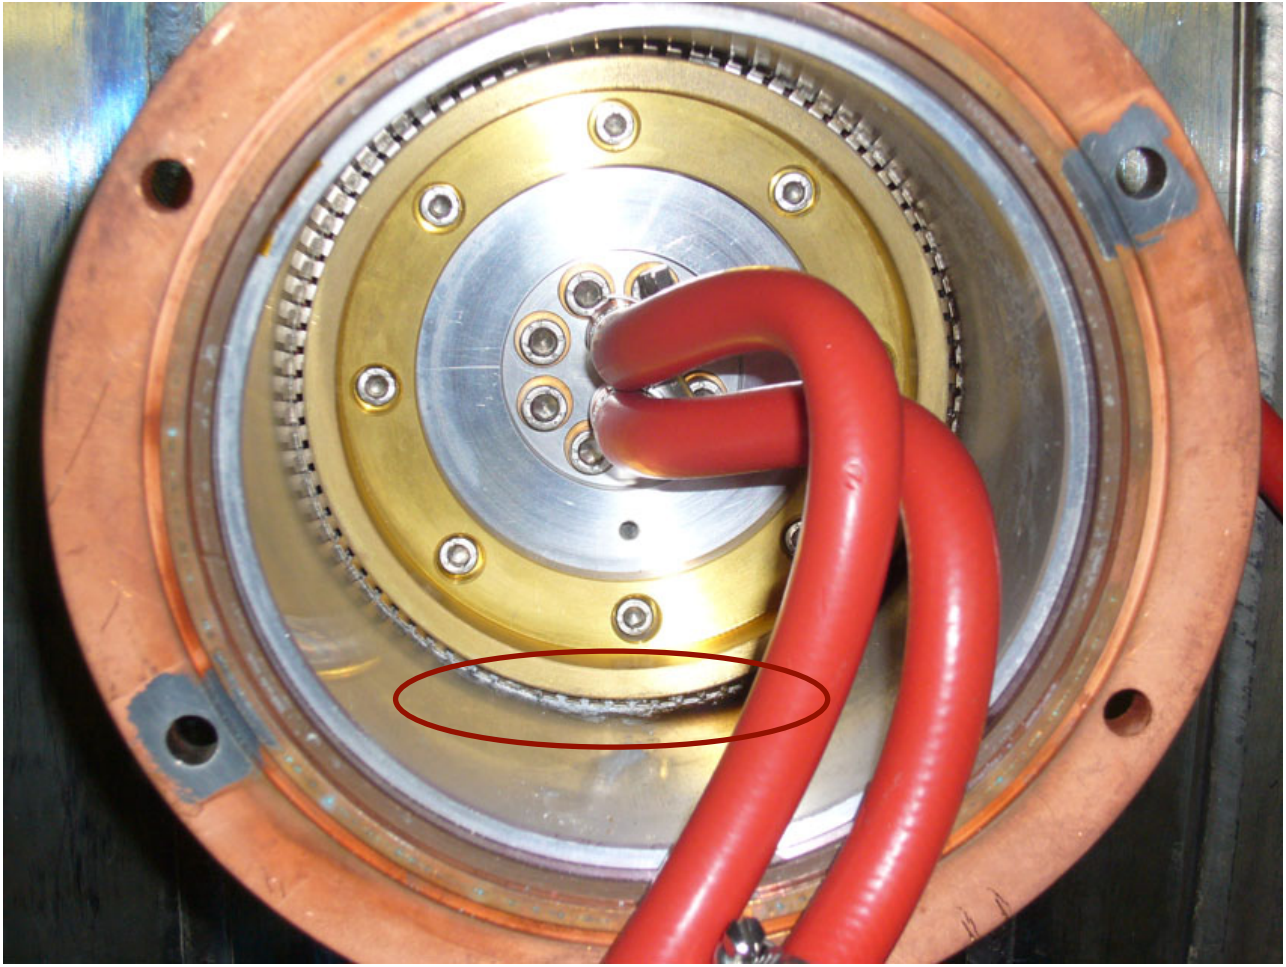
Cavity 88 ... something is starting ...
