## M E M O R A N D U M

Subject/Sujet : SPS North Area Startup Delay due to TAX Failure

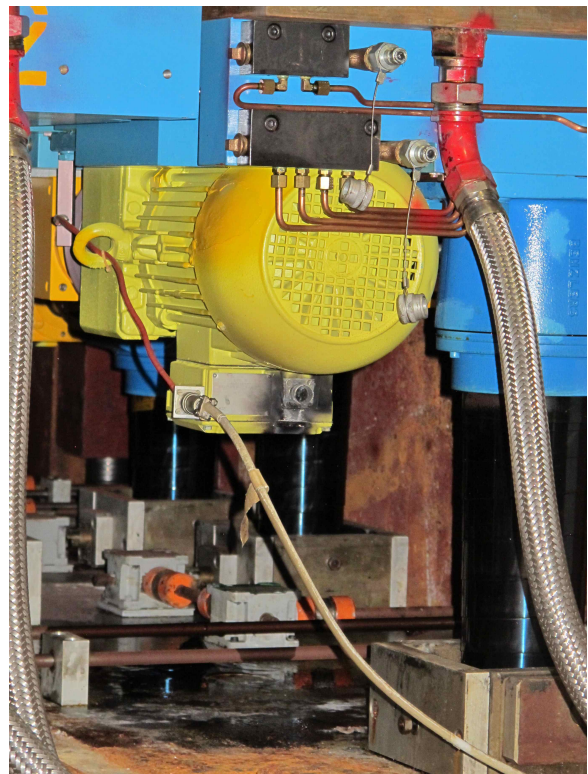
During the annual maintenance scheduled before the Easter break on week-18, **two TAX motors for the P41 and M2 beams failed**. To exclude the problem comes from the power cables to the motors being damaged by the high-radiation levels in TCC2, an intervention was scheduled on **Friday 29/4** to exchange them. During the intervention it was discovered that for one of the motors the short circuit was in the motor already (see *Figure 2*). The cable was changed for the second one but unfortunately didn't work as well, showing a short circuit to ground. In the meantime **a third TAX motor for the M2 beam failed**, again with the same symptoms.

The North Area TAXs were last renovated in 2001-2003 (blocks and motorizations). We believe the motors are specially ordered for high-radiation environment; we'll go back to the old orders and documentation to find out, but even so it is difficult to predict their exact lifetime. The motors that failed are for the high-intensity beams, however the state of the others may not be that good either.

*Figure 2: Photo of one of the damaged motors. The signs of the short circuit at the connector are clearly visible.*

We (EN/MEF & EN/STI) are presently preparing the intervention to remove the faulty TAXs from their shielding and replace the motors with new ones. It is a major intervention that requires work in radioactive areas and on highly radioactive equipment (see *Figure 3*), and a discussion and approval in an ALARA-L3 committee.

**In a first rough estimate, assuming the existing procedures for the TAX replacement will be still acceptable, and we will be able to find new motors (we have only two spares), a minimum of five weeks will be required to complete the repairs. This means four weeks lost for the physics program that would affect COMPASS, H4IRRAD/R2E, and other test beam users scheduled for the first period. I will contact the SPS**

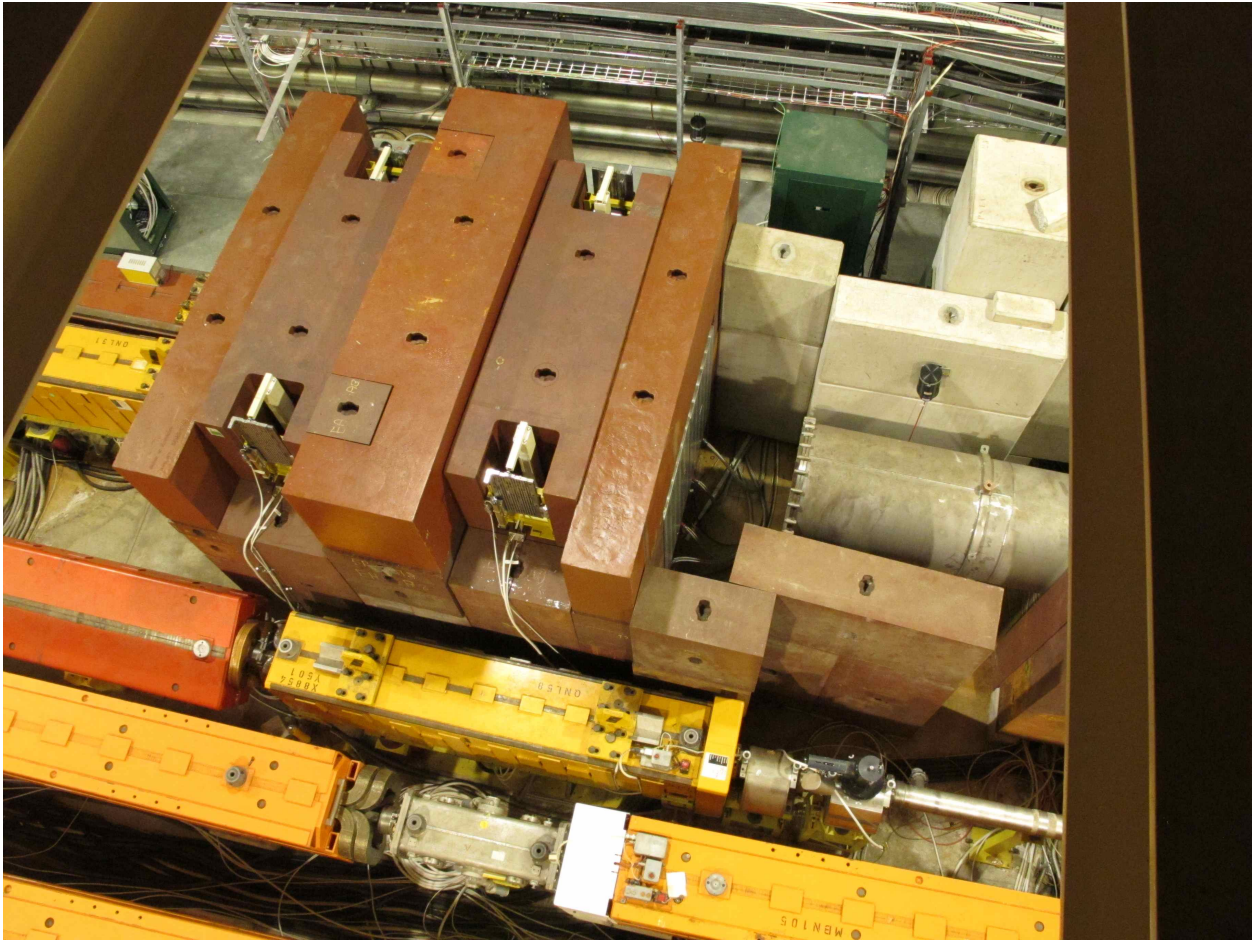
**In summary today we have both TAXs for the M2/COMPASS beam and one TAX of the P41/ECN3/NA62 beam out of order and stuck in intermediate non-safe positions.**

*Figure 3: Photo from the TCC2 overhead crane showing the M2 TAX assembly. The TAX blocks are inside the iron shielding*
