The ISOLDE Robot Incidents

Richard Catherall EN-STI-RBS

13th August Incident

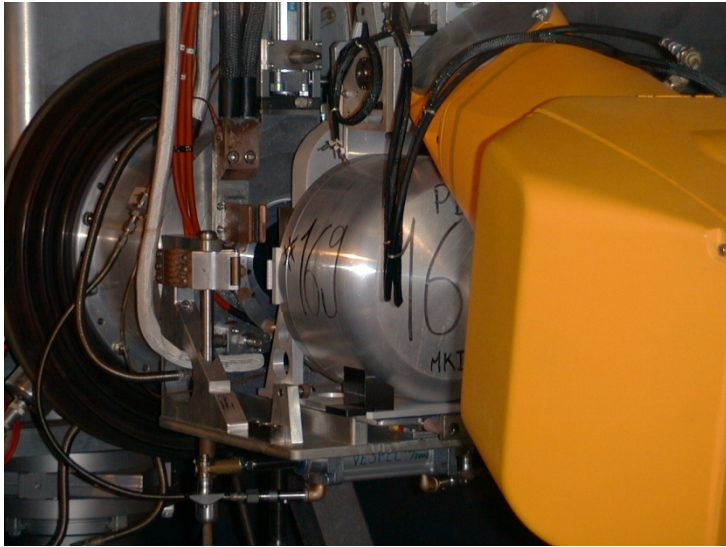
View from ~3 meters in situ

- Obvious that target/FE/robot interface jammed...worst case scenario.
 - Robot does not grip target handle, possibility of target falling if robot is retrieved.
- Tried to open grip and retrieve robot remotely but unsuccessful due to poor visibility.
- Abandoned after ~1 hour. The risk of generating further damage or worsening the situation was too high.

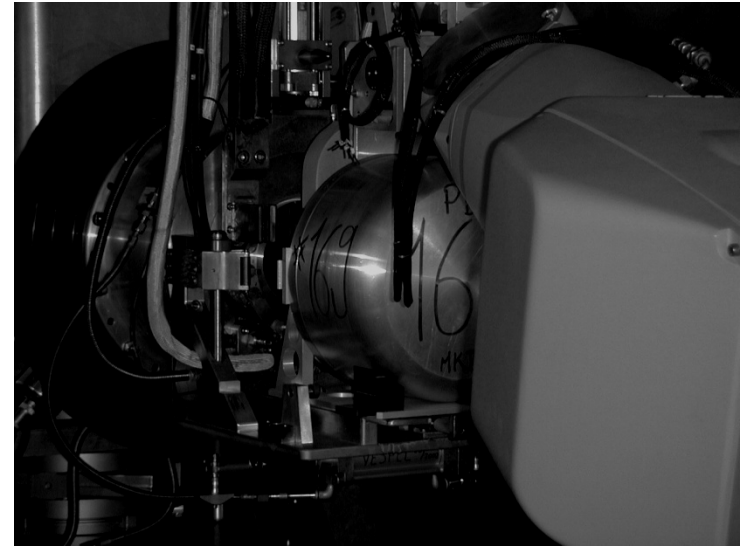
Simulated monitor view

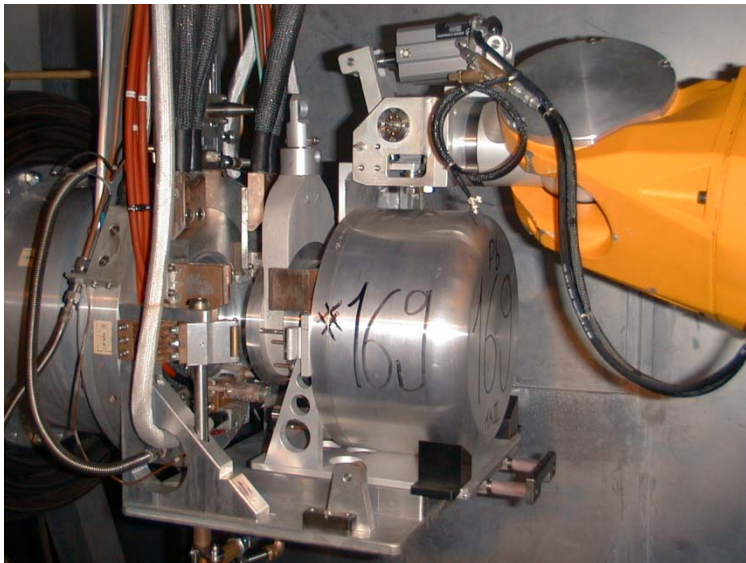
Correct target pick up

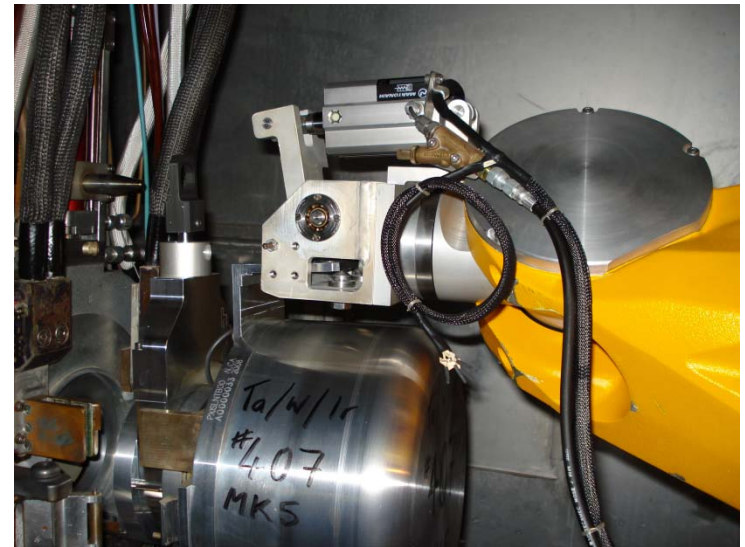
Target #407 failed pick-up

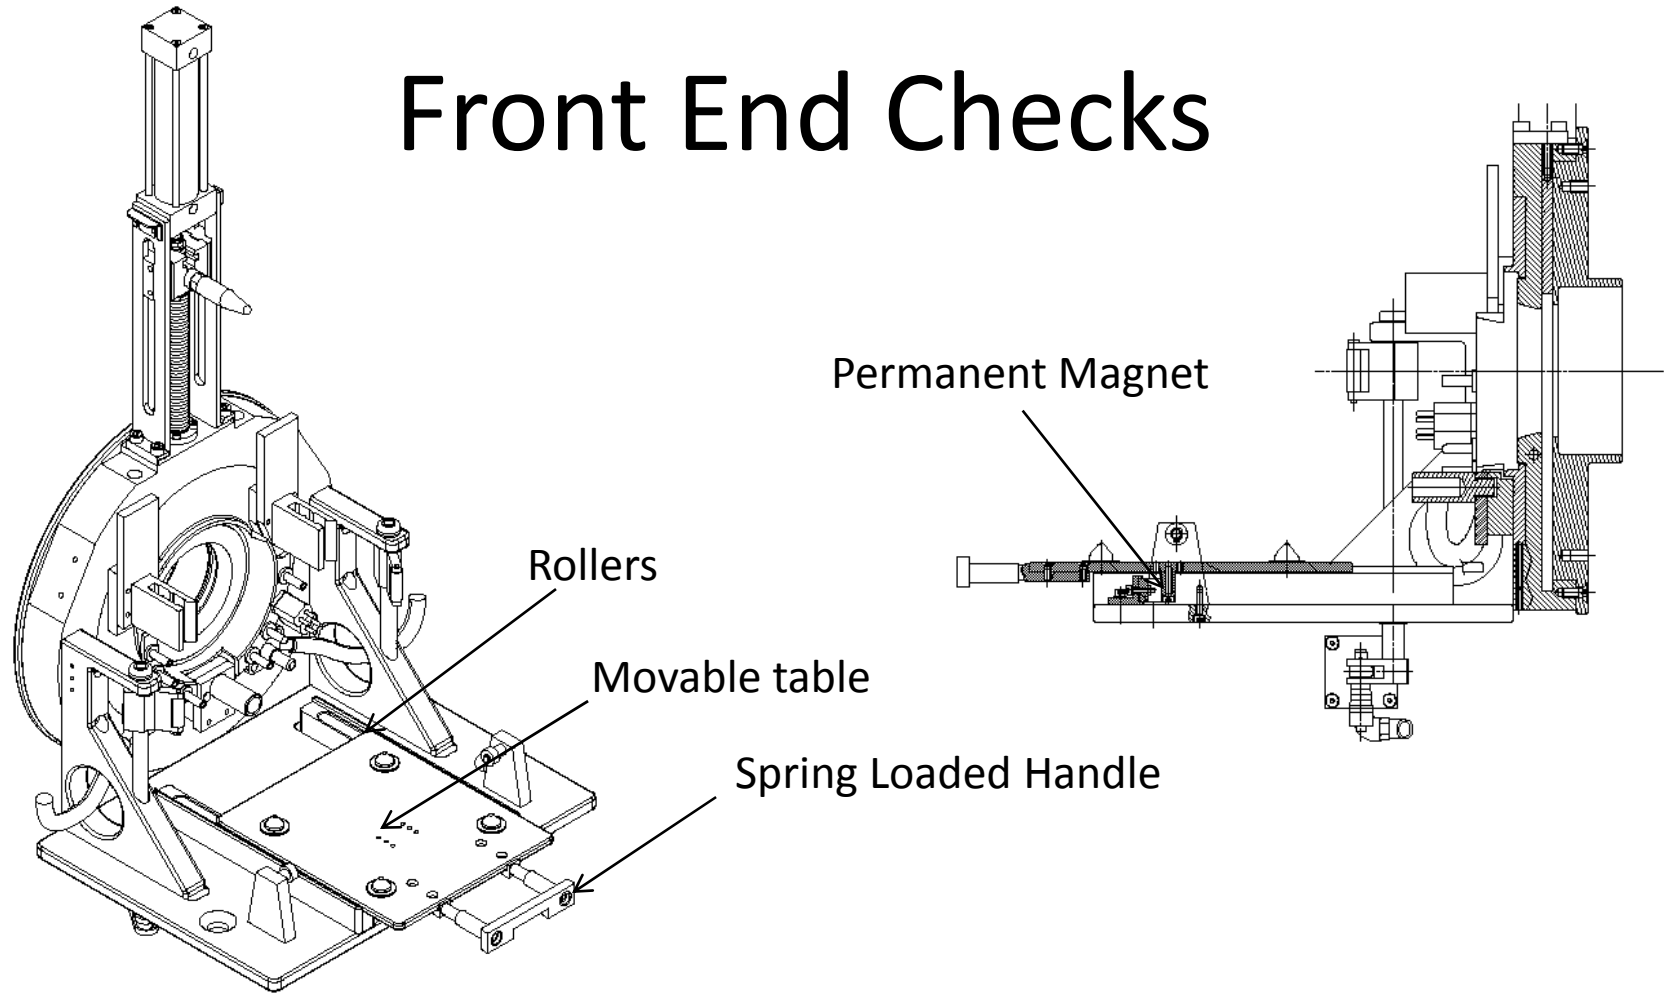
Front End Checks

- Situation found to be OK but could be improved.
- Table, rollers, handle and permanent magnet replaced

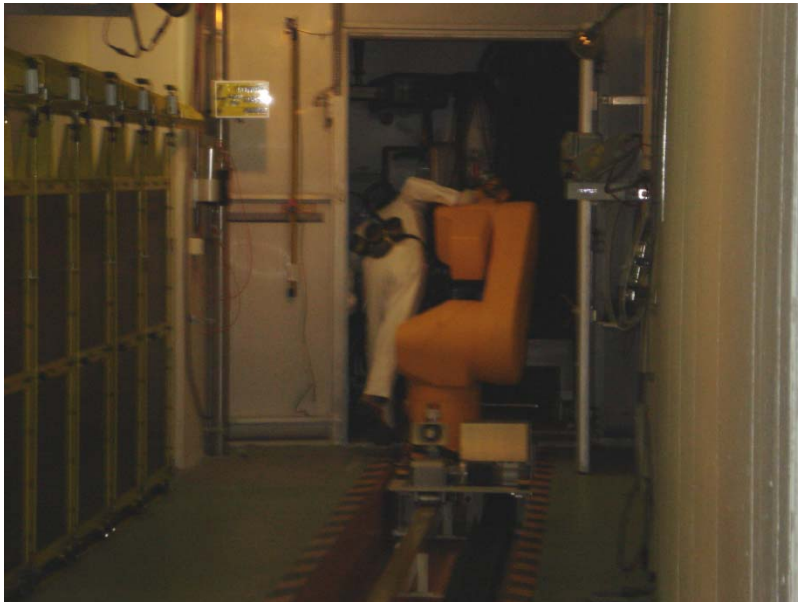
Robot Checks

- Observation: The finger on the robot gripper was barely touching the spring loaded handle when pulling the target to the pre-defined position.
- Consequence: Any friction or when beyond tolerance of the robot movement ($\pm 0.5\text{mm}$), the robot would fail to pull the target table to its correct position.
- Probable cause: Ground movement/creep. $\sim 1\text{-}2\text{mm}$ over ~ 7 years.
- Action: Robot gripper pulling height parameter lowered by $\sim 2\text{ mm}$.

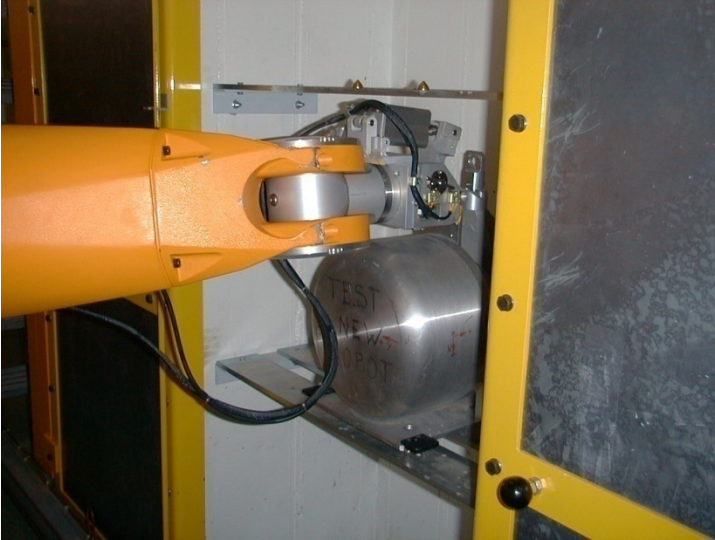
GPS – a separate incident

- Pre-programmed pick and place cycle
Pre-defined locations
E.g. Take target from Front End to door position 322
Incident occurred because 321 coordinates were saved as position 322.
Human error? Overwritten values...Save as!!
Program manipulation error, software?
Action:
- Do not use this shelf position this year.
 - Test other shelf positions without target before use.
 - Re-program robot correctly during next shutdown.
