Linac 2 leak on 28th August

G.Vandoni, on behalf of

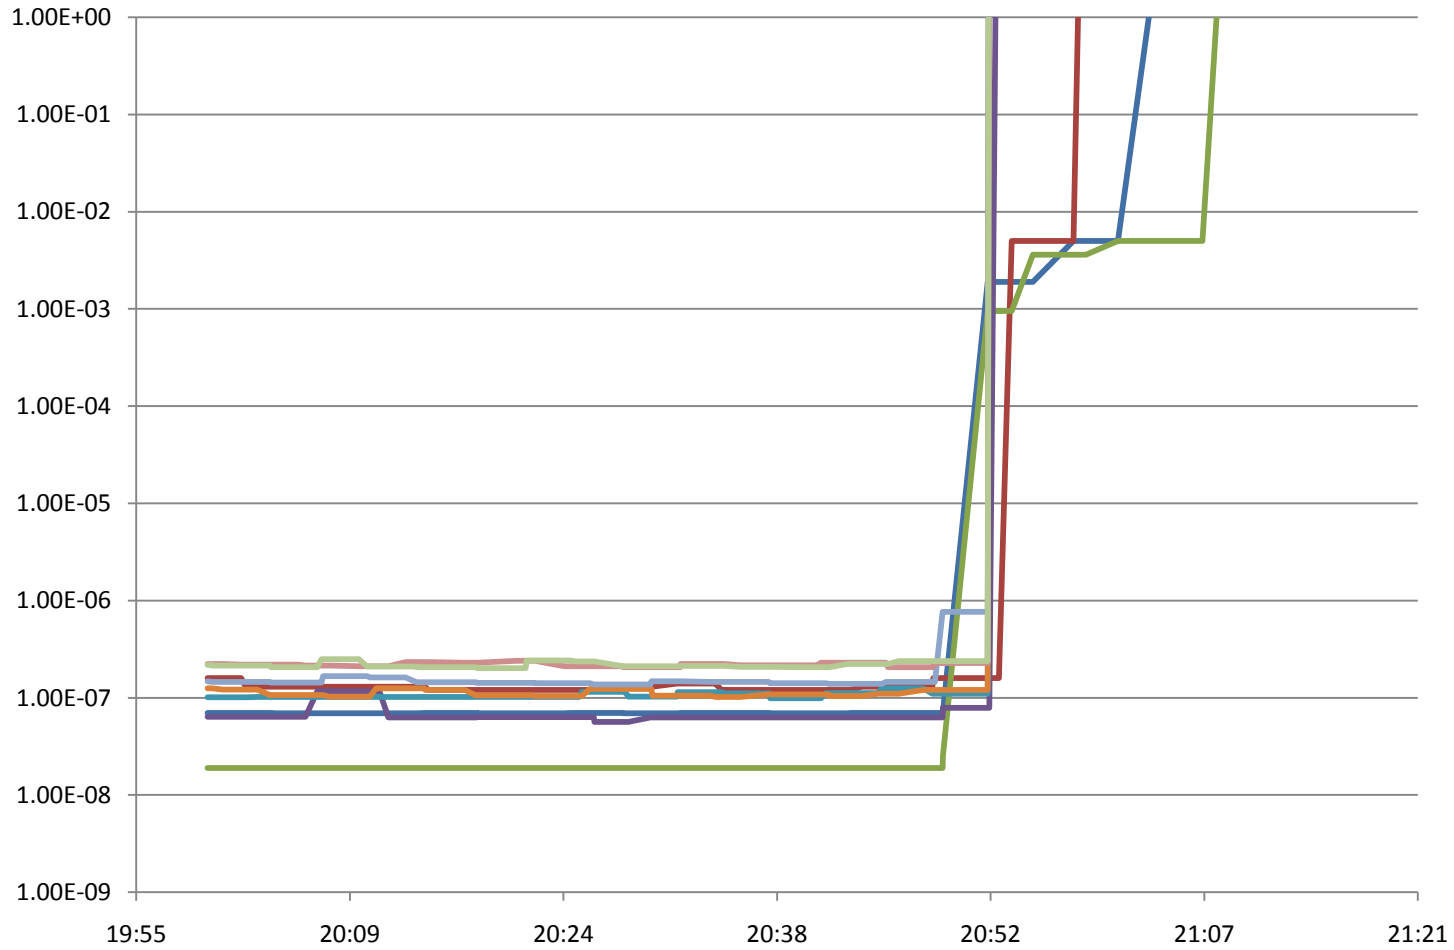
Leak!

28th August, 20:50

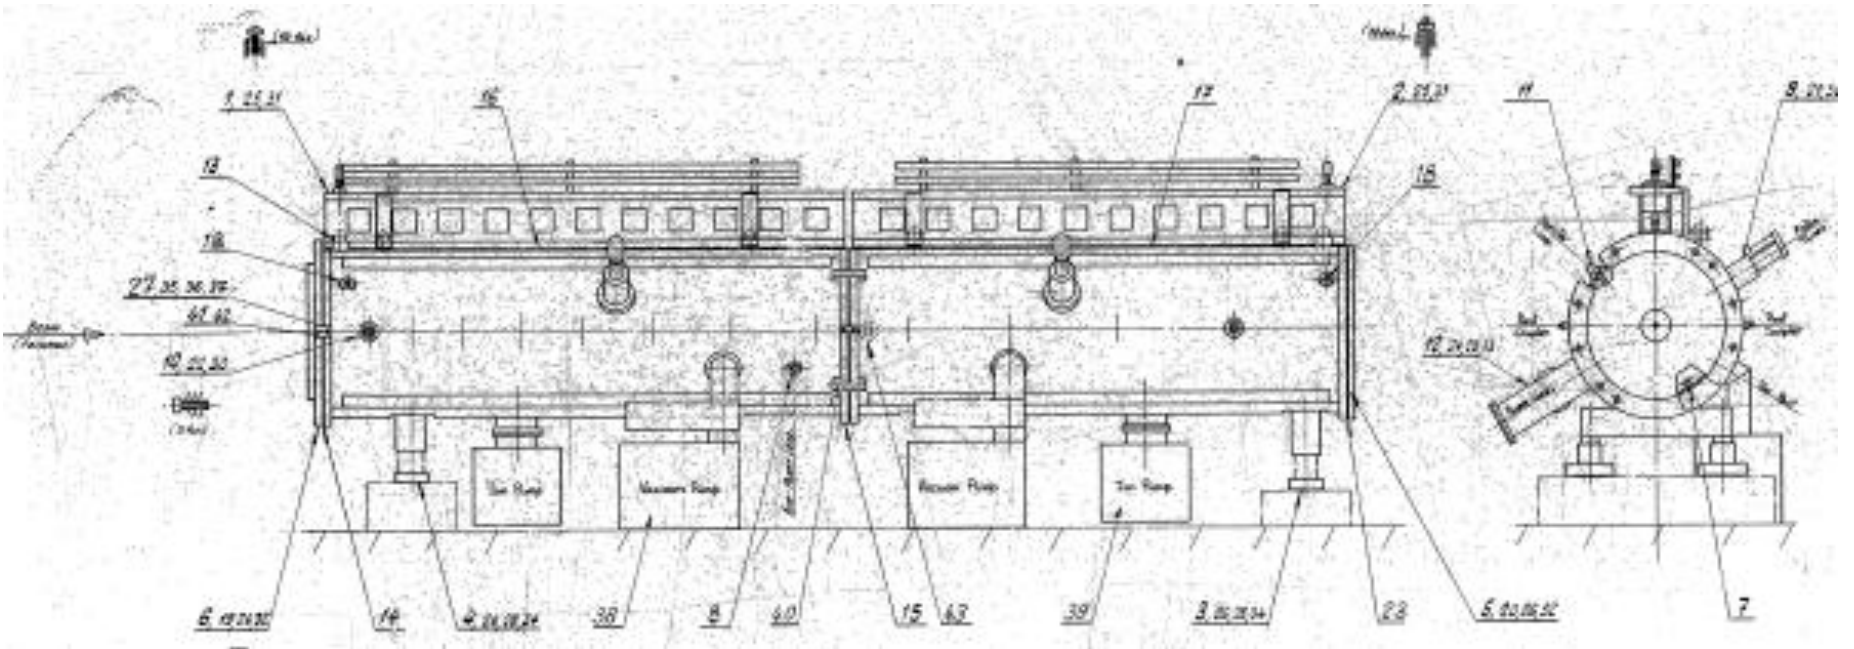
Tank 2

- Pumping speed: 1000l/s. Ultimate pressure: 10^{-3} mbar => leak of 1 mbar l/s **BIG**
- Friday night: small leak found on Q5 of tank 2
- Saturday: leak on Q5 is evaluated quantitatively and results to be too small, so leak detection continues to analyze the girder
- Sunday: girder entirely analyzed, several smaller leaks
- Monday: RF feeder loops on tank2 are opened, the leak is found there.

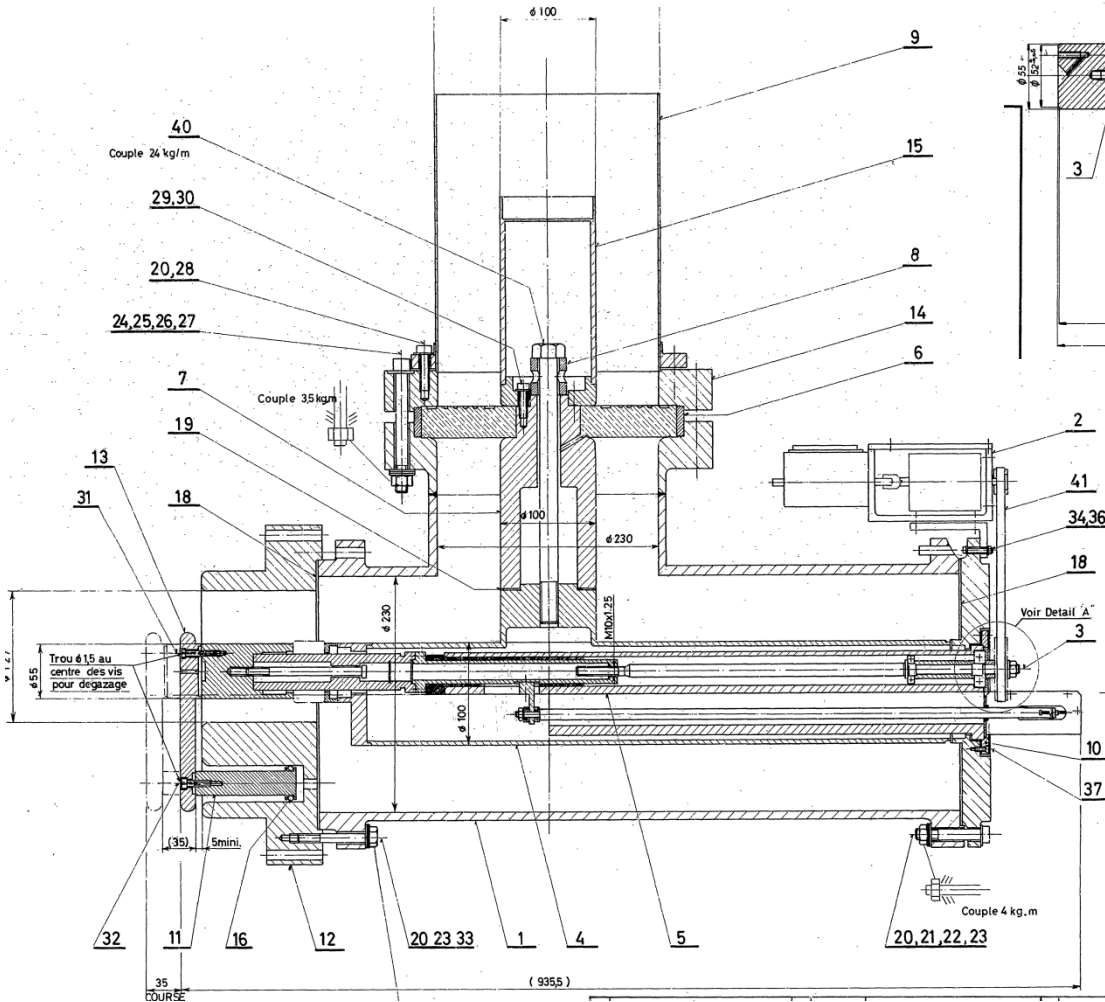
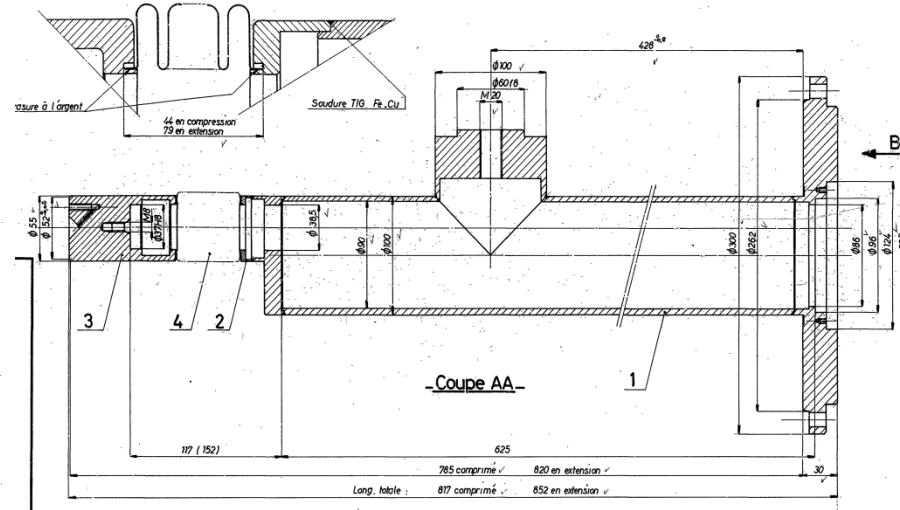
RF feeder loop

In the early afternoon of Monday the leak was eventually located on the inner conductor of the upstream RF coupler of Tank2. The leak has been fixed by the vacuum group applying differential pumping on the outside of the coupler. This has required removing the motor and the mechanism allowing to change the coupler position, but this will have no effect on the operation, the coupler being fixed on the position of maximum beam current since many years. We do not know the exact position of the leak, because to trace it one should have disassembled the coupler breaking the tank vacuum, but we suspect the bellow that allows the coupler movement, which is the most critical item in the leaking region. It is not easy to understand why such a bellow can develop a leak after 30 years of operation. The coupler is not cooled, and there is no water around it that could induce corrosion. The only hypothesis that I can express is that because the bellow is silver brazed to the copper inner conductor, some brazing alloy could have dripped inside the coaxial at the moment of construction, causing some multipactoring to develop in that region when powered with the RF. We have already seen in similar cavities that multipactoring can go on for many years in some regions during the normal functioning of the cavity, undetectable from the outside, but eventually damaging the surfaces (vaporisation of the material). If this is the case, after years of slowly vapourising the brazing alloy, a discharge on Friday night has opened up a leak. By the way, this hypothesis could also explain some asymmetries in the RF behaviour of the 2 couplers of Tank2 that we have seen in the past. But unfortunately we can not verify it because we do not want to take the risk of venting the delicate tanks to look into the coupler.

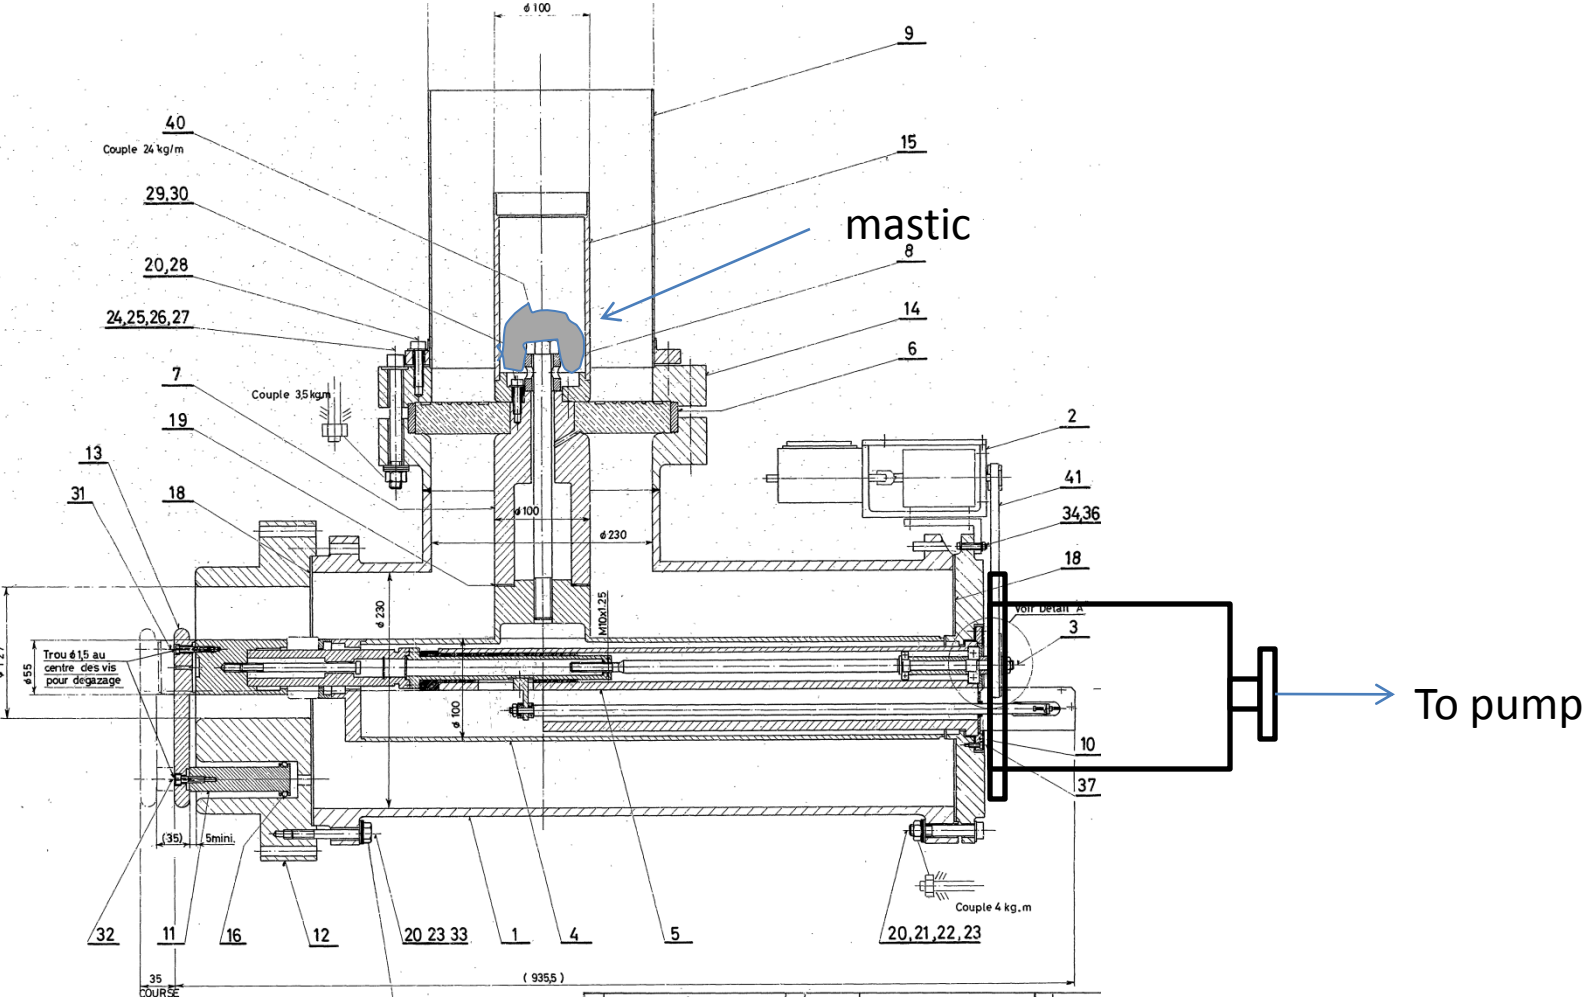
Leak (temporary) repair

In case this explanation is correct, we clearly take a risk in going on with the operation without solving the problem. On the other hand, these processes are very slow, and if it has taken 30 years to develop a leak, we can reasonably assume that it will take a few more years before a crack is opened in the bellow, which would cause its overheating and break it completely. What we foresee now is to prepare (test and clean) the spare RF coupler in such a way that it is ready for a quick replacement in case of problems with the bellow. At this point, the problems could only come from the RF because the differential vacuum applied can probably stand a slight worsening of the leak. The replacement would not be easy (the coupler weights 130 kg) and would require venting of the tanks, but the intervention can be probably compressed in about 0.5-1 day.
