## TE-MS-C-MNC

### PS Ring, Unit 22 – 23 Bus Bar Insulation Break Down

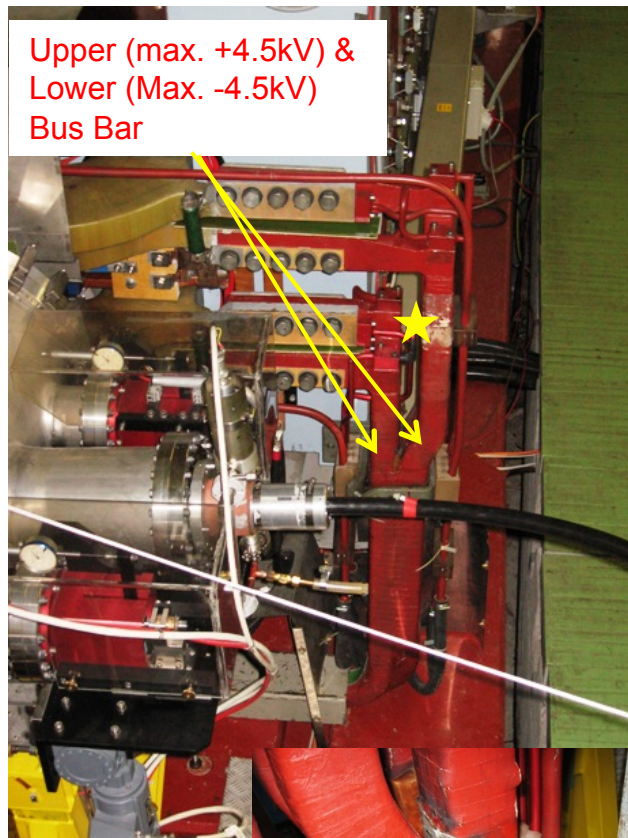
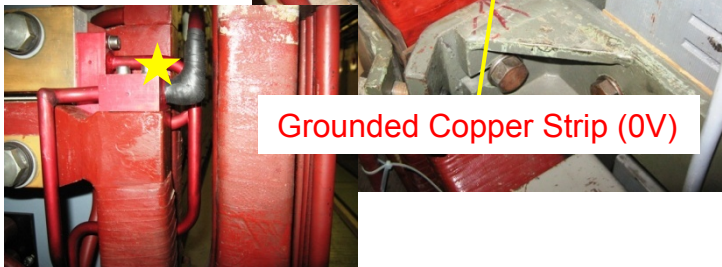
- 3<sup>rd</sup> – 4<sup>th</sup> September 2009, the magnet piquet service was called to help investigate a problem with the PS main magnet circuit.
- The main generator had tripped with an irregular function detected by the new control system, no problem could be found with the control system.
- A high voltage test on the magnet circuit revealed a short circuit to ground for the lower coils of the main magnets (below the threshold of the ground fault detection circuit).
- By sectioning the machine the problem was identified as a short to ground for the bus bar between main units 22 and 23.
- Embedded in between the bus bar insulation for the upper and lower coils is a grounded copper strip, so that each bus bar goes up to  $\pm 4.5$  kV to the strip. The lower coil bus bar insulation had failed to this strip, while the upper coil bus bar had failed to the grounded covers.

In summary one bus bar was in short to the strip, the other to the cover. To allow the machine to operate for two more weeks without jeopardizing the ION run until the bus bar is replaced we :

- removed the ground connection of the strip to resolve the ground problem with the lower coil circuit.
- checked the insulation between the two bus bars (lower bus bar and strip against the upper bus bar, as the lower is in short to the strip) up to 10 kV.
- secured the insulation of the assembly to ground by a polyimide wrap.

★ In addition to the ground fault a small water leak has been temporarily repaired until the bus bar can be changed
