# **Failure of PI.SMH42 on 2 October 2009**

FOM – 6.10.2009

J. Borburgh

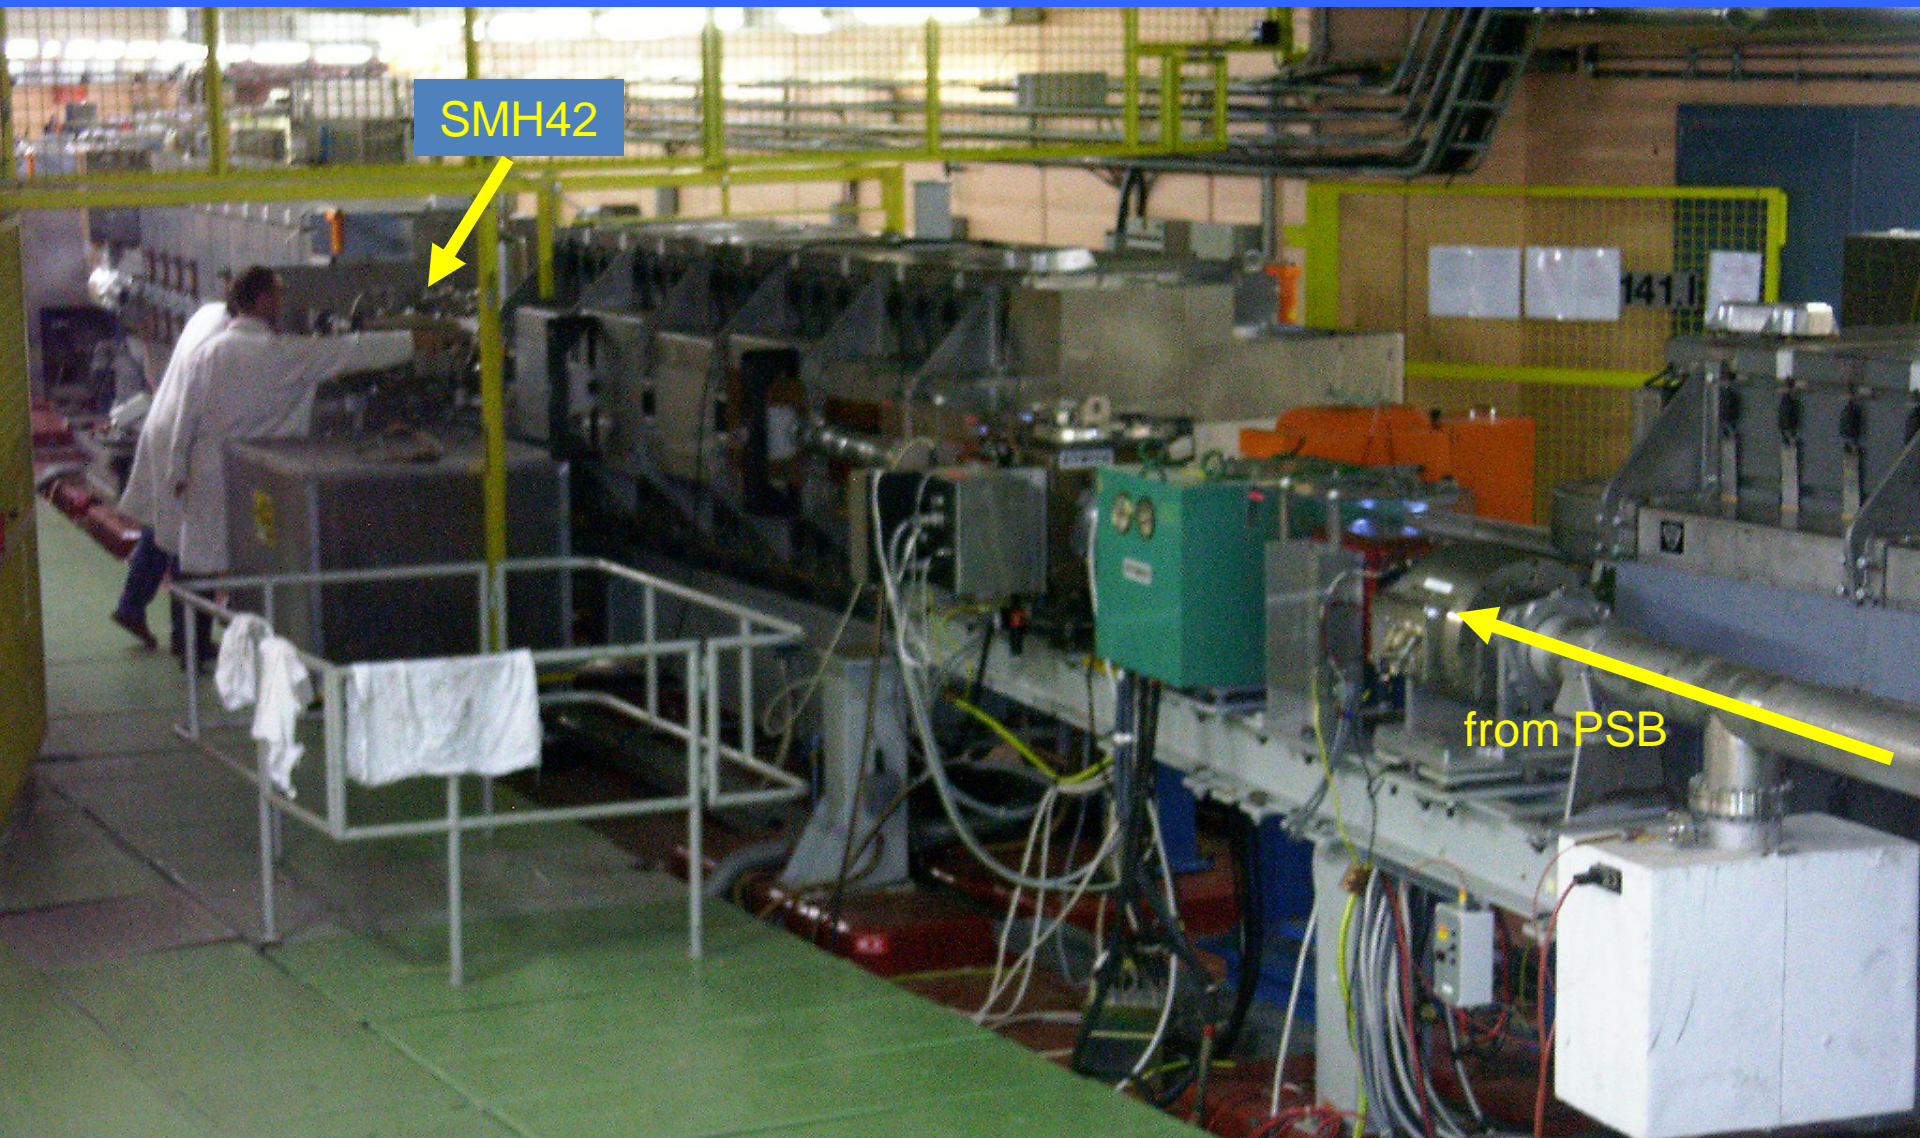
# PS 42 region (picture from 2006 intervention)

First RP check Saturday ~7:00: still 4.8 mSv/h – closer look scheduled for ~15:00

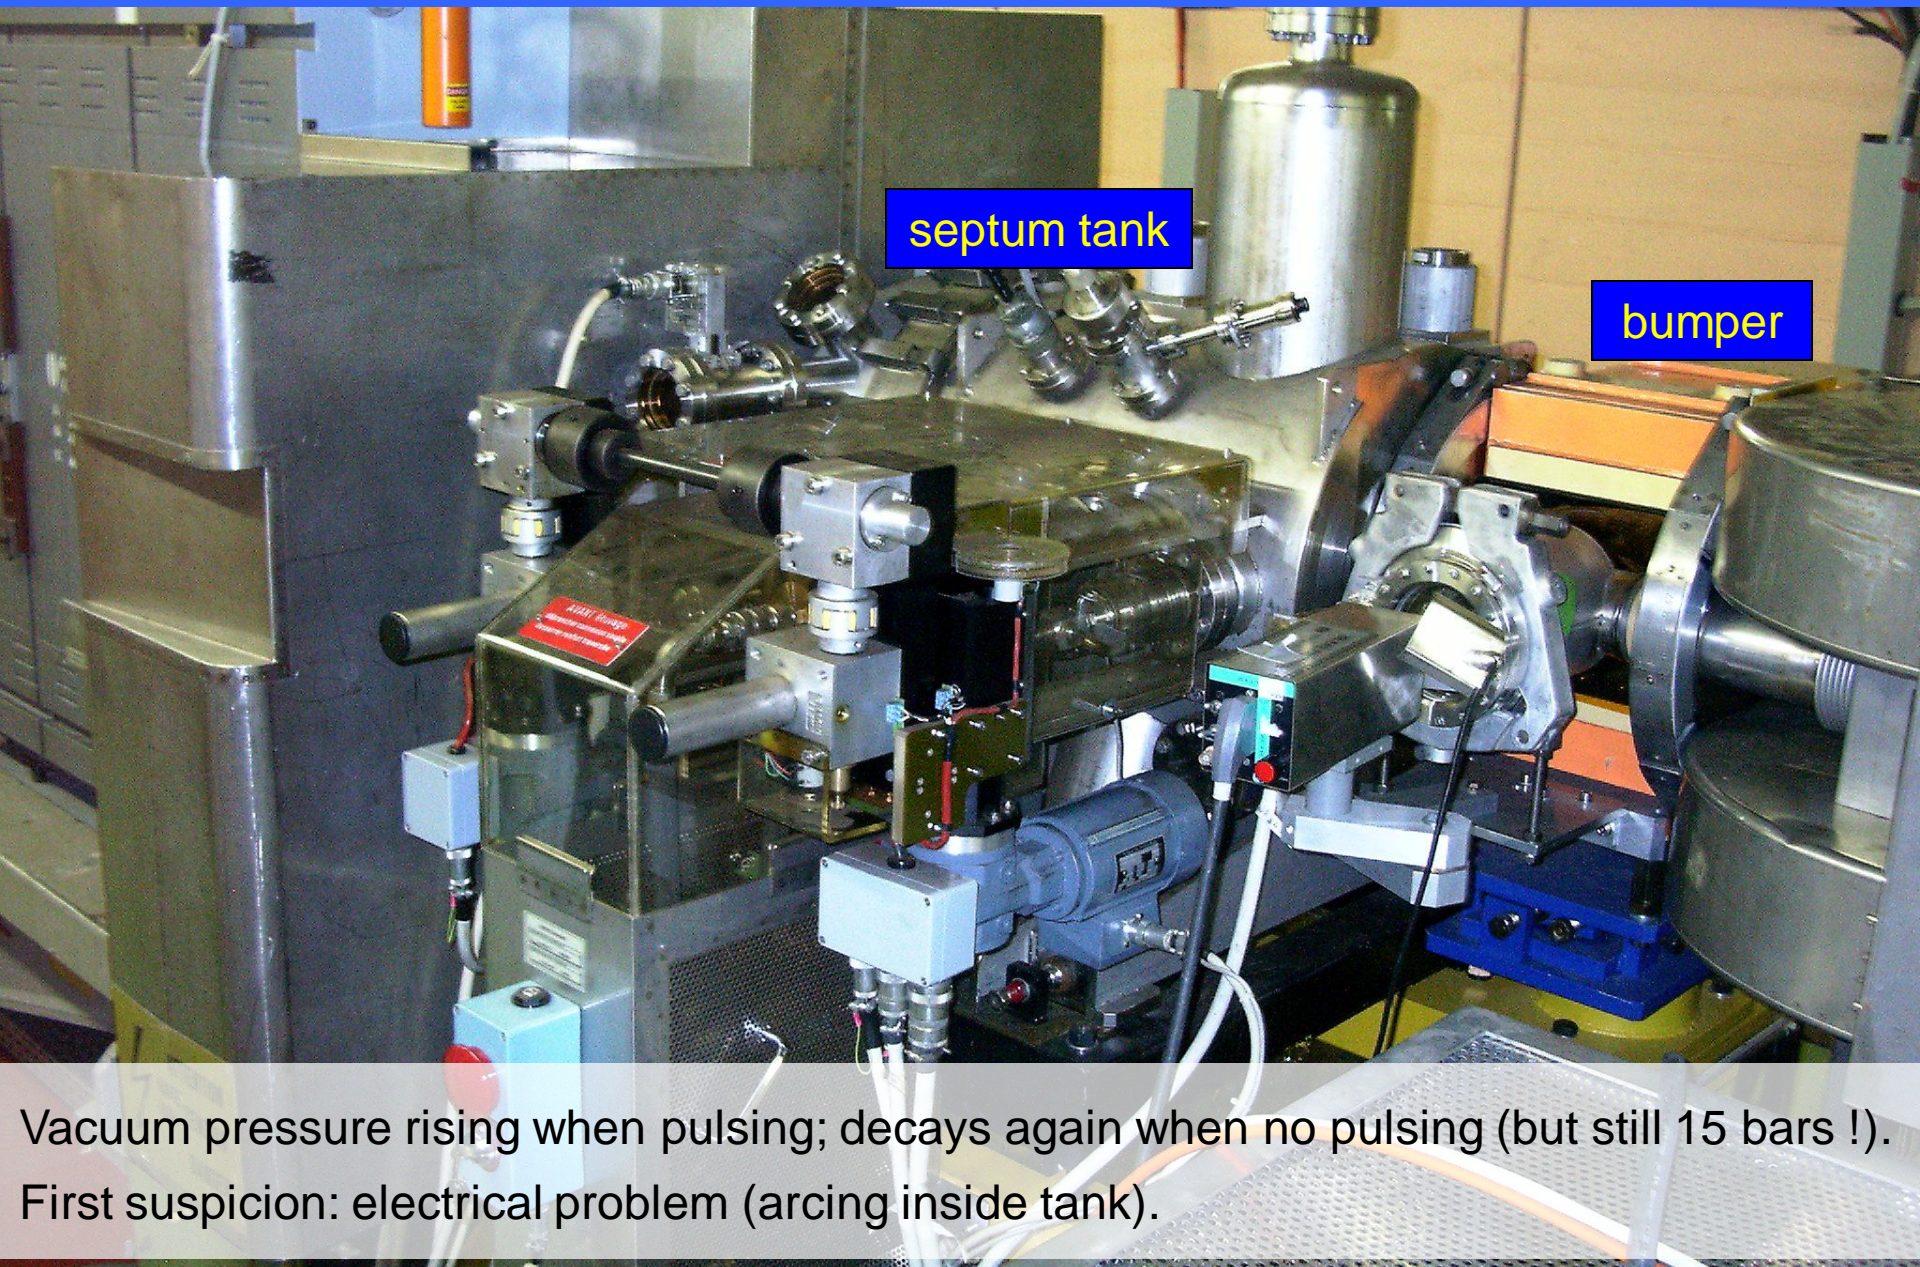
Vacuum pressure rising when pulsing; decays again when no pulsing (but still 15 bars !).  
First suspicion: electrical problem (arcing inside tank).

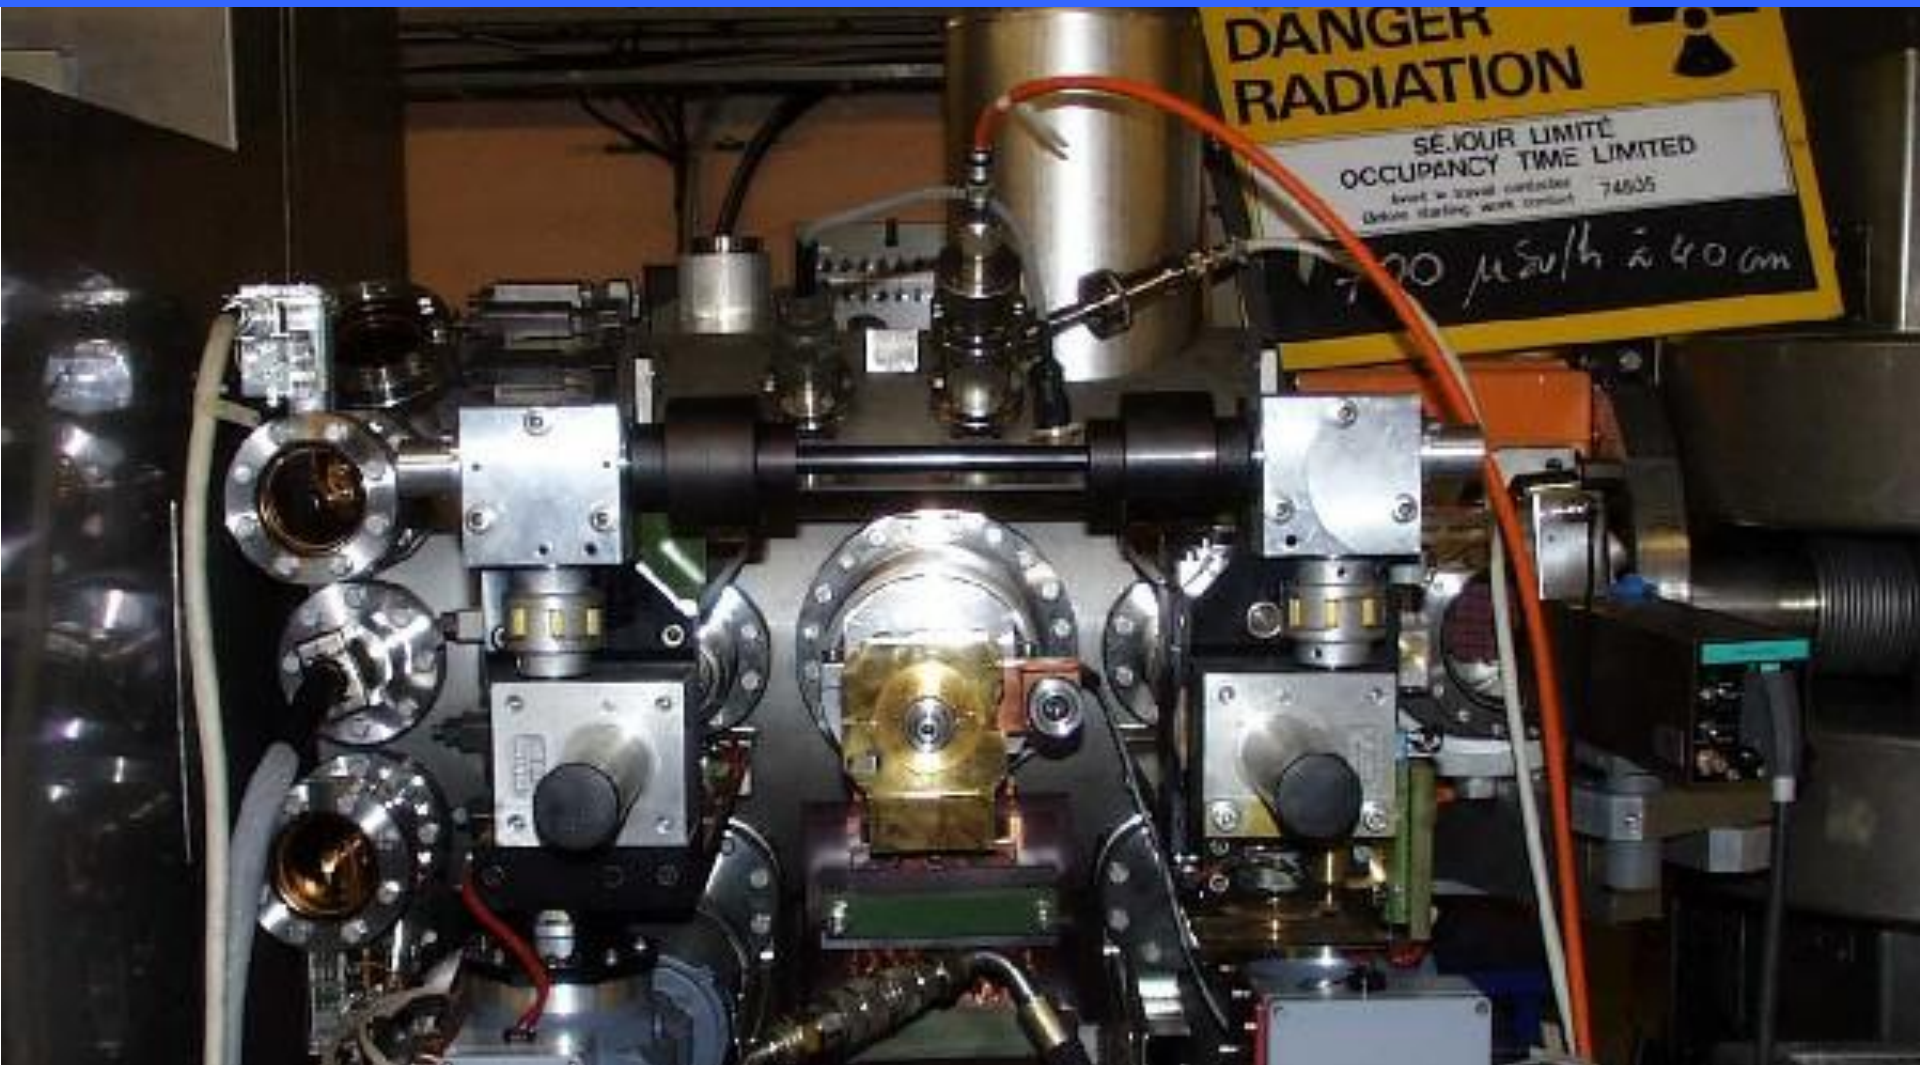
# PI.SMH42 (picture taken a few years ago)

Water circuit emptied, and He injected → leak found

Decision to replace septum on Monday – delicate operation + area still hot
