Operational Experience and Longevity Studies in the CDF II Silicon Detector

Sergo Jindariani

Fermilab

2010 Vienna Conference on Instrumentation
Vienna, Austria, Feb. 15 - 21, 2010

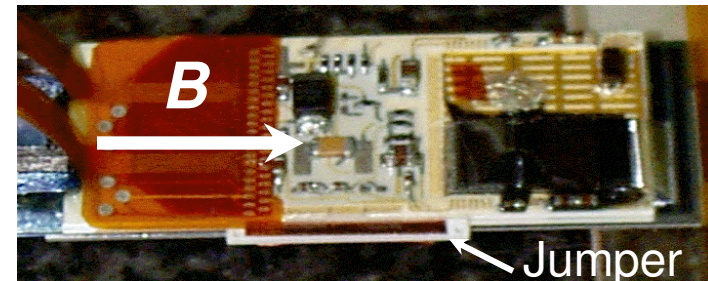
➤ Resonances

- ➔ Wire bonds \perp to the magnetic field
- ➔ Synch. Readout \rightarrow wire oscillate and break
- ➔ Solution: Stop high frequency synchronous readouts.

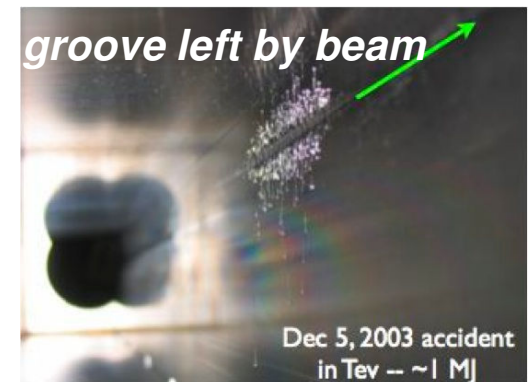
➤ Beam Incidents

- ➔ High dose accidentally delivered to the detector
- ➔ Solution:
 - Collimators in key parts of the Tevatron
 - New Diamond based BLM system.

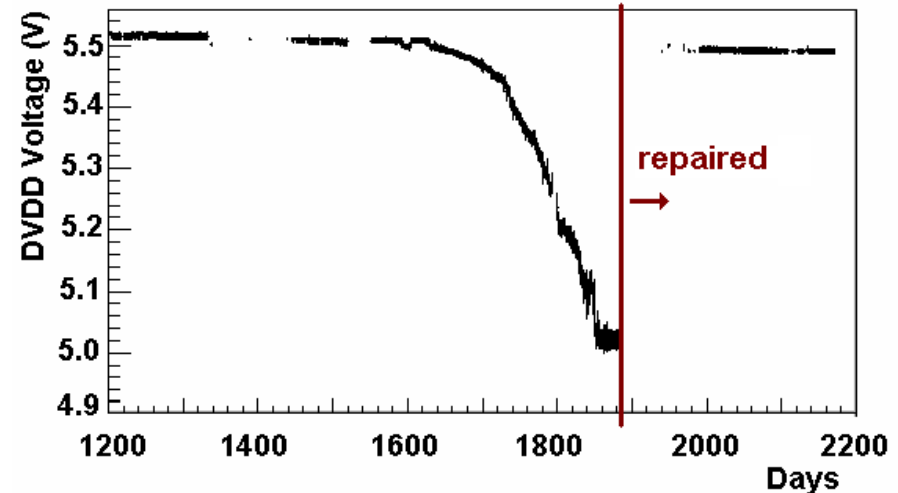
- Common failure modes of CAEN SY527
 - ➡ Communication loss
 - ➡ Corrupted read back of voltages/currents
 - ➡ Spontaneous switch off
- Failure mode of power supply modules:
 - ➡ Voltages in Analog, Digital and Port-Card supply start slowly dropping.
 - ➡ Most Power supplies started to show this.

- Problem:
 - ➡ aging of one type of capacitor
 - ➡ 36 capacitors per power supply
 - ➡ Can result in bit errors
- Solution:
 - ➡ Work during shutdowns in 2007 and 2009...
 - ➡ take all faulty power supplies out
 - ➡ replace all 36 capacitors (on FNAL site)
 - ➡ put them back in and test them on location.
- Time intensive effort, lasted about 2 months.
 - ➡ Not enough time to change all at once
 - ➡ Some need to be shipped to CAEN
 - ➡ **Still expect to replace others as failure appears**

All power supplies with this failure were replaced!

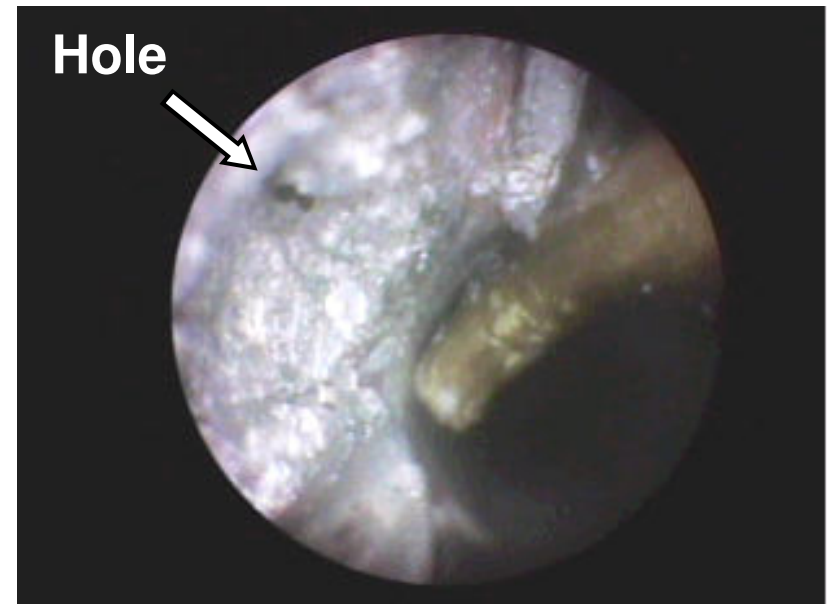
ISL cooling repairs

- ➡ Cover holes with epoxy from the inside of the pipe
- ➡ using borescopes and catheters.

➤ Current status:

- ➡ Tight vacuum in the repaired lines
- ➡ Repairs of conical manifolds are needed

Repaired cooling system has been running stable!

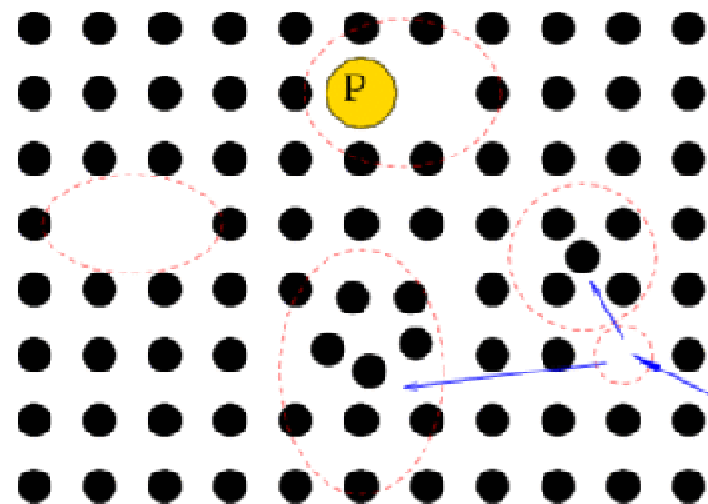
The inner layer **SVX-L0**:

⇒ Inability to deplete the sensors: **breakdown of AC-coupling capacitors @ ~150 V**

⇒ Increased noise from the sensors: **degraded signal to noise ratio (S/N)**
