MKD ERRATIC TYPE 3

MPP meeting, 8-April-2016

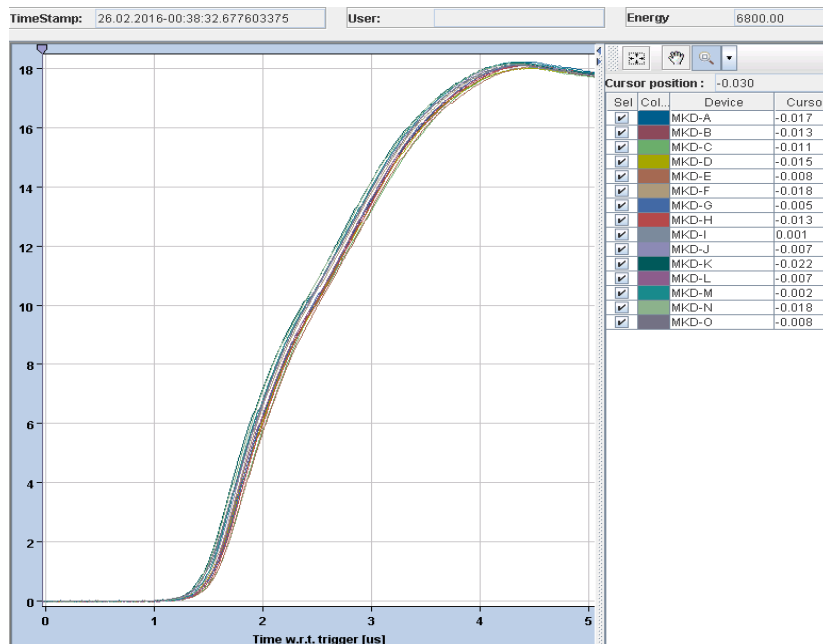
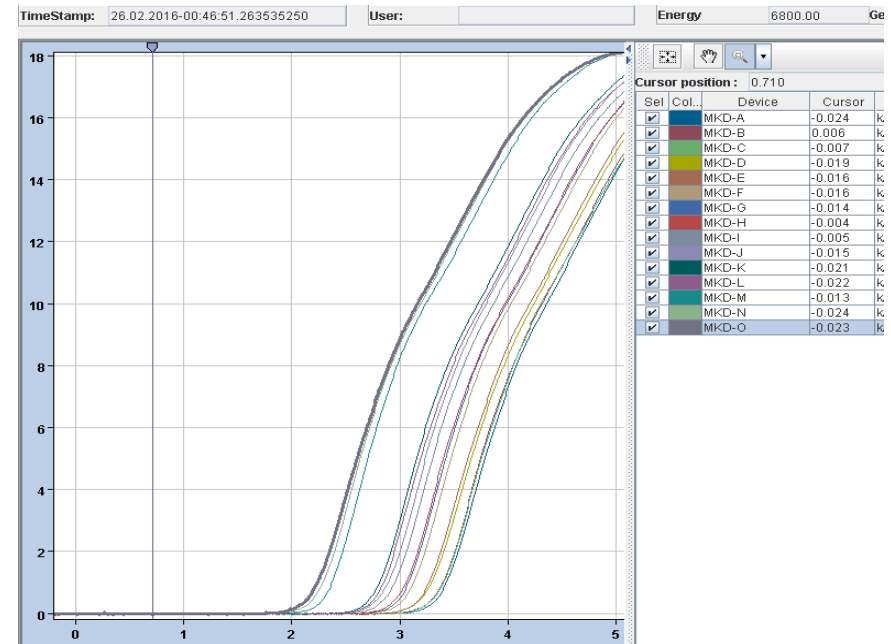
- Strange “triple erratic” on 26/02/2016 00:46:15 while conditioning LBDS2 at 6.8 TeV and pulsing every 10 min
- MKD/B2: generators O + N + M triggered by a signal in the retrigger system
- Then retrigger of the rest of generators

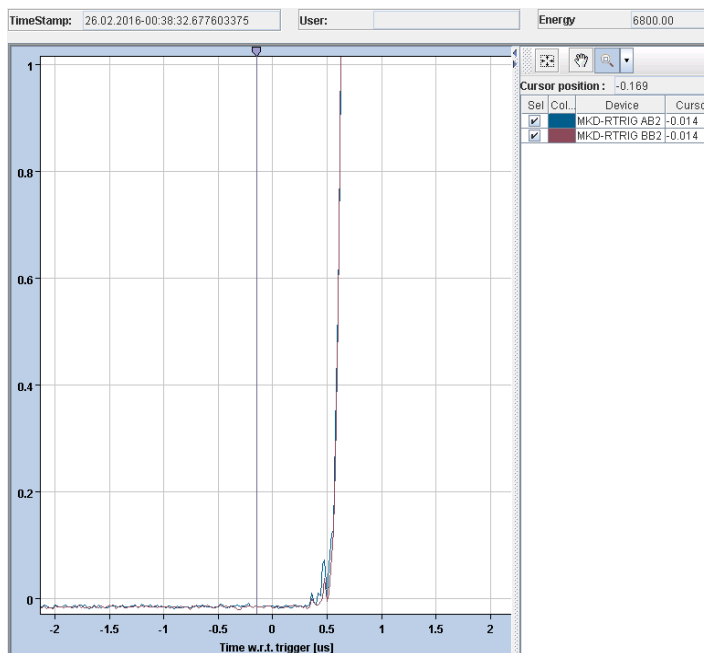
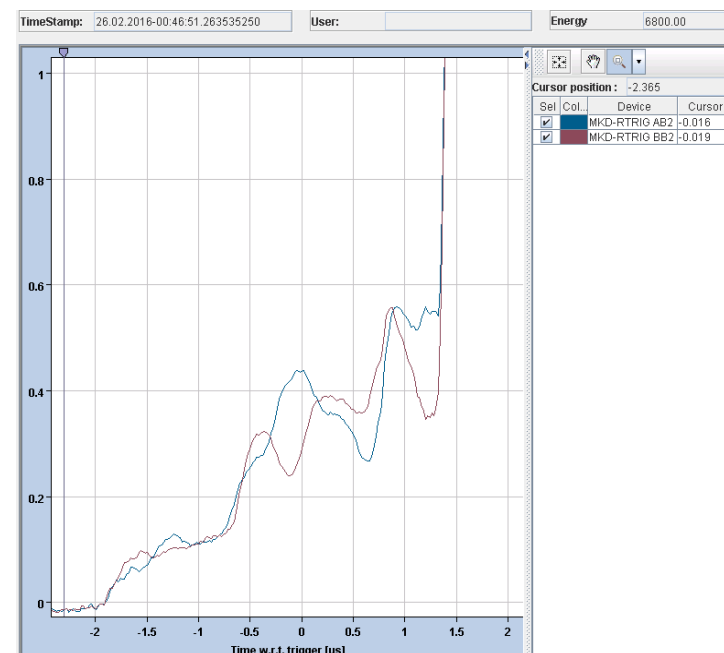
- Instead of fast rising signal on the retrigger line, measured a slowly creeping up voltage signal
- Normal magnet current rise time and waveform
- Before erratic – MKD L, M, N, O spent 64 h @ 6.5 TeV and 32 h @ 7 TeV (gen. A – K the same + more)
 - Probability of erratic increases with voltage and time of exposure

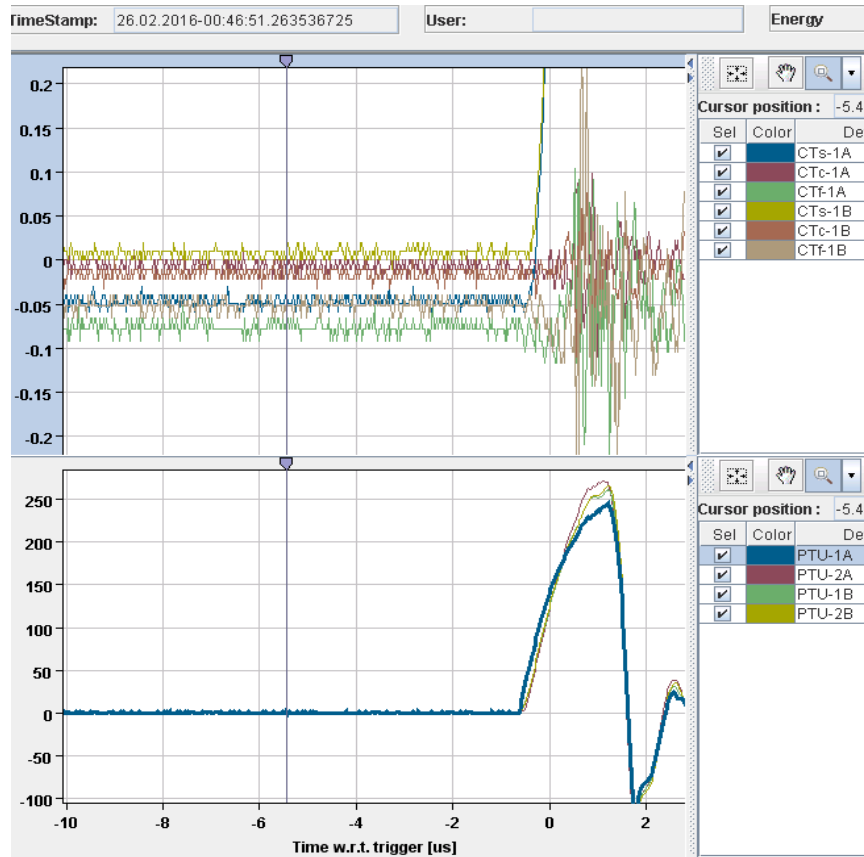
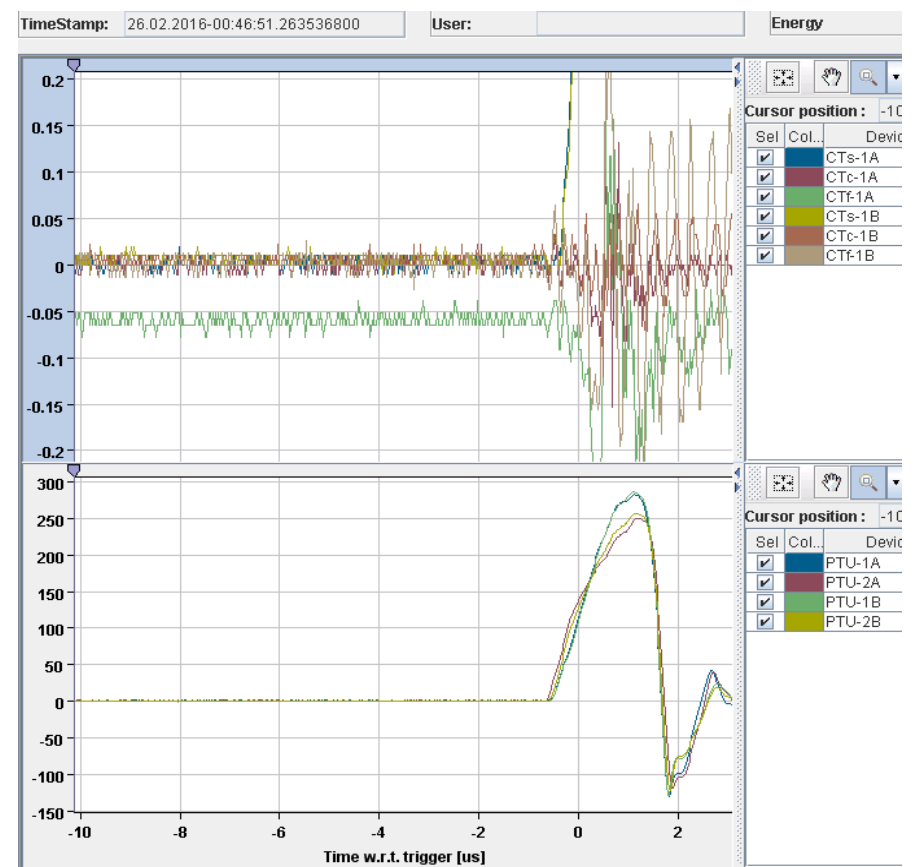
No sparking signal visible

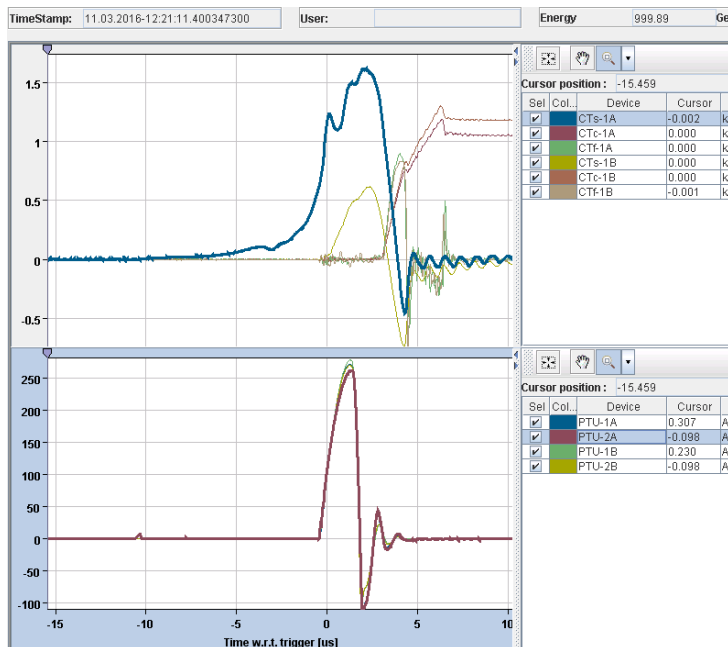
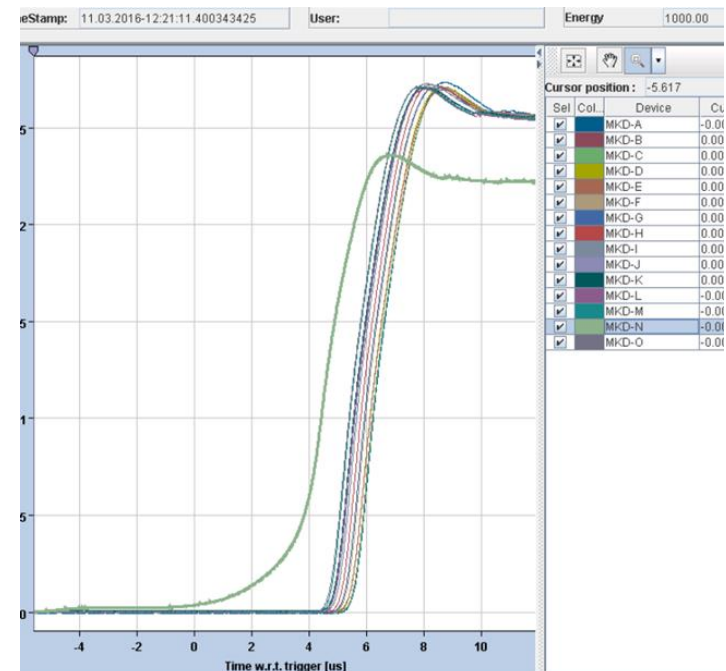
- Try to mimic signal by injection of perturbation signal into the retrigger line
- Activated fast retrigger path of the most sensitive PTM which has a \sim factor 2 lower sensitivity than the logical path depending on the MOSFET threshold voltages (5-6 Volts vs 11 Volts)
- As a result, the stack supplied by activated PTM starts slow commutation process with high commutation losses
- Less current in a magnet and risk for GTO stack

- Short term
 - Additional instrumentation in the tunnel (during the energy scans and reliability run)
 - Further tests in the lab
- Longer term – all to be studied in detail
 - Modifications of fast retrigger path - individual adjustment of threshold to higher value than today
 - increased immunity to perturbations
 - Would increase retrigger delay, thus cannot be done now
 - Modifications of the logical path – faster logic with eventually lower threshold; gain of ~ 150 ns possible
 - Modification of the analogic power part of PTM; gain of ~ 50 ns expected
 - Timescale EYETS at the earliest - or part of upgrades foreseen on GTO stacks and controls during LS2
- Before any HW modifications should review the retrigger time specification

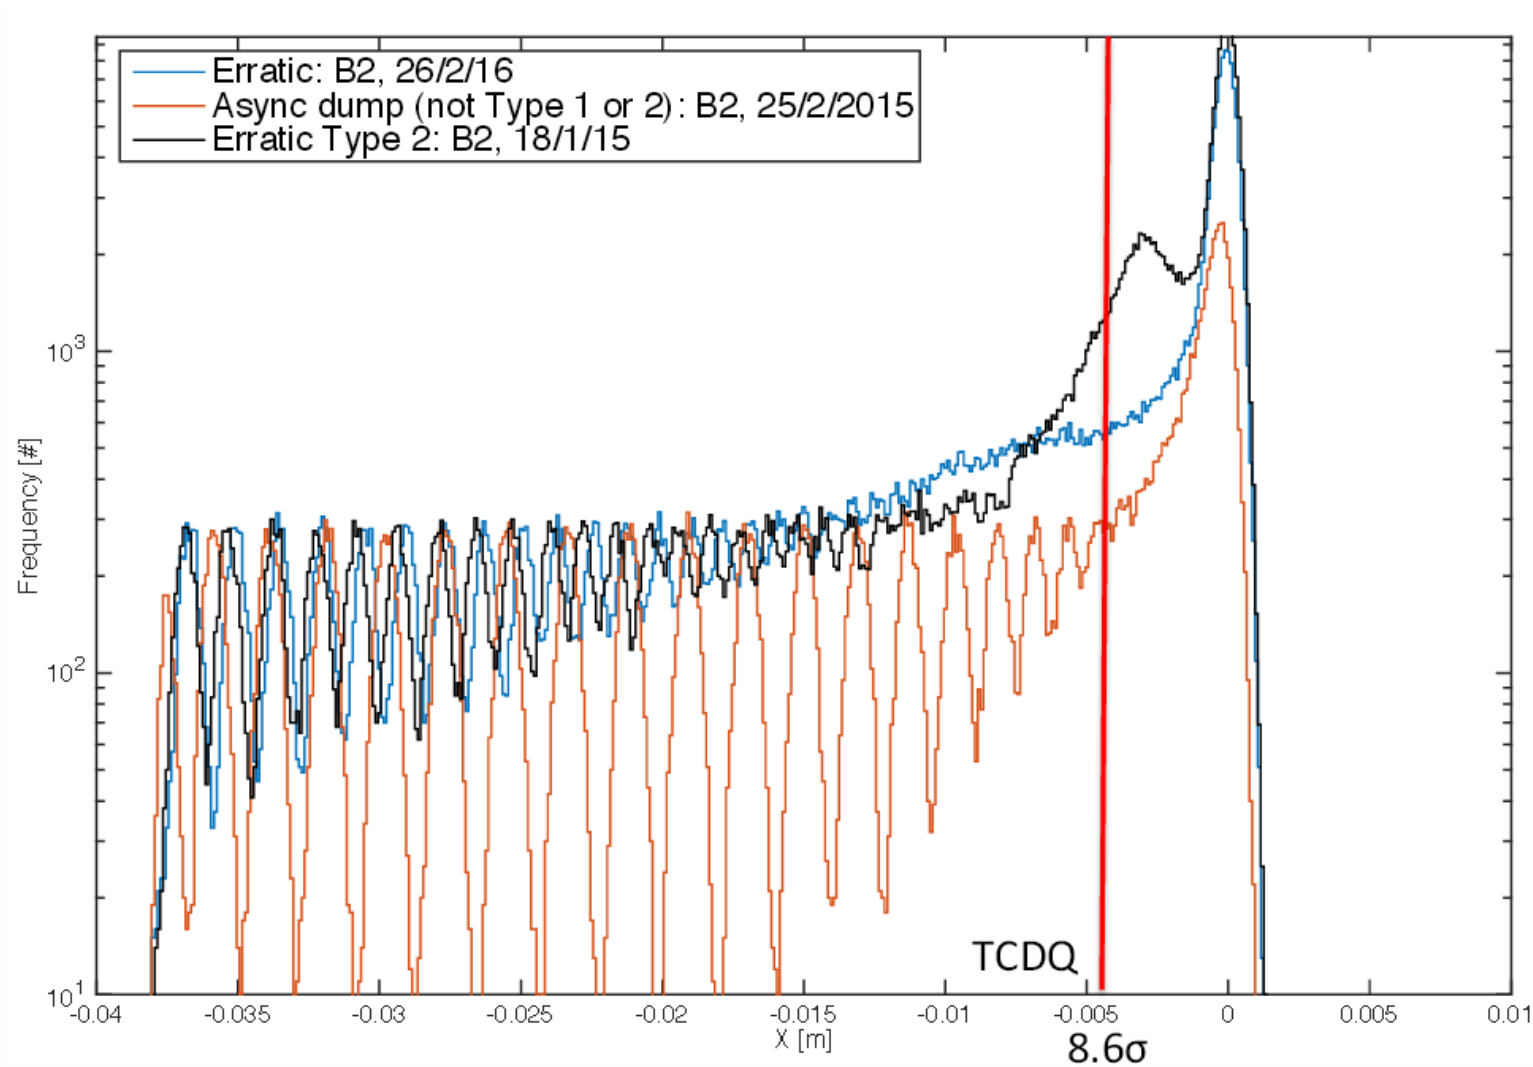
Erratic type 3 effect on the beam

- But the source of the signal cannot presently be explained
 - The expected failure rate can consequently also not be estimated
- Effect on the beam
 - Particle density induced by type 3 on the TCDQ and in the circulating beam aperture (4 - 8.6 sig) is not worse than type 2 erratic; even for one or two MKD prefiring

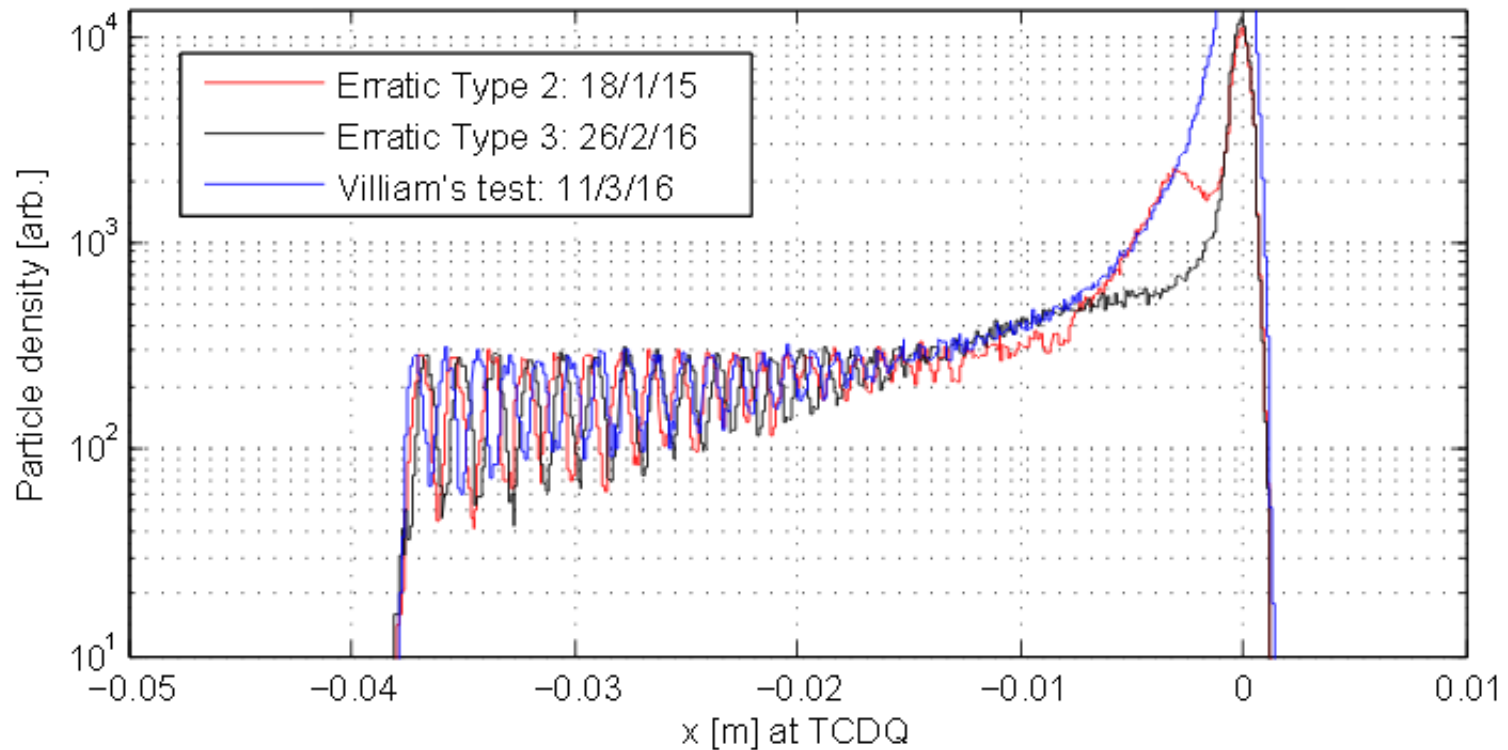
Particle distribution for test-erratic

- Test-erratic happened at 1-2 TeV
- To be tested if this erratic is possible at higher energies
