Study of vacuum RF Breakdown in strong magnetic field

The University of Chicago/Fermilab

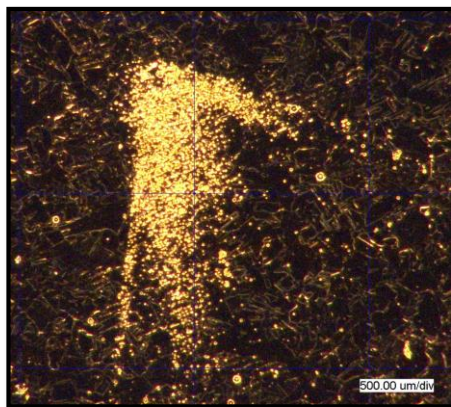
Type 1
 Count : > 250

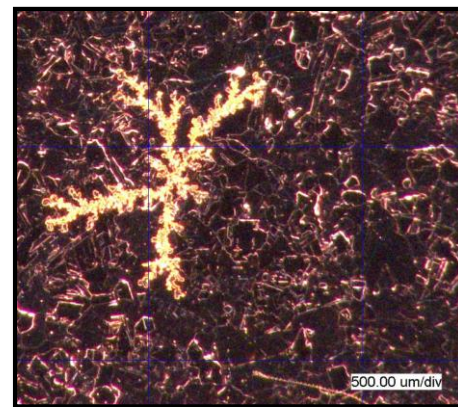
Type 2
 Count: 92

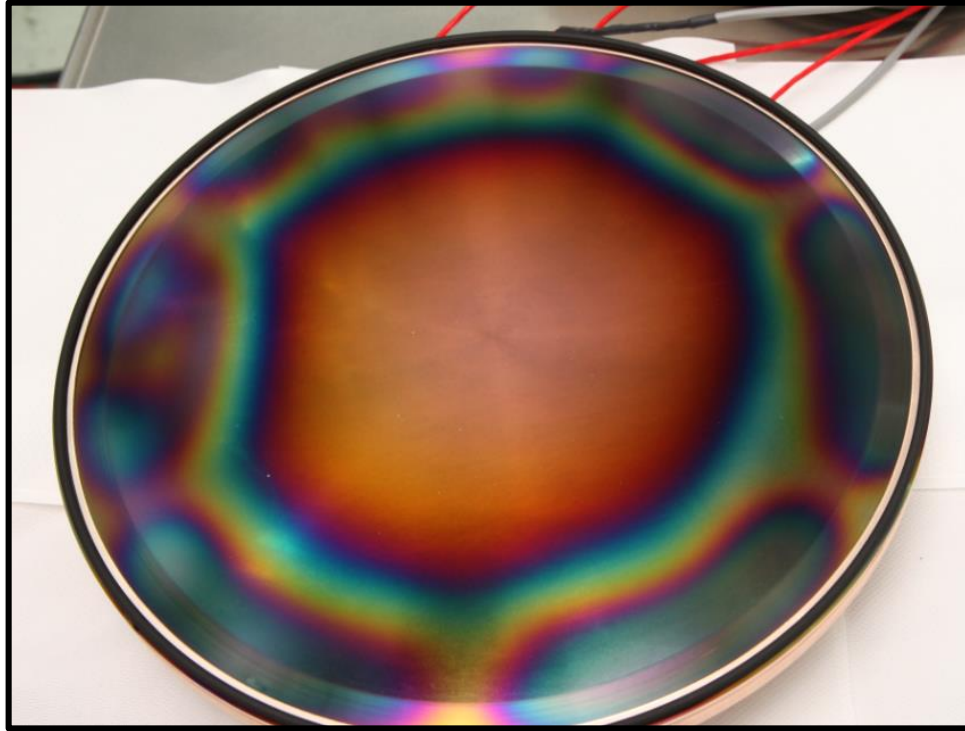
Downstream endplate after B=0T run

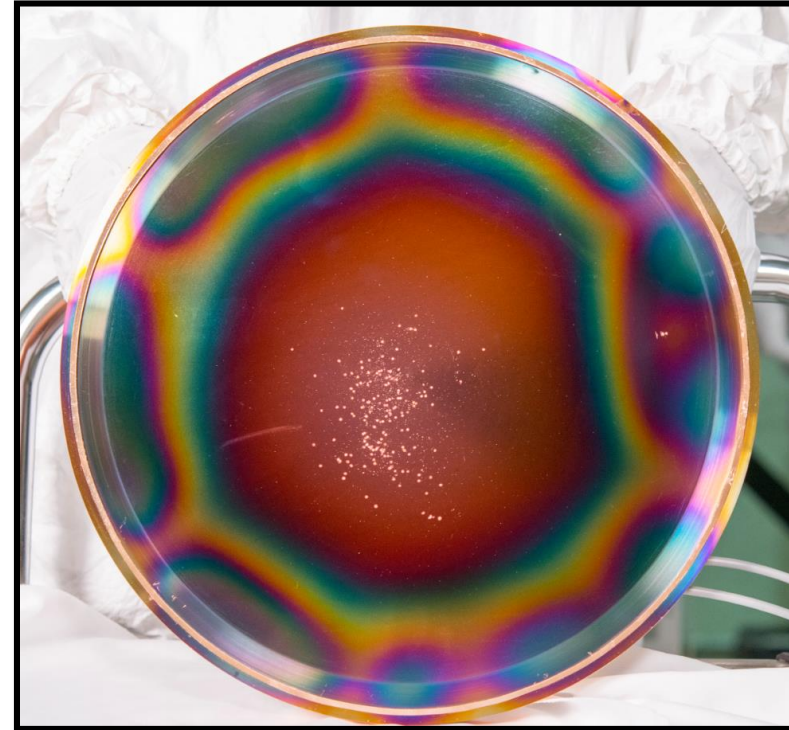
Downstream endplate after B=3T run

All clearly visible damage was inflicted during B=3T run (!)

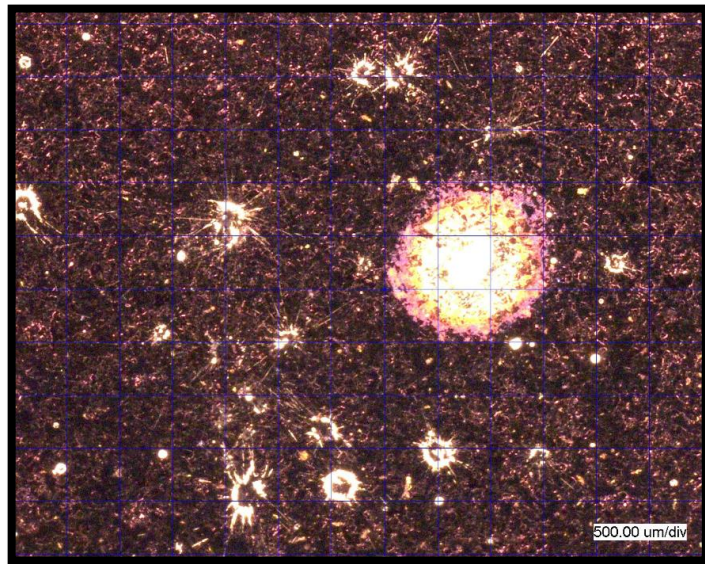
Typical BD pits

- Similar to BD damage we observed in other cavities
- Characteristic pit diameter $\sim 1.5\text{mm}$
- Traces of splashing

splashing

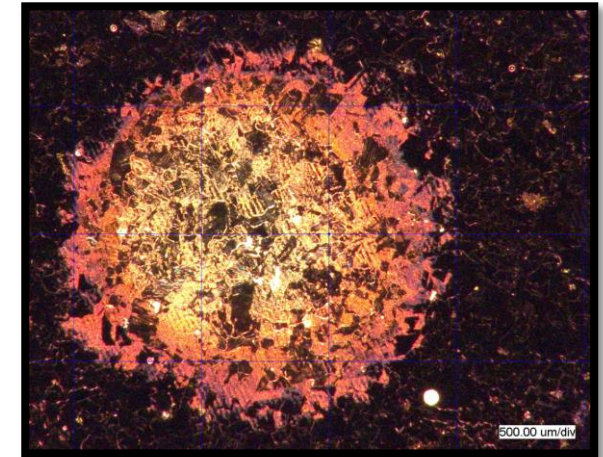
Flat structure

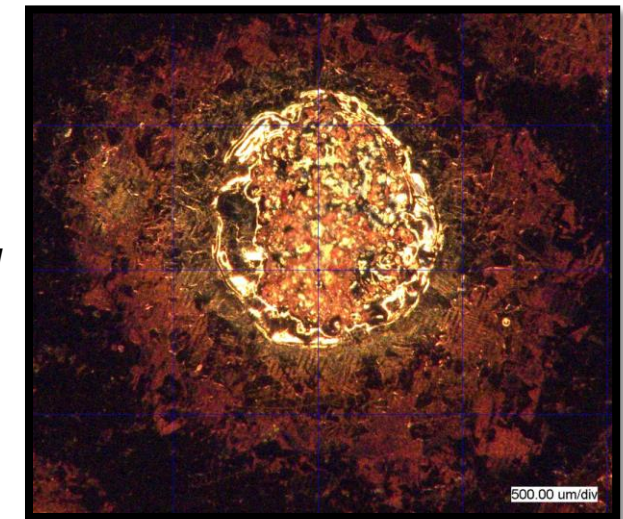
Structure with melted core

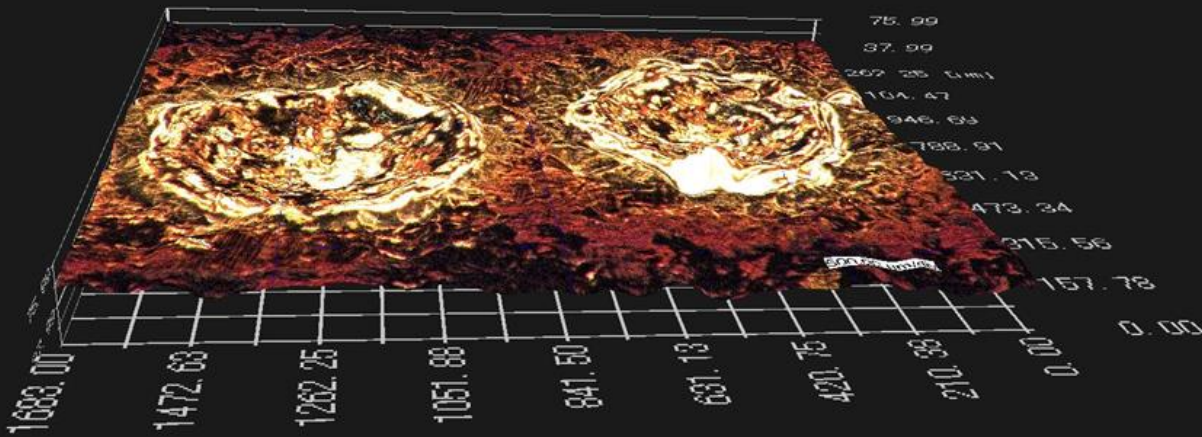
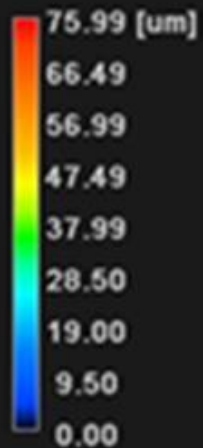
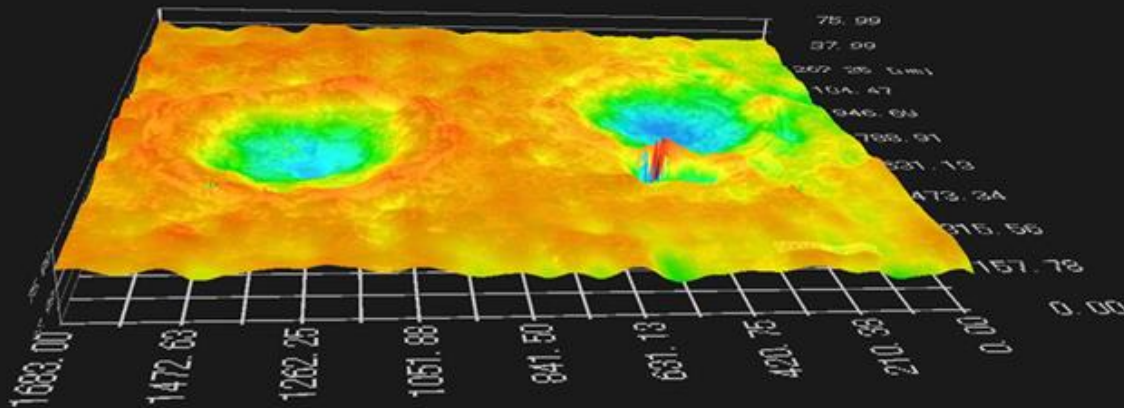
- Damage is much more “violent” than after B=0T
- Melted bulk of copper
- Craters up to ~0.5mm in diameter and up to ~ 60um in depth
- SEM analysis will be possible in the future

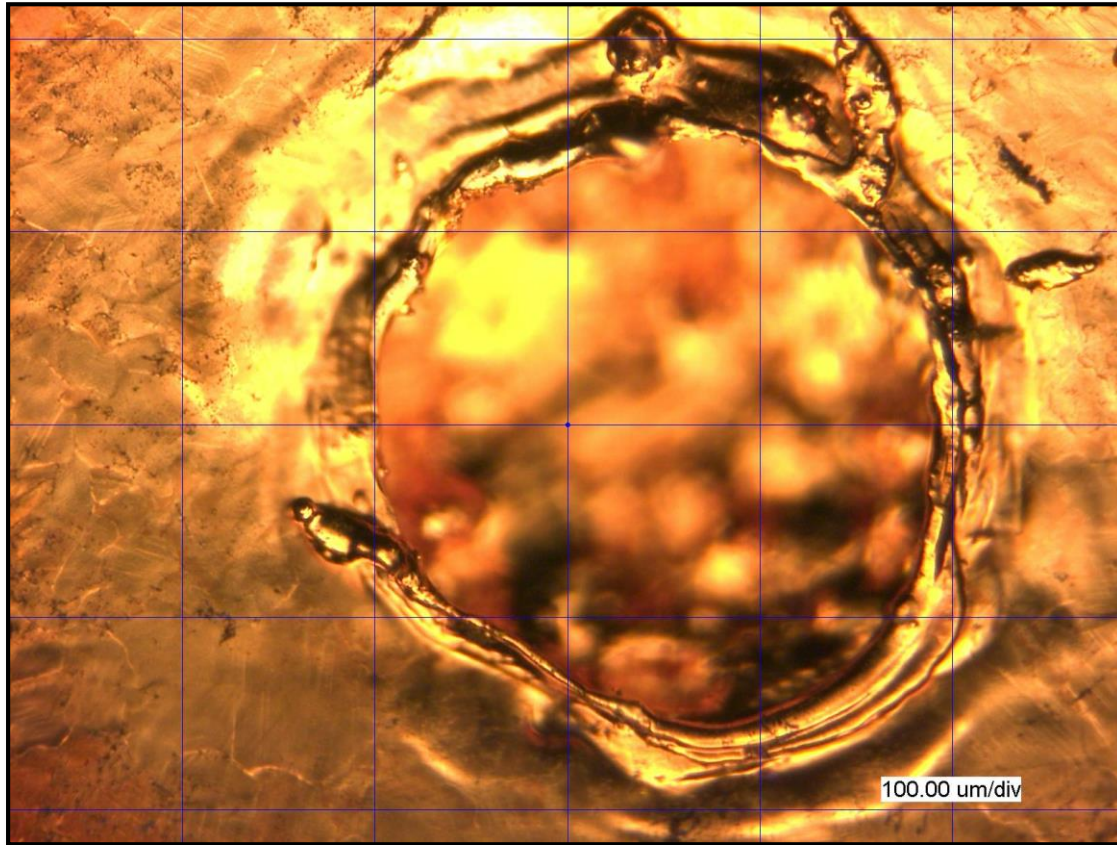
Crater edges

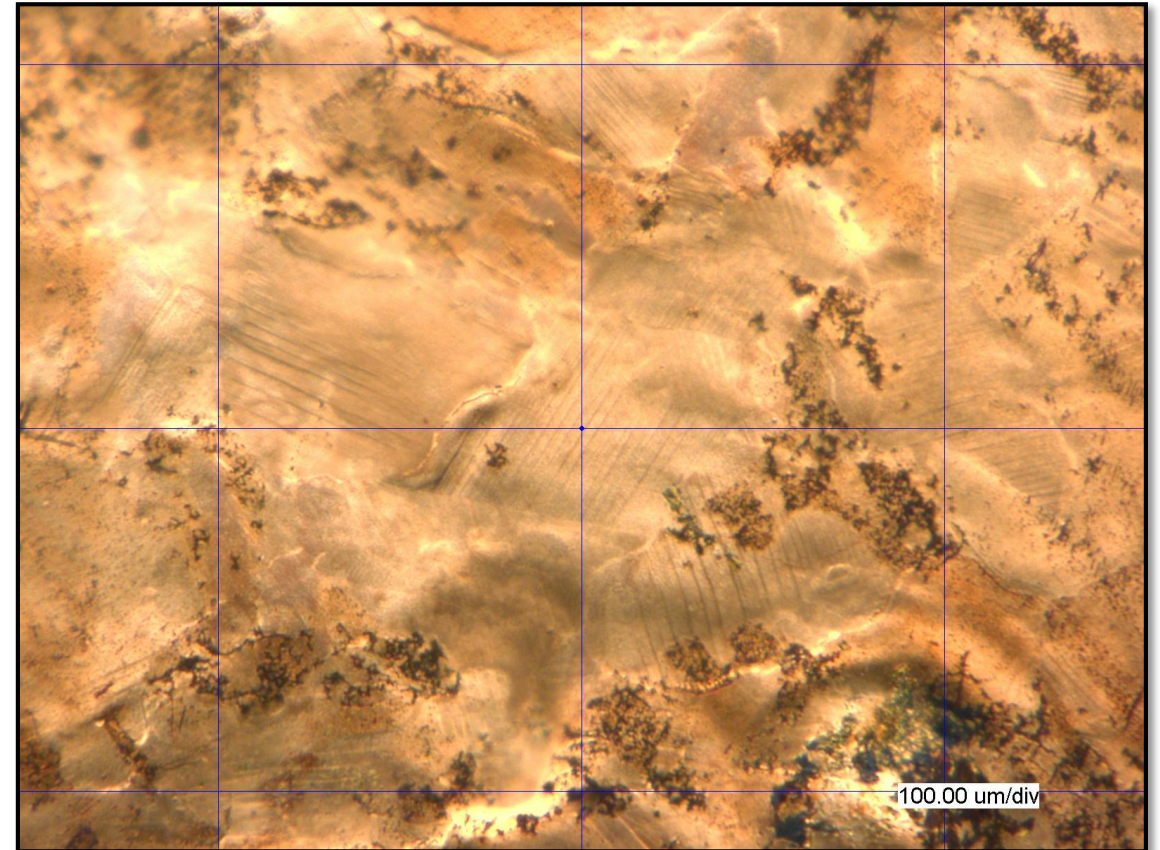
Core center

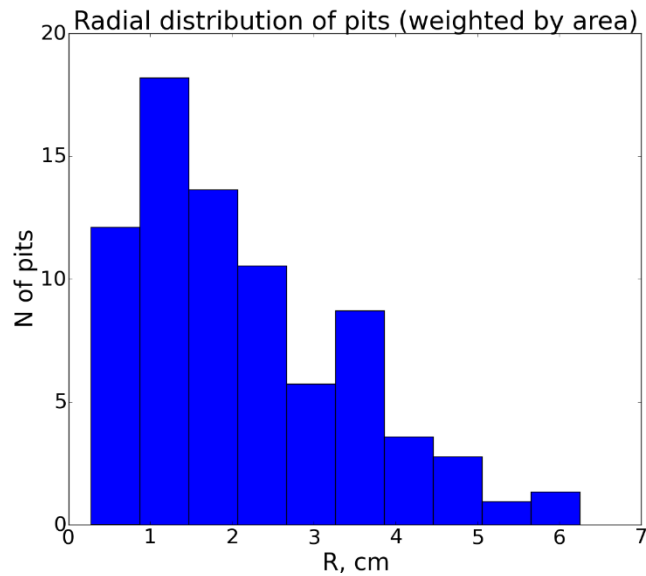
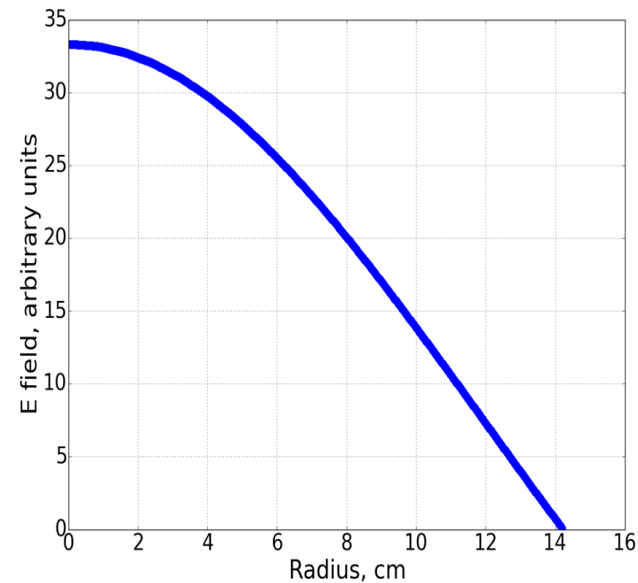
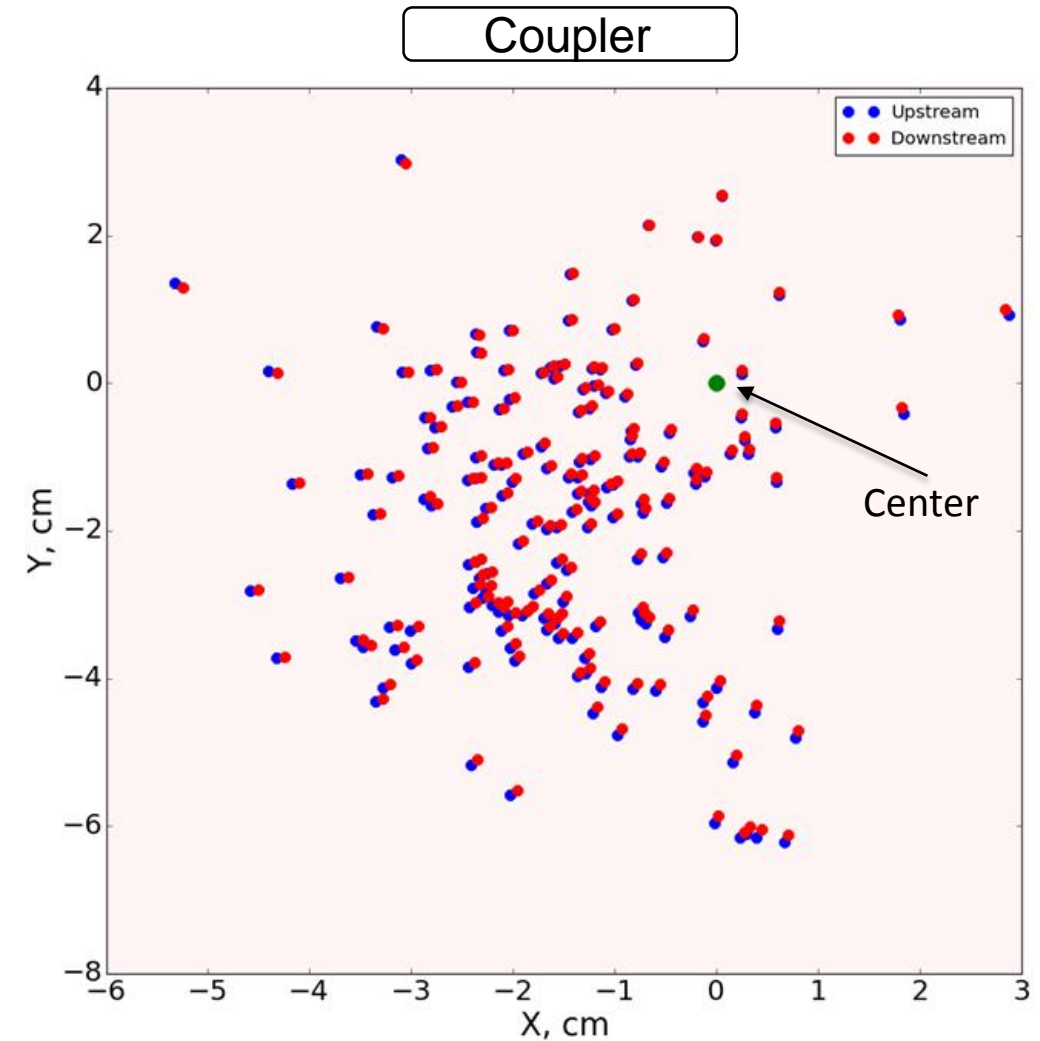
Map of damage pits

- **Perfect 1-to-1 correspondence between 168 pits on each endplate**
- Detected 55 sparks, but observed 168 damage sites
- Damage distribution is in agreement with E(R) dependence

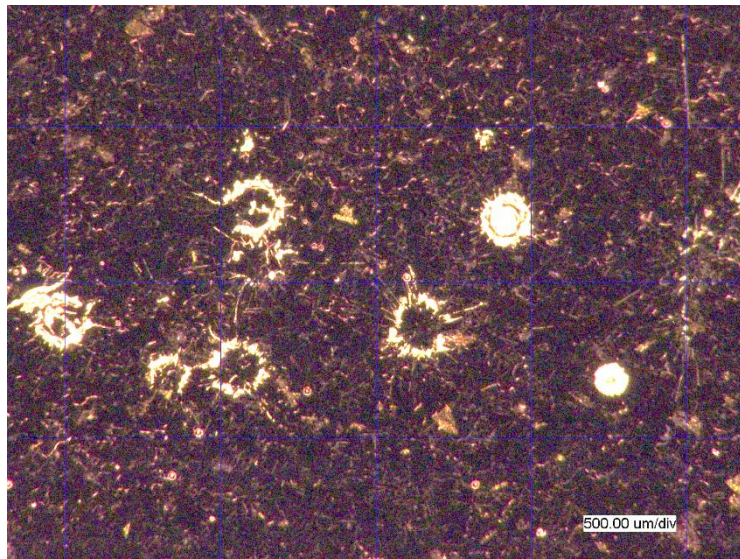
Microscopic image of splashing pattern after B=3T run

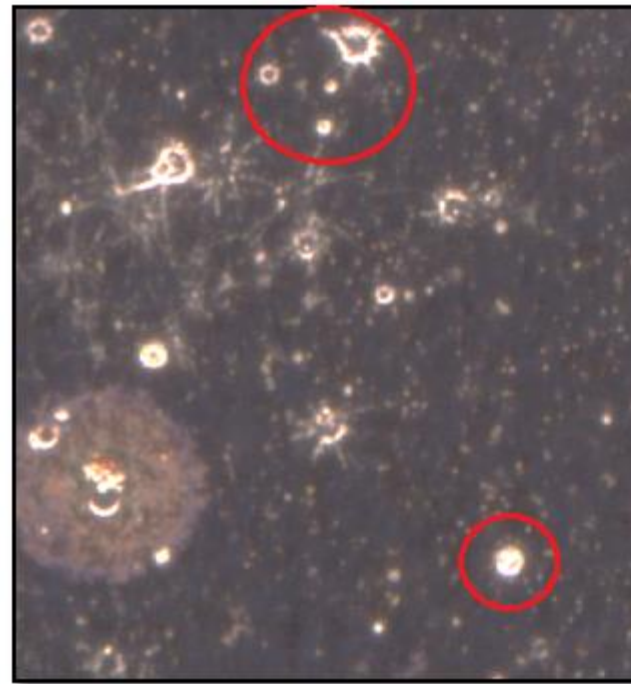
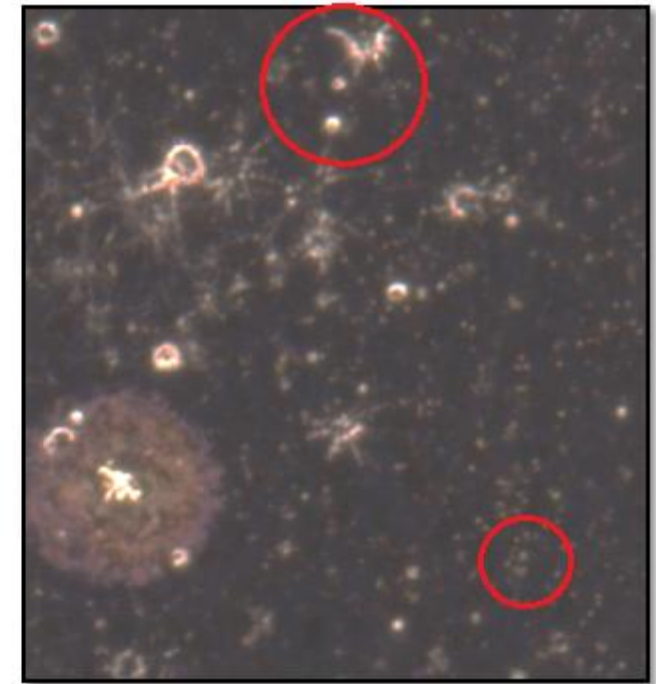
No new damage sites observed
Some splashing traces disappeared

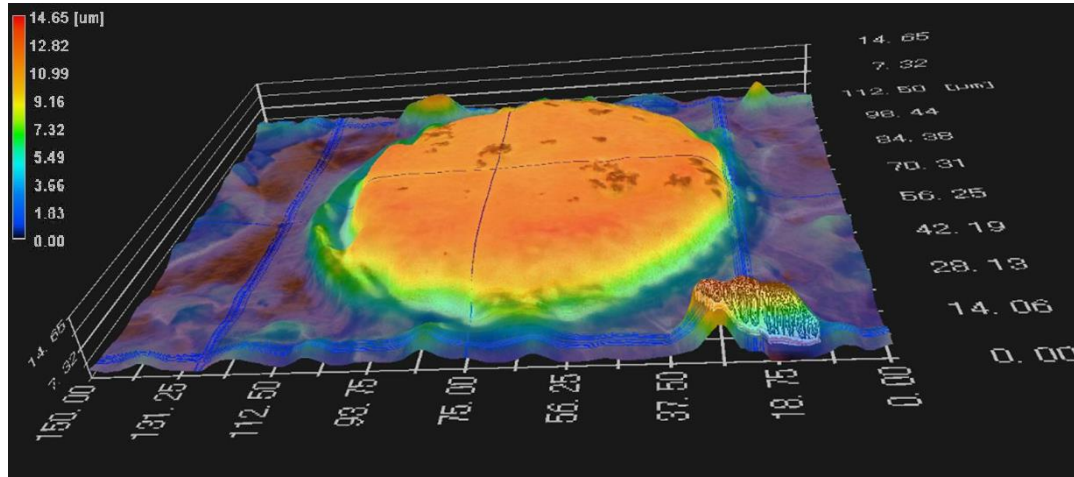
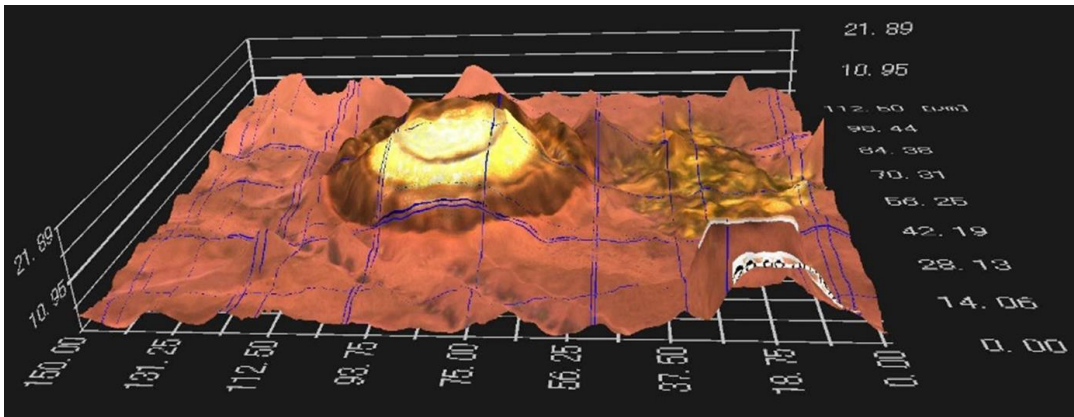
Melted copper “drops”

- Features that are being processed out during conditioning
- Splashes mostly lack directionality, often ~cm away from closest BD pit
- Characteristic time to solidify and cool down: 0.1 – 1s

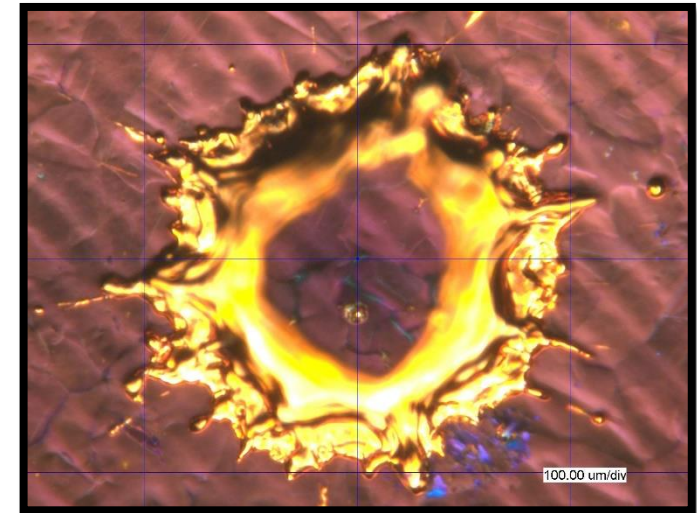
Common type of damage feature – splash with hollow center

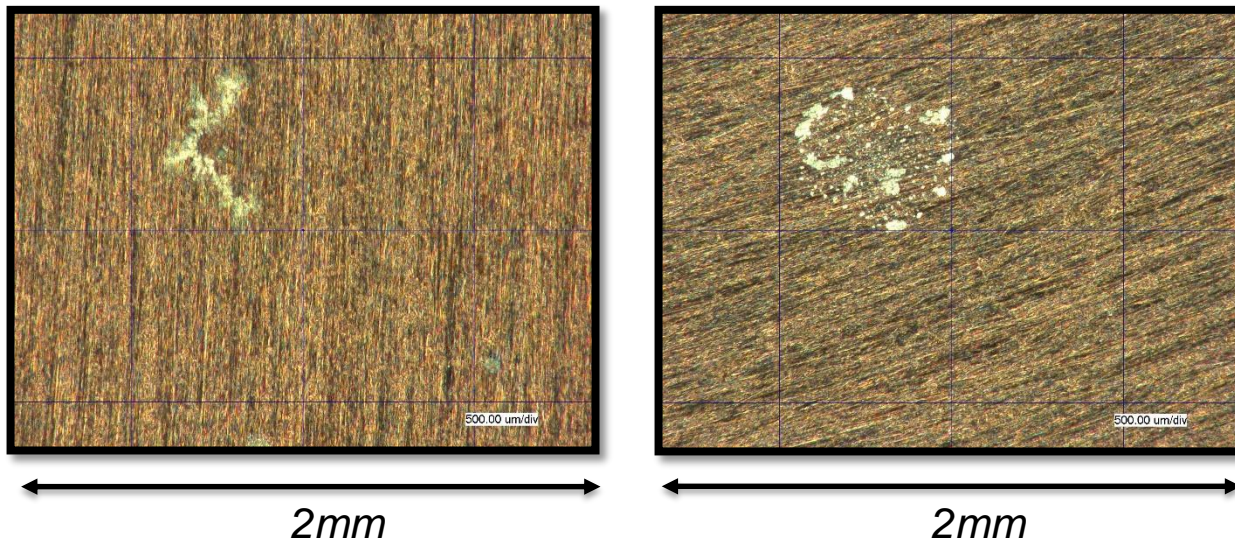
Asymmetry between endplates' damage

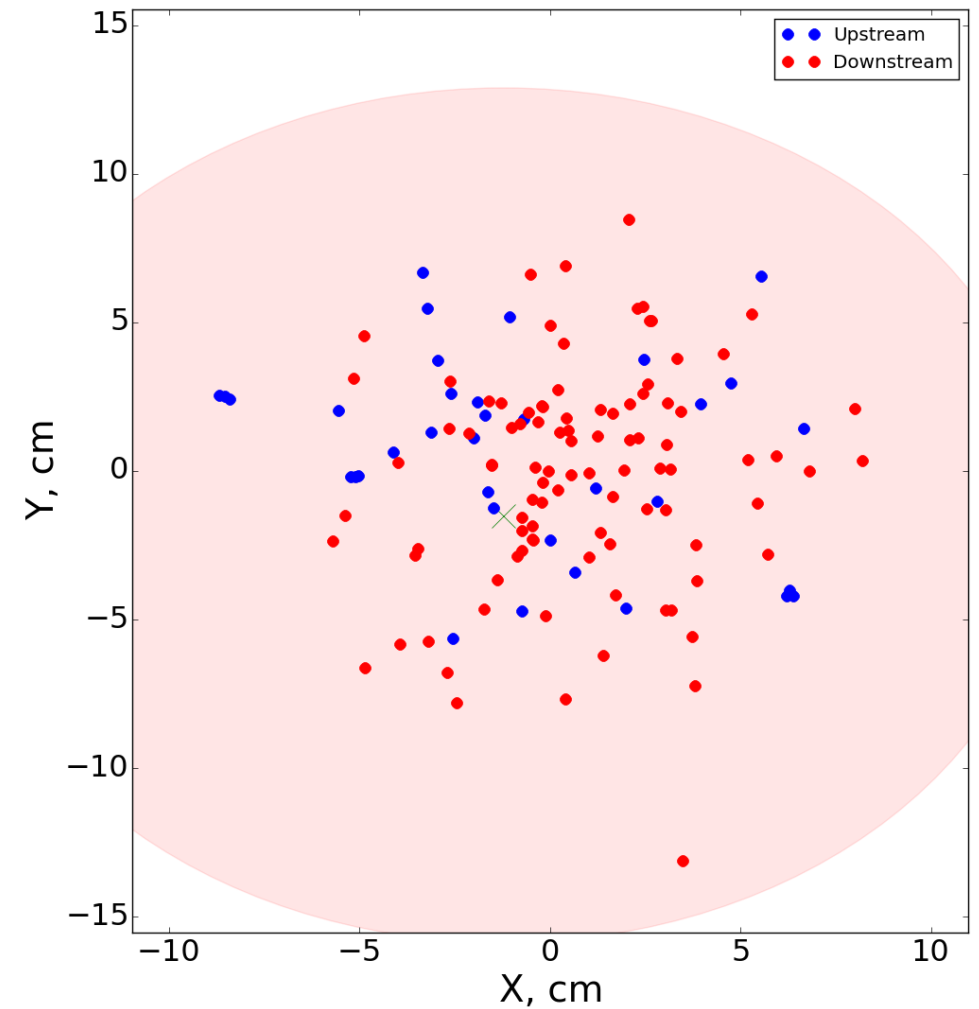
Damage distribution map

- Safe operating gradient of 37MV/m established
- 11M RF pulses accumulated
- Detected 160 breakdown events
- Observed ~ 135 damage spots (subjective counting)
