# WHAT DID WE LEARN WITHOUT BEAM IN 2008?

R. Saban and M. Pojer, CERN, Geneva, Switzerland

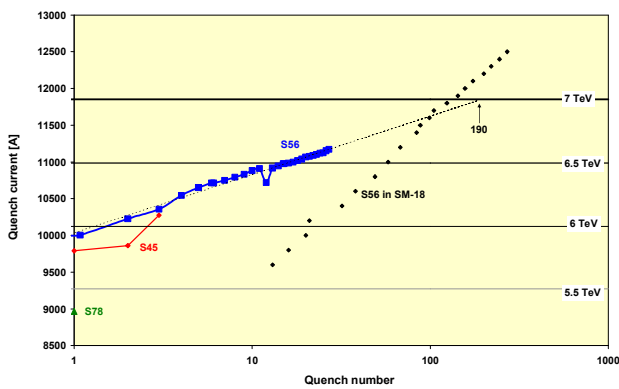
Chronologically, the first surprise was the assessment that the training of the dipoles was taking much more time than expected. The figure below shows the observations in Sector 56 where an extensive training campaign was carried out and interrupted at 6.6 TeV.

Figure 1: Training in the tunnel versus training at the test benches

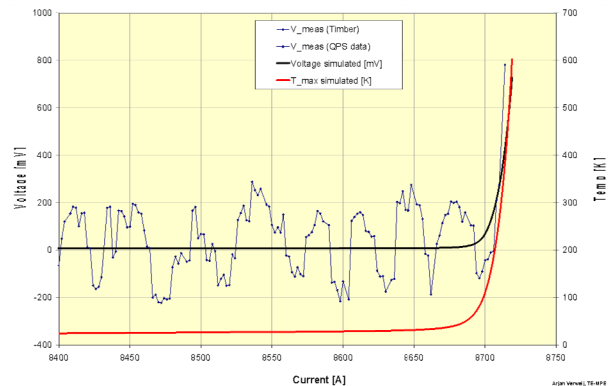
The task force established that the initial fault developed in an interconnect splice on the dipole circuit where both the longitudinal continuity of the copper stabilizer and the bonding of the superconducting cable to the stabilizer were missing. This assumption was confirmed by simulation.

Figure 2: Measured versus simulated incident with 220 nΩ joint and bad contact with U-profile and wedge

A study of how the energy stored in the magnets was dissipated at the time of the event where the circuit was energized with 8710 A showed that almost half of the energy (275 MJ) was used to create electrical arcs which punctured the helium vessel. This caused a helium discharge from the cold mass into the insulation vacuum with a flow that was calculated to be as high as 23 kg/s. This is well above the nominal design value of 2 kg/s for which two DN90 relief devices were installed on each insulation vacuum subsector. The pressure rise was responsible for the forces on SSS vacuum barrier, which displaced the cold masses and caused the collateral damage. Secondary arcs were also created in two different

The task force formulated recommendations on two axes: the first ones aim at the prevention of initial fault and the second ones aim the mitigation of consequences. They concern actions, hardware upgrades, improvements of test procedures as well as personnel access rules. Many of these are already implemented during the present shut down, others will be implemented during the commissioning and operation of the collider.

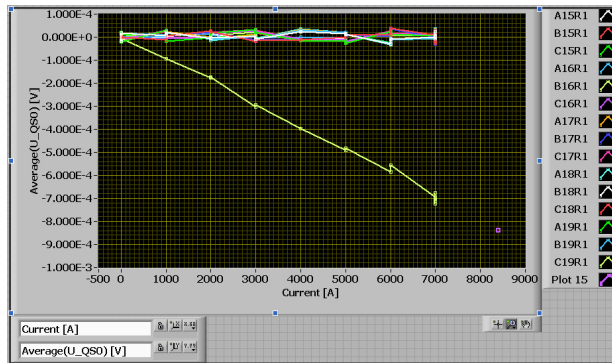
One of the first studies of the task force was the examination of data recorded during the tests to assess whether there were precursors to the September 19<sup>th</sup> incident that had gone undetected. This analysis revealed [4] that some sectors indeed had shown an anomalous increase of temperature during high current plateaux. Among them Sector 34 which exhibited a parabolic increase of 30 mK per hour during a one hour-long plateau. The observations however were done in unstable conditions because of the activity of the temperature control loops. A method was developed to repeat these measurements in normalized conditions; the method was validated by simulating the heat load of a faulty splice with a heater located inside the cold mass. Clearly these measurements will have to be repeated during the recommissioning. This method revealed two additional regions in the collider (Sector 12 and Sector 67) where abnormally high heat loads were measured during current ramps in the dipole circuit.

Figure 3: Confirmation of a 100 nΩ resistance measured inside a magnet cold mass (B16R1) spotted by calorimetric measurements

These suspect regions were equipped with voltmeters to measure, with an accuracy of a few  $\mu\text{V}$ , the voltage drop across the splices in the interconnects. These electrical measurements did not reveal any non-conformity and only confirmed very good quality splices. It was therefore decided to measure the resistance of the splices inside the magnets: the splices in the coils, the inter-pole and inter aperture splices. This measurement could be carried-out with existing quench detection electronics. They indeed revealed faulty splices with resistances compatible with
