Quench heater failure in dipole magnets

M. Bajko

M. Bajko for the LHC Risk Review
6th of March 2009

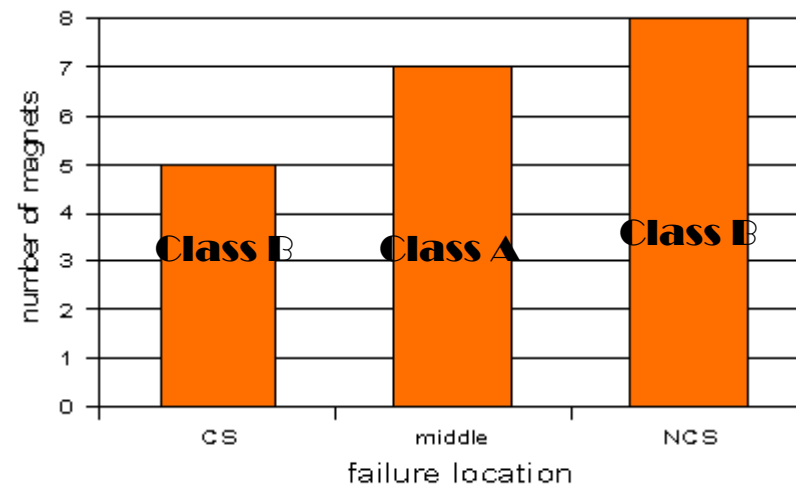
Location of QH failures in ASG magnet

The idea of the existence of two different classes is supported by the observation that failures in the straight section occur with almost the same probability in the upper and lower part of the aperture; while they are located in the 85% of cases in the upper zone if they are going to happen in the coil ends.

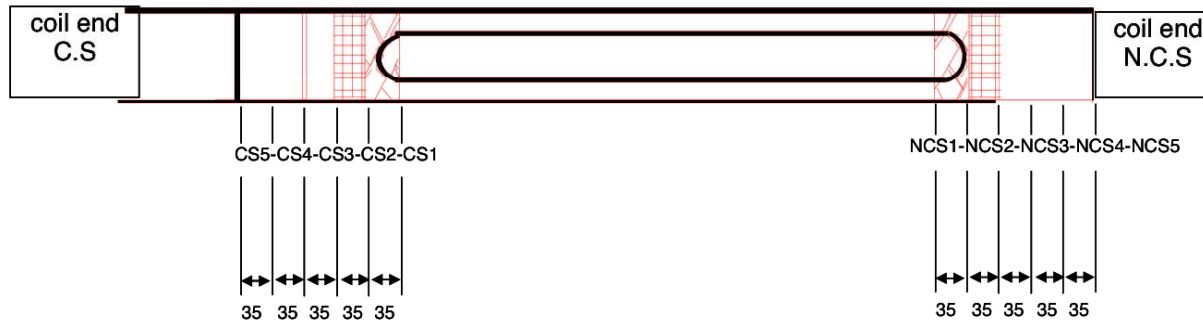
Coil head shimming

Shims are used to control the pressure profile in the coil ends. QH failures observed in the coil ends are likely to be due to over pressure in the same region. Therefore it is possible to think of a correlation between QH failures and coil ends shims. Extra thickness of the shims can cause over pressure and consequently damage of the QH strips.

As a result of the analysis, it can be stated that thick shims cannot be neither identified as the main source of QH failures in the coil ends nor excluded from the list of parameters that can cause the problem in a combined way.

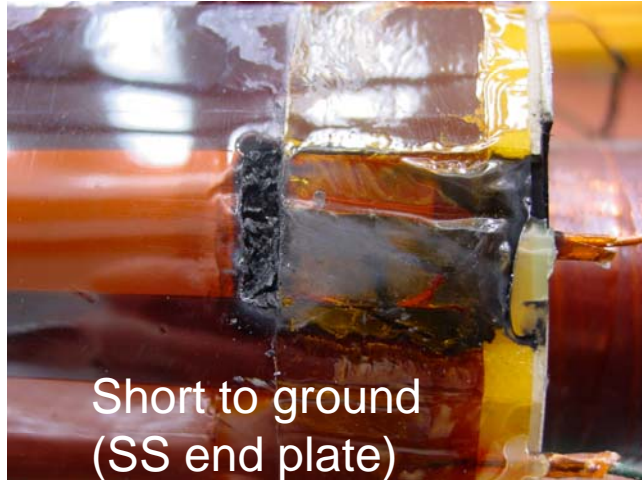
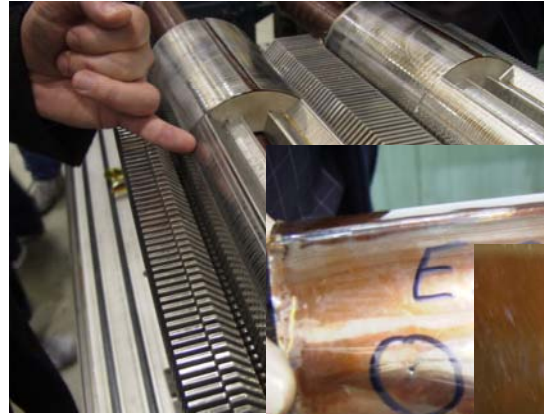
1. Electrical insulation fault after successful discharge test

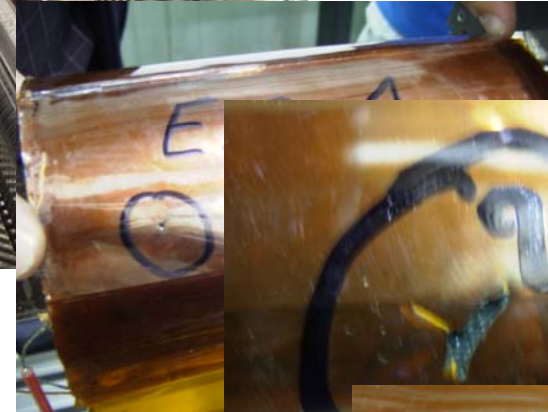
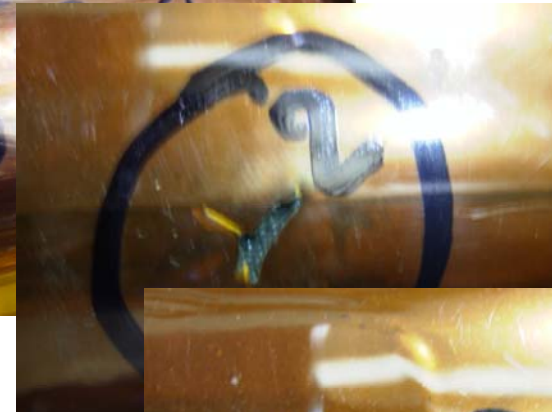
Short to ground (SS collars)

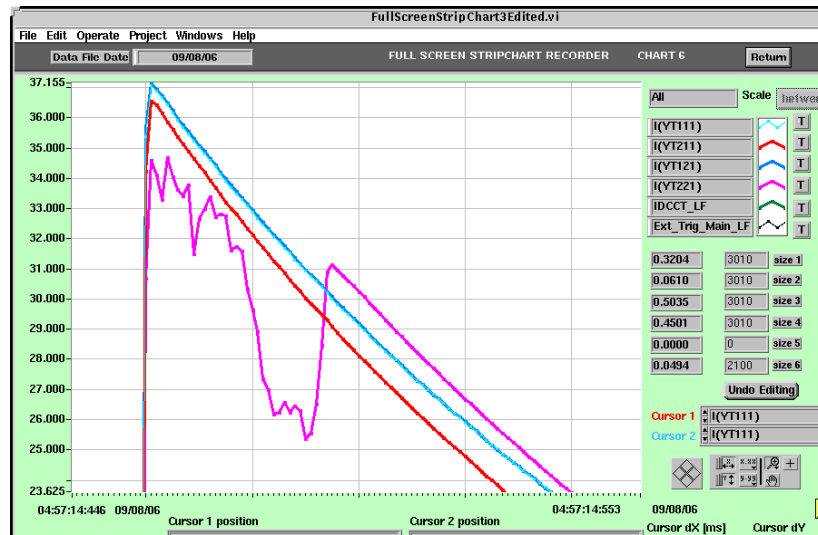
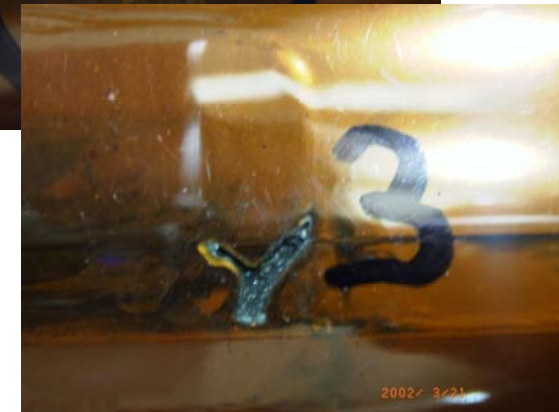
1. During discharge

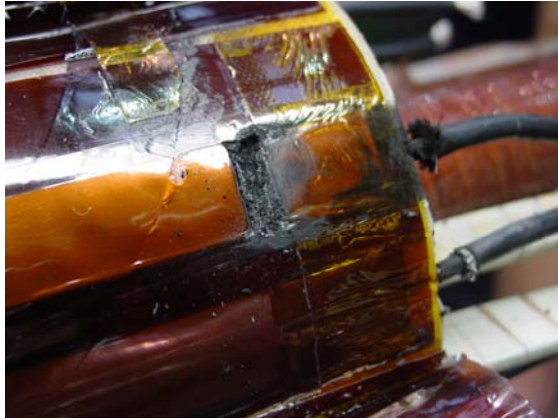
1. It is difficult to detect before damaging a coil

A metallic strip partially open (90% of its width) is still electrically continuous, no variation of its resistance can be seen and it withstands also a high voltage discharge test several times before it burns and maybe damage the coil.

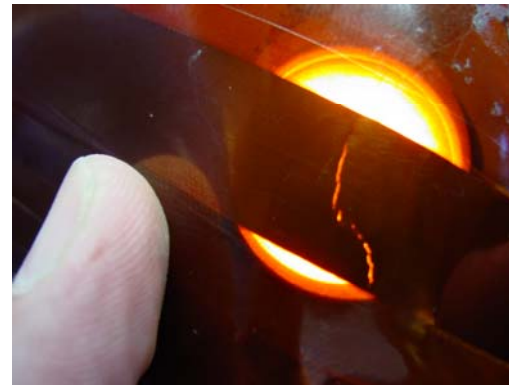
2. We already discovered failures without having seen it at any test

....case that could not be detected by any of the electrical tests but it was seen after disassembling of the magnet. Although a failure was detected at cold on the QH in question, it was localised on the opposite side.

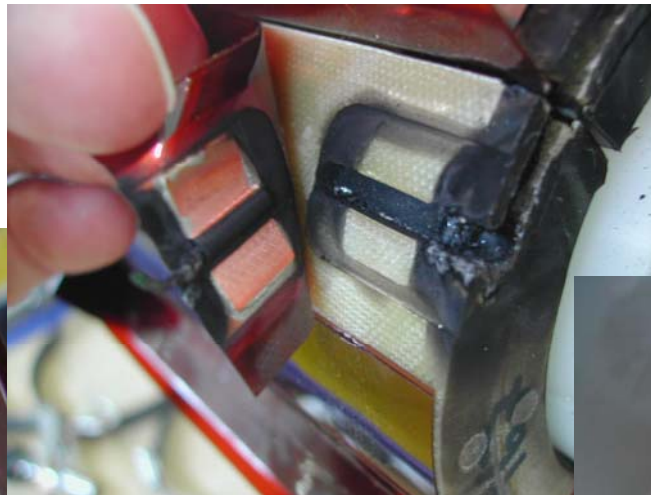
From aperture 21 (so magnet 10) onwards the design changed

So magnets 1 to 9 could have problems!
