NON-CONFORMITY

**We're Not All the Same.
No, *Really.***

How to deal with non-conformities

HARDWARE COMMISSIONING DAY

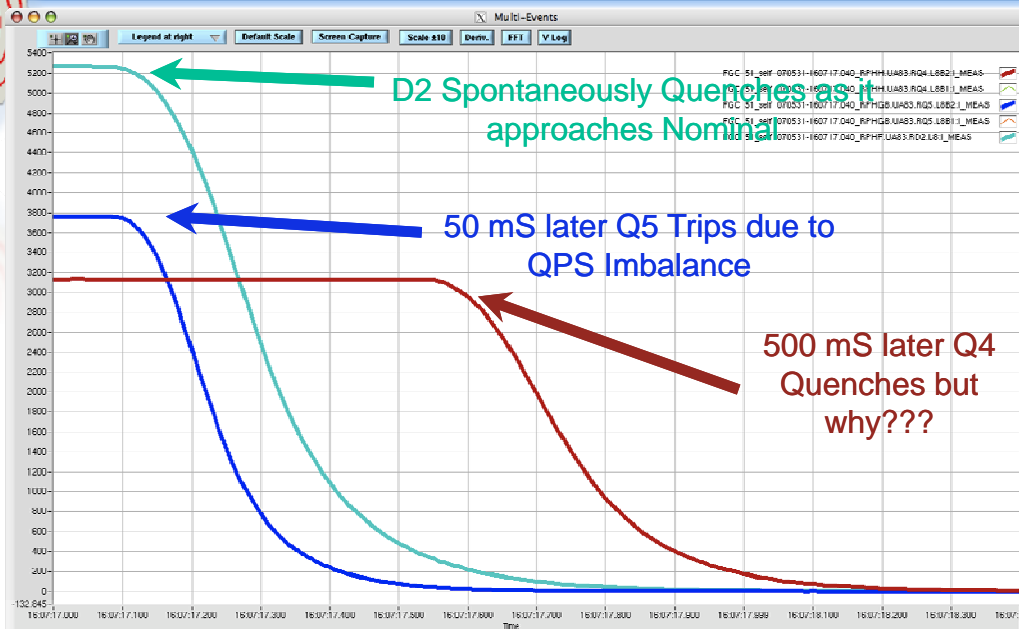
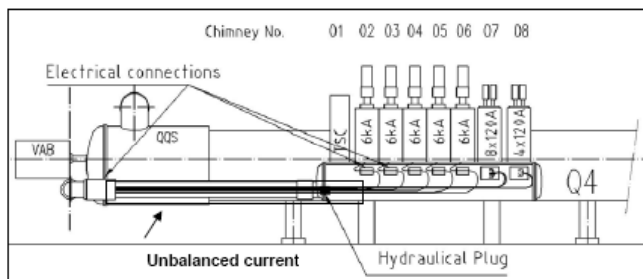
D2-Q4-Q5 MIX-UP

The D2 was quenching when the Q4-B1 was at high value

The Quench was likely in the part, where the power busses are in the DFBM "side-by-side"

Once the cable where shaken into place, no quench occurred any more

The fault is still in the LHC and may show up again, here and elsewhere.

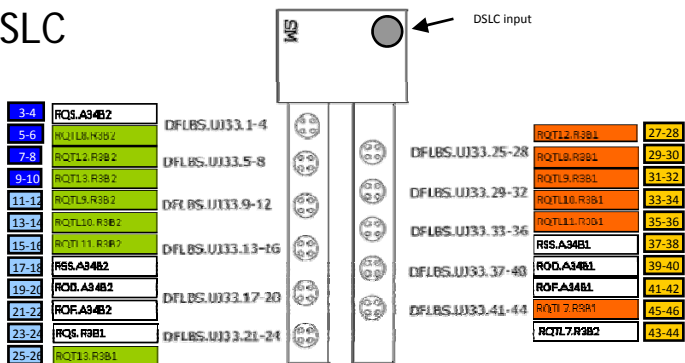
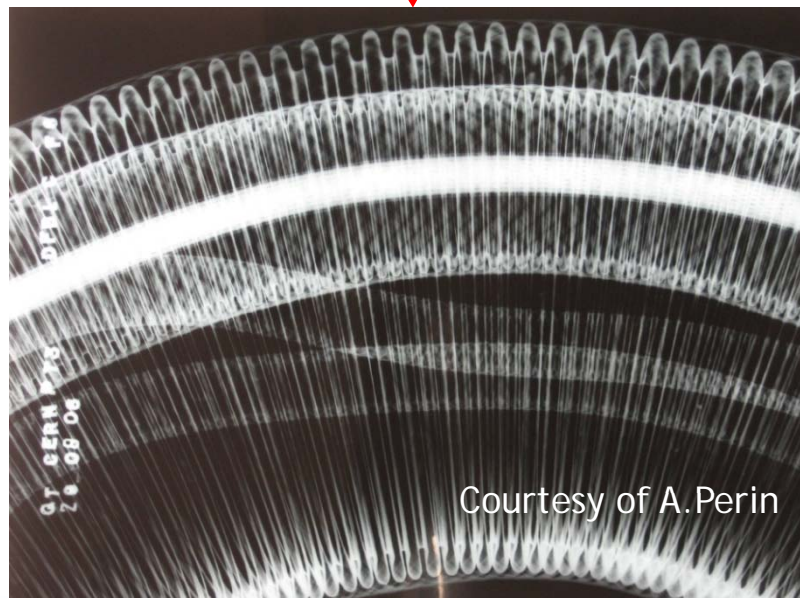
When powering some 600-A correctors of sector 3-4, fed from the DFBMC through the superconducting link, a voltage rise was observed, which is related to a mechanical NC on the DSLC

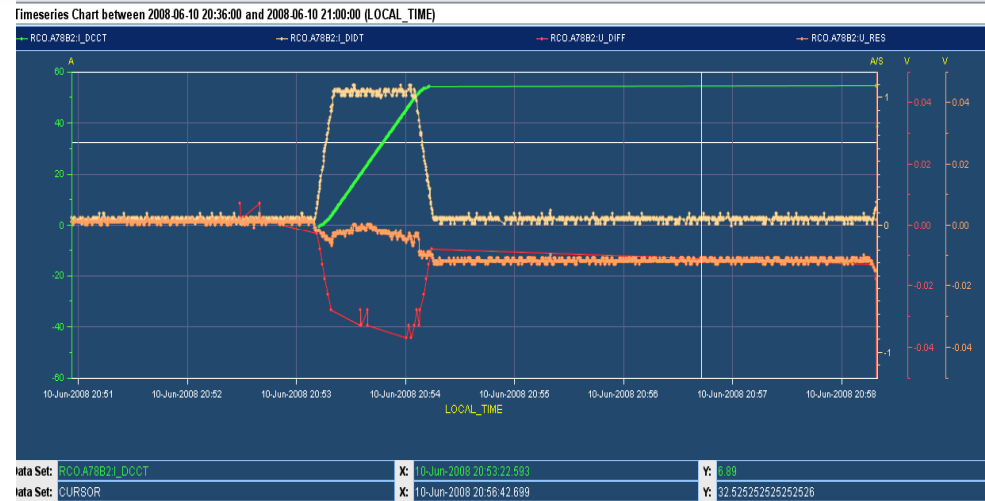
Is there a bad splice hidden somewhere?
 Is reducing the nominal current enough?

Circuit	Current	Delay	Comment
RQT13 L5B1	549.9 A		Quench
	550 A	28 s	Quench
	550 A	90 s	Trip, unknown
RQTF A45B2	525 A		Quench
	362 A		Quench
	454 A		Quench
	550 A	32 s	Quench
	550 A	2 s	Quench
	550 A	24 s	Quench
	550 A	26 s	EE Dump

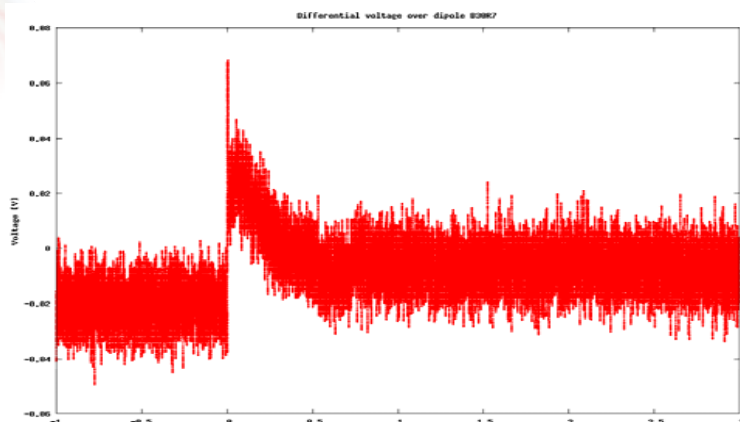
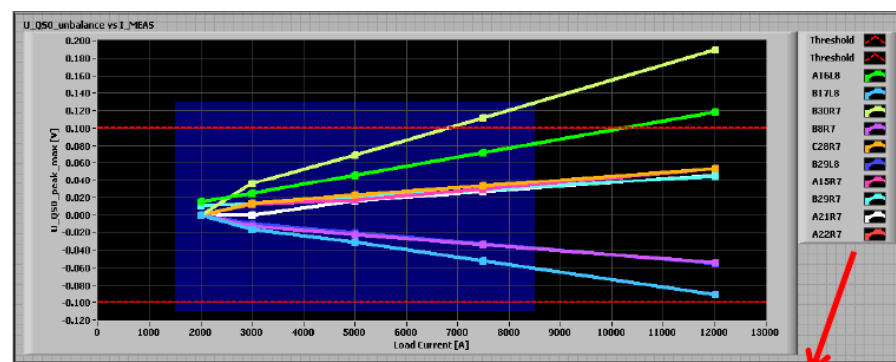
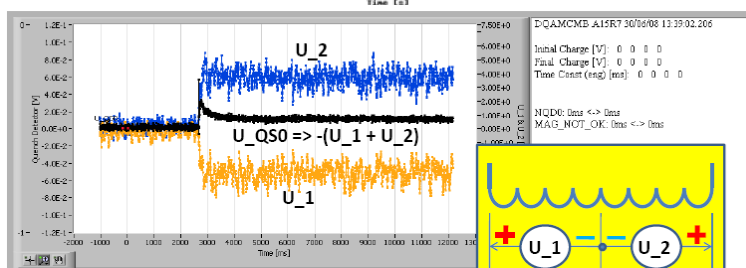
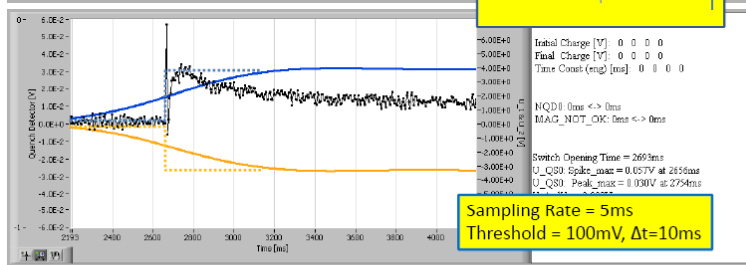
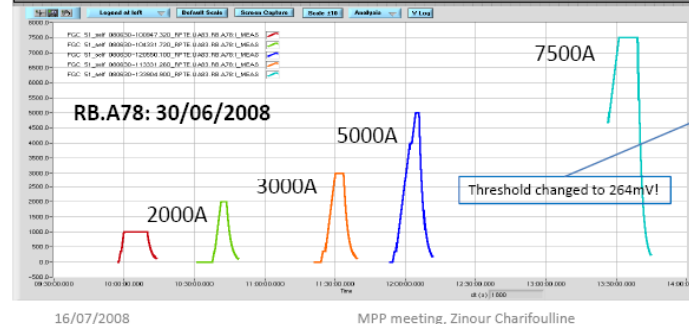
THE TRANSIENT SPIKE PROBLEM

- “Quench” in MB B30.R7 during fast discharge at 7000A $di/dt = -70A/s$
- There is no real quench. There is a voltage difference between the two apertures which grows with di/dt and exceeds 100mV.

- Top 10 magnets:
- A16L8 – 3504
 - B17L8 – 2006
 - B30R7 – 1007 *
 - B8R7 – 1031
 - C28R7 – 2011
 - B29L8 – 1009
 - A15R7 – 3020
 - B29R7 – 1013
 - A21R7 – 3014
 - A22R7 -- 1023

Changing the threshold is potentially dangerous!!!!

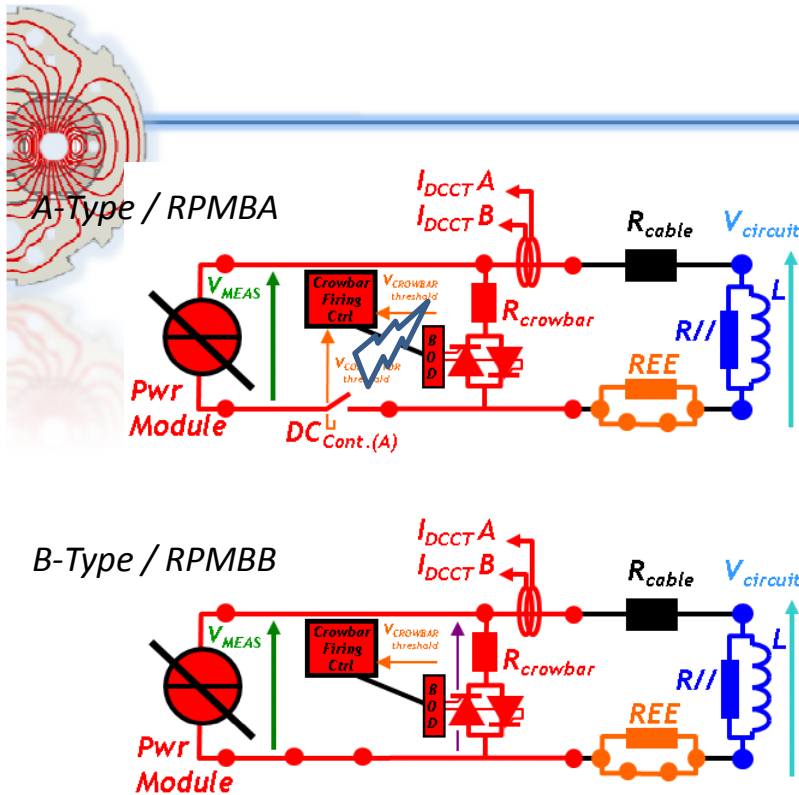
600 A-10 V CROWBAR ISSUE

A 600 A power module, when off, STILL drives a current in the range [-20A..20A], due to its 4-quadrant stage being STILL operating.

The A-Type rack is not affected by this behavior of the power module, since A-Type means a DC contactor is placed in series between the power module and the circuit.

For the B-Type, the crowbar activation relies on a 13 V threshold. For a low current (45 A during PCC test), the current generated by the 4-Q stage, when switching off the converter, reduces the voltage developed.

The PCC current was changed to 60 A

The installation of a DC contactor has been requested

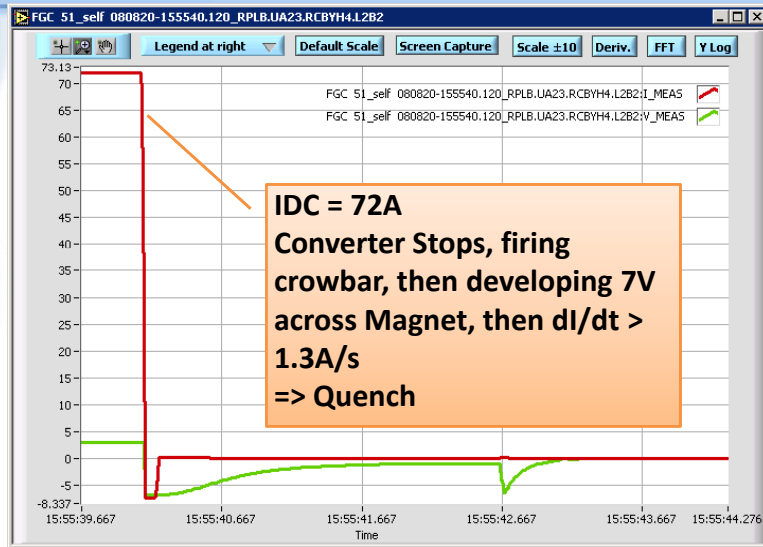
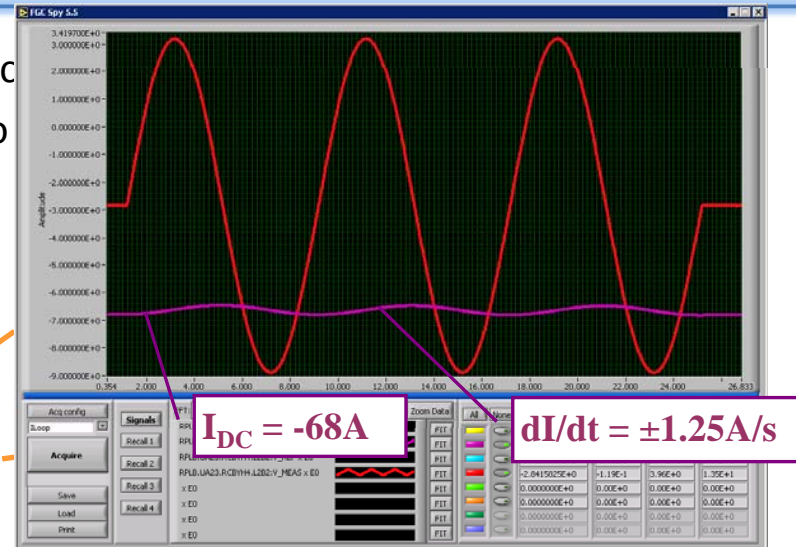
120 A WEAK MAGNETS

Electrical circuit	Fault	Critical ramp rate
RPLB.RR53.RCBYHS4.L5B1	Cannot handle LHC di/dt	0.6 A/s (LHC: 0.66A/s)
RPLB.UA87.RCBYHS5.R8B1	Cannot handle LHC di/dt	0.46 A/s (LHC: 0.66A/s)
RPLB.UA87.RCBYH4.R8B1	Cannot handle LHC di/dt	0.6 A/s (LHC: 0.66A/s)
RPLB.UJ83.RCBCH7.L8B1	Quench @ discharge	> 2.5 A/s (LHC: 1A/s)
RPLB.UA23.RCBYH4.L2B2	Quench @ discharge	> 1.25 A/s (LHC: 0.66A/s)
RPLB.RR13.RCBCV8.L1B2	Quench @ discharge	1.2 A/s (LHC: 1A/s)
RPLB.UJ23.RCBCV7.L2B2	Quench @ discharge	> 2.5A/s (LHC: 1A/s)
RPLB.UA43.RCBYV5.L4B2	Cannot reach nominal current

Rated 72 A, it cannot go higher than 65 A

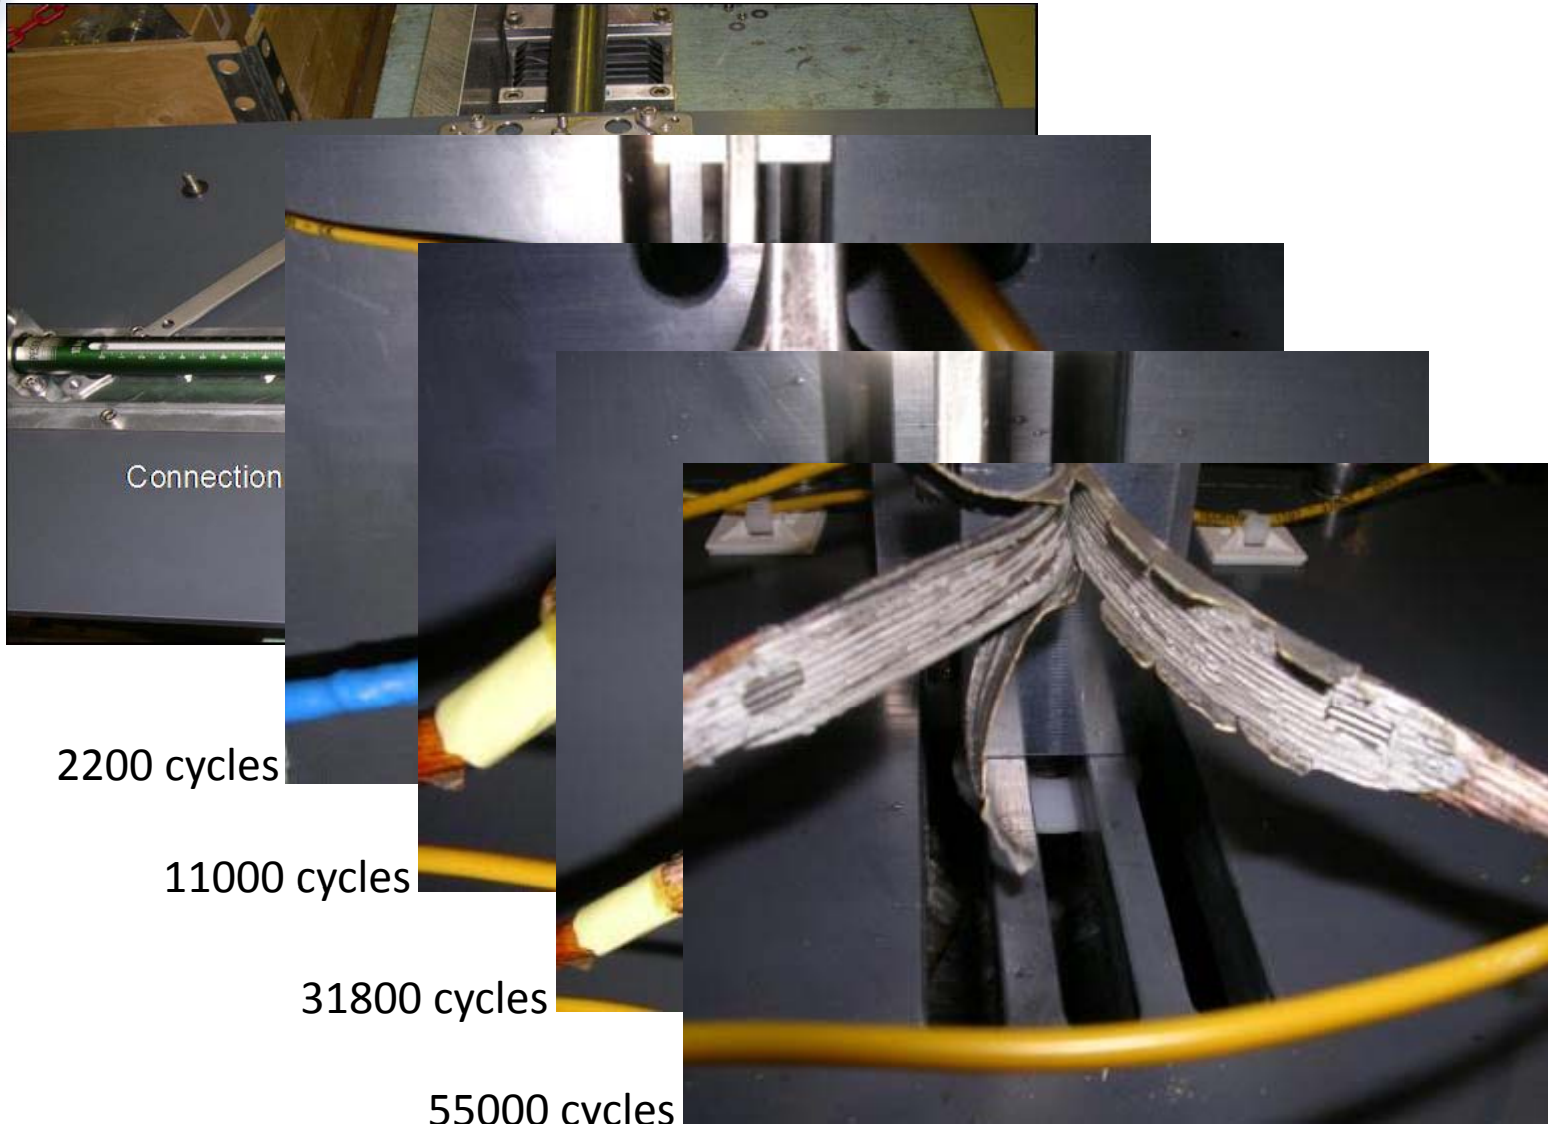
"PRAYING HANDS"

At the request of Karl Hubert Meß, a mechanical cycling test at room temperature was performed on a 6 kA “hand-prayer” type LHC electrical connection. A set-up was assembled to verify the reliability of the joint when subjected to thousands of mechanical cycles (see Fig.1). An electrical connection, supplied by the interconnection team, was tested in the configuration shown in Fig.1. A force of 88 N (as in EDMS procedure N. 533260) was applied at both ends of the connection. In total, 60000 cycles were performed. As visible in the following pictures, the degradation of the joint starts at 2200 cycle. At 11000 cycles the copper crimping box around the connection starts to open. At 30000 cycles the soldered joint is open along a length of about 50 %. At the end of the cycling tests, the joint is completely open.

The test configuration is more severe than the final configuration in the tunnel – the force is applied at a 90° angle. Conclusions should only be taken after comparing the results of these tests with those obtained after electrical cycling at nominal current and cryogenic temperatures.
