Issues faced during the XFEL mass production

Walid KAABI- LAL/CNRS

CERN, July 12th 2016

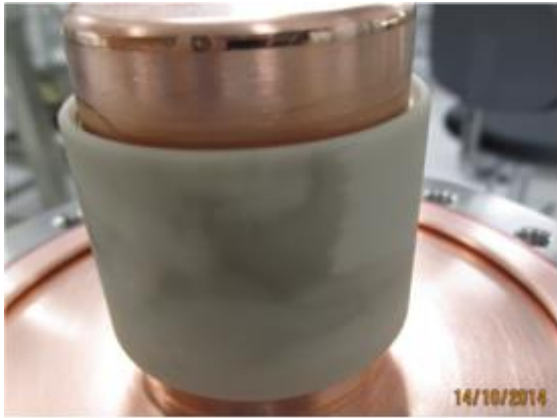
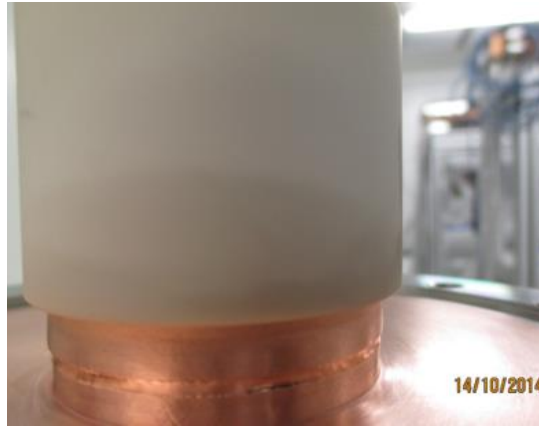
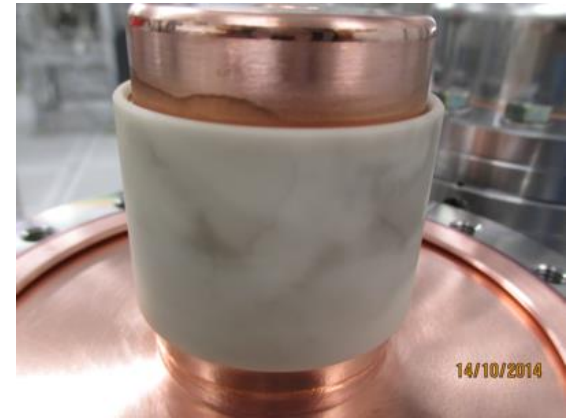
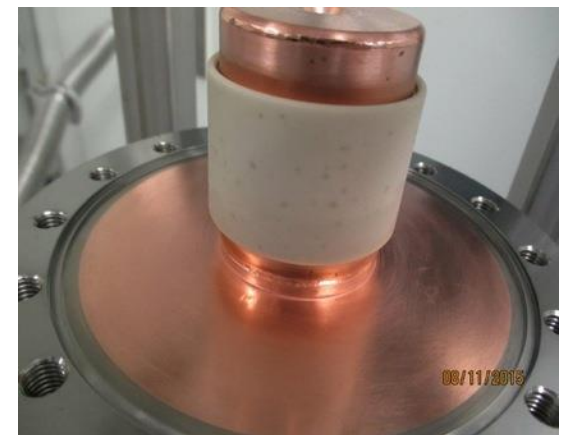
Main defect discovered during the final inspection: **Dark layer in cold ceramic window**

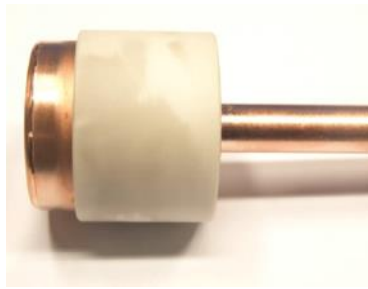
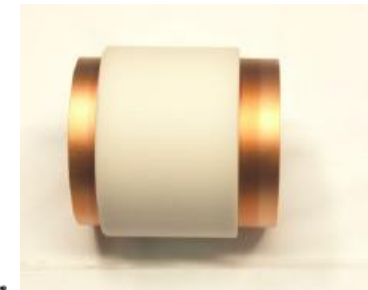
Figure 4: Details of the TOF-SIMS spectra of negative secondary ions

- In the spectra of sample 2 (not discolored) mass signals of **titanium**, **titanium oxides** and **silicon oxides** as well as mixed **silicon/titanium oxides** are distinctly observed (look at figures 4 and 5 on pages 8 and 9). Moreover **chlorine**, **higher fatty acids** (figure 5 on page 9) and the additive **4,4'-Bis(diethylamino)benzophenone** are detected with high signal intensities.
- In the spectra of both preparations **sodium**, **potassium**, **calcium** and **CN/CNO-** as well as **SO₂ anions** are identified with high signal intensities.
- Only in the spectra of the discolored sample 1 the lubricant **erucamide** (figure 5 on page 9) and **soot-like carbon anions** (C₂H⁻, figure 4 on page 8) as well as **alkylsulfates** (figure 5 on page 9) are clearly detected.

While in the spectra of the not discolored sample the ceramic material is distinctly observed, particularly erucamide and soot-like carbon anions are detected in the spectra of the discolored surface. The former compound can probably be attributed to the plastic wrapping of this sample (→ as-received condition). However the soot-like carbon anions (→ carbon black) can possibly be associated with the observed discoloration.

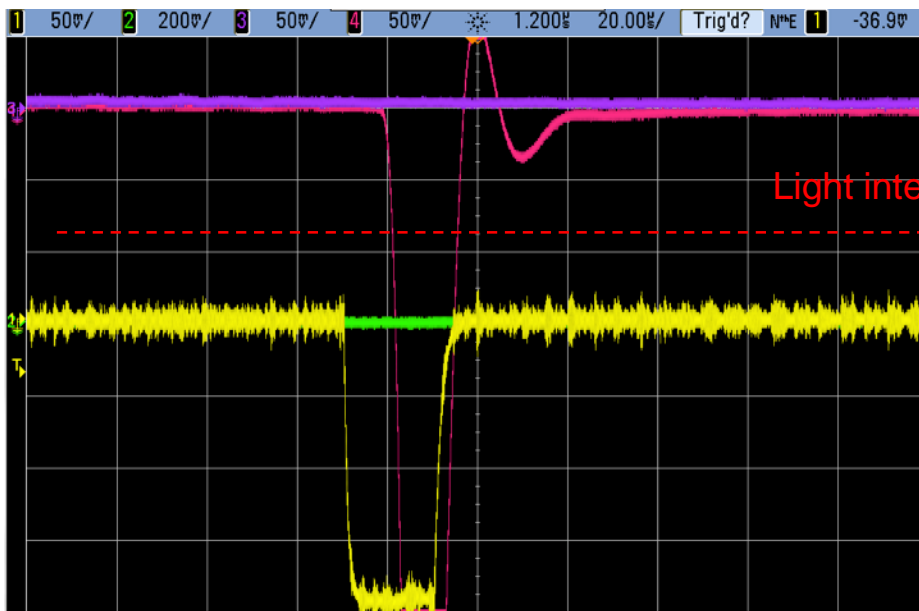
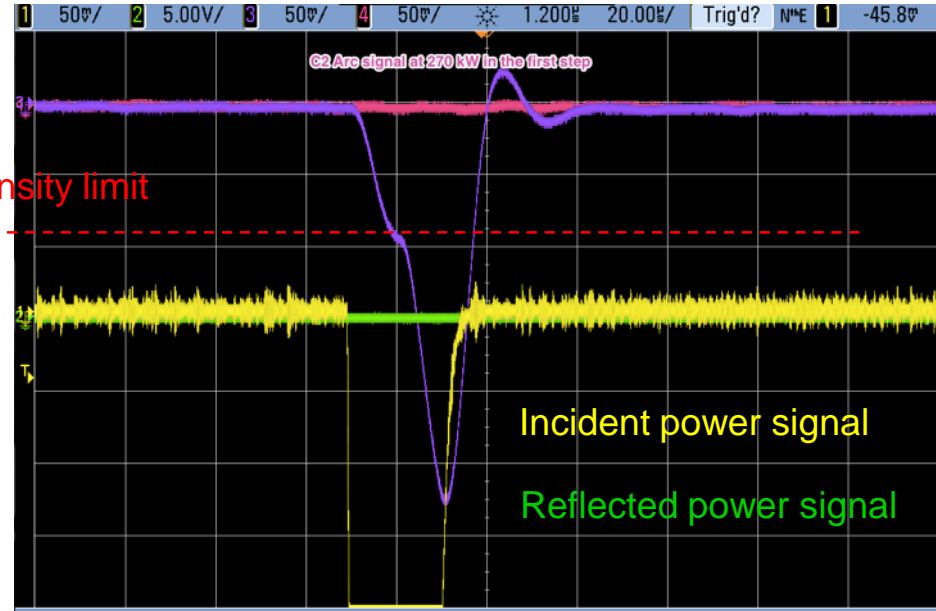
Sudden increase of the light intensity causing arc interlock: generally occurs at low power (under 250 W) at the shortest pulse (20us) → impossible to go further: the pair is removed from the test stand.

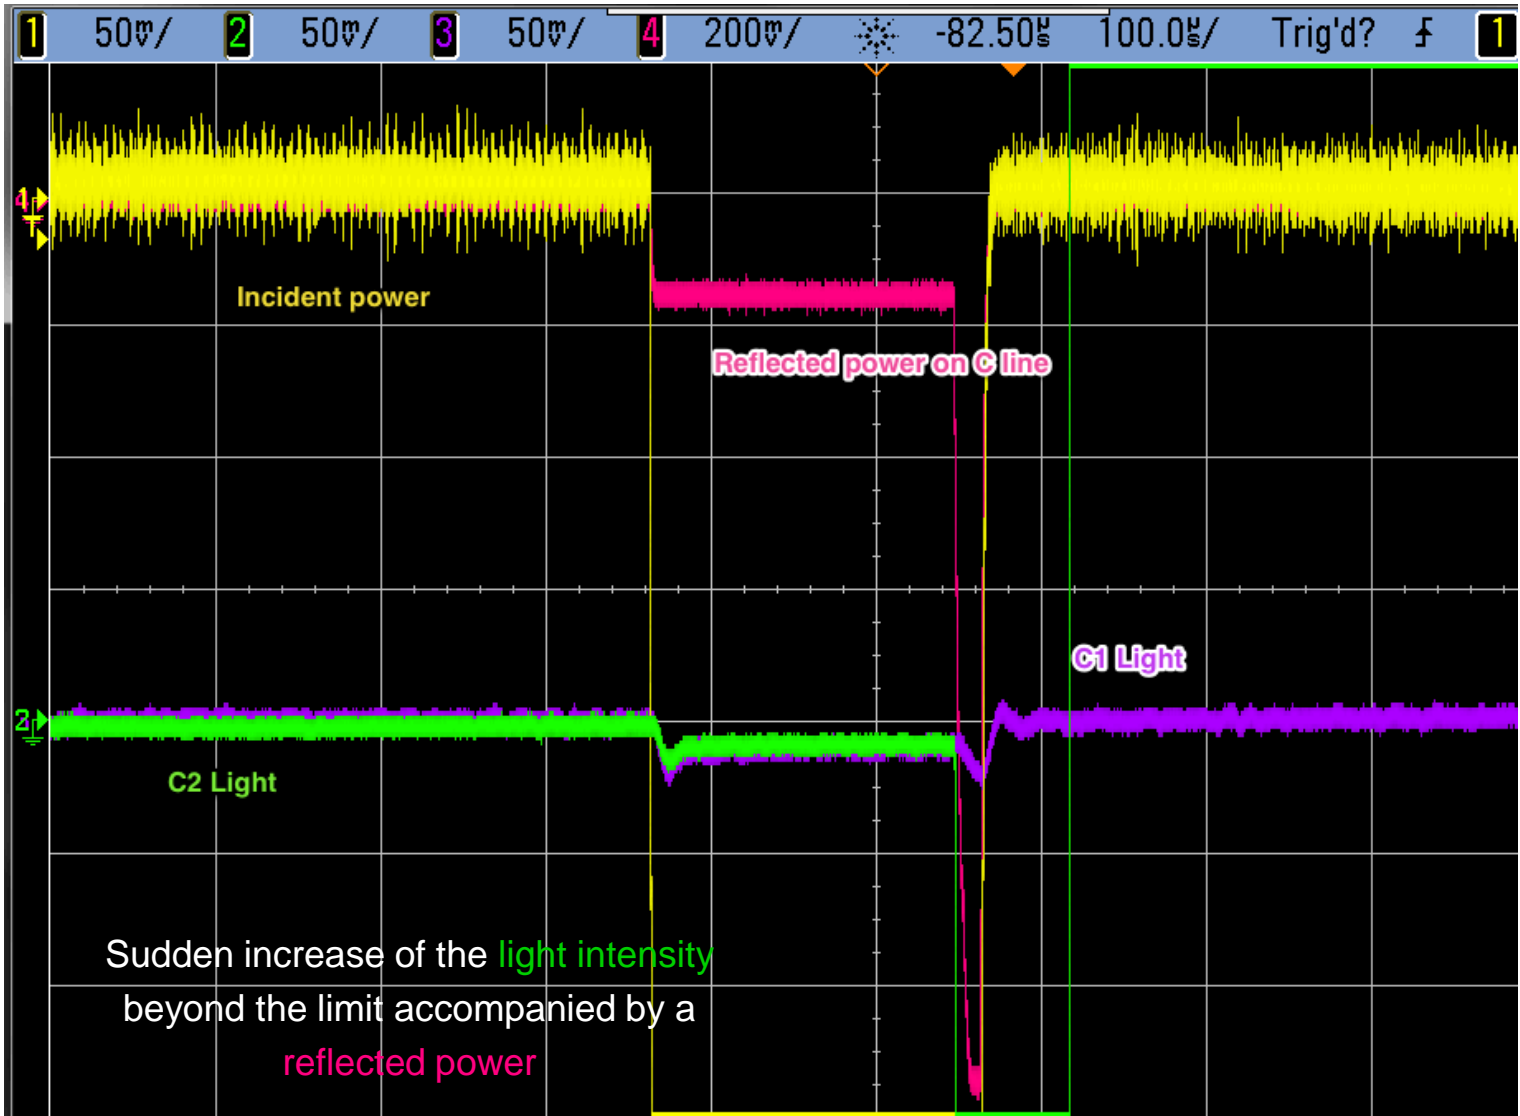
Sudden increase of the light intensity beyond the limit accompanied by a reflected power

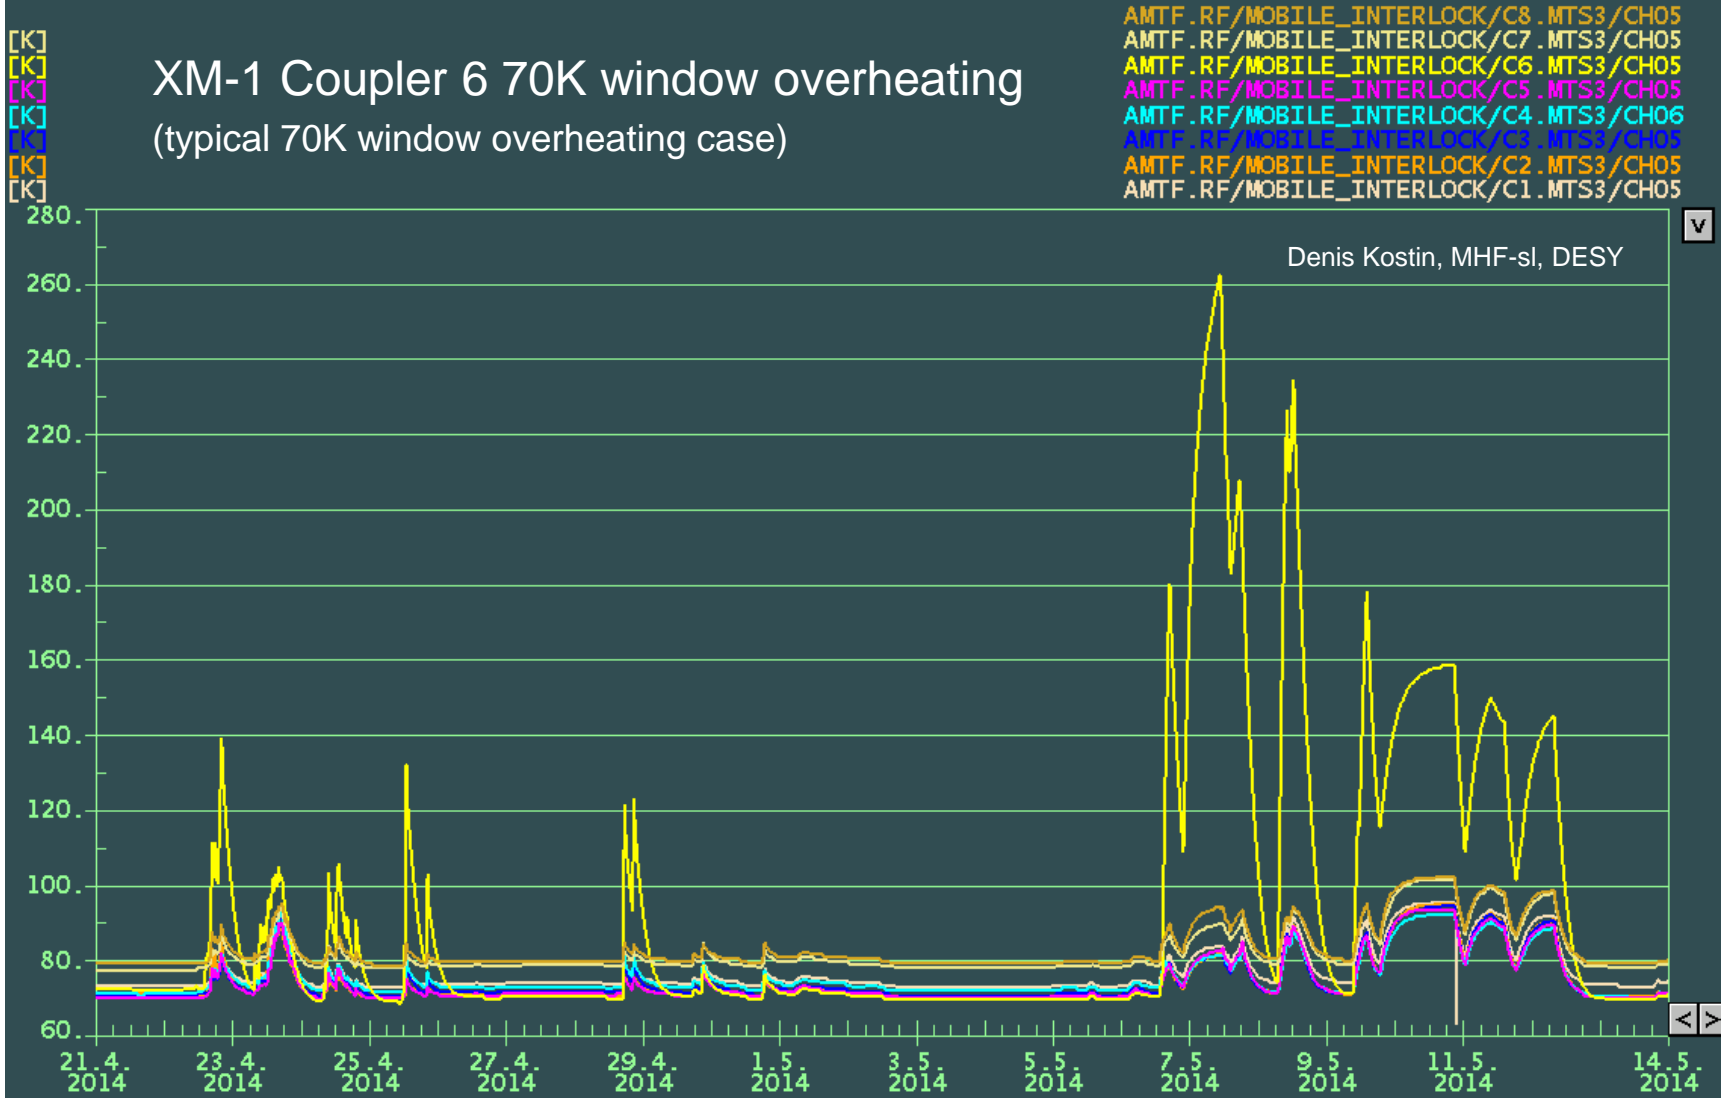
XM-1 Coupler 6 70K window overheating
(typical 70K window overheating case)

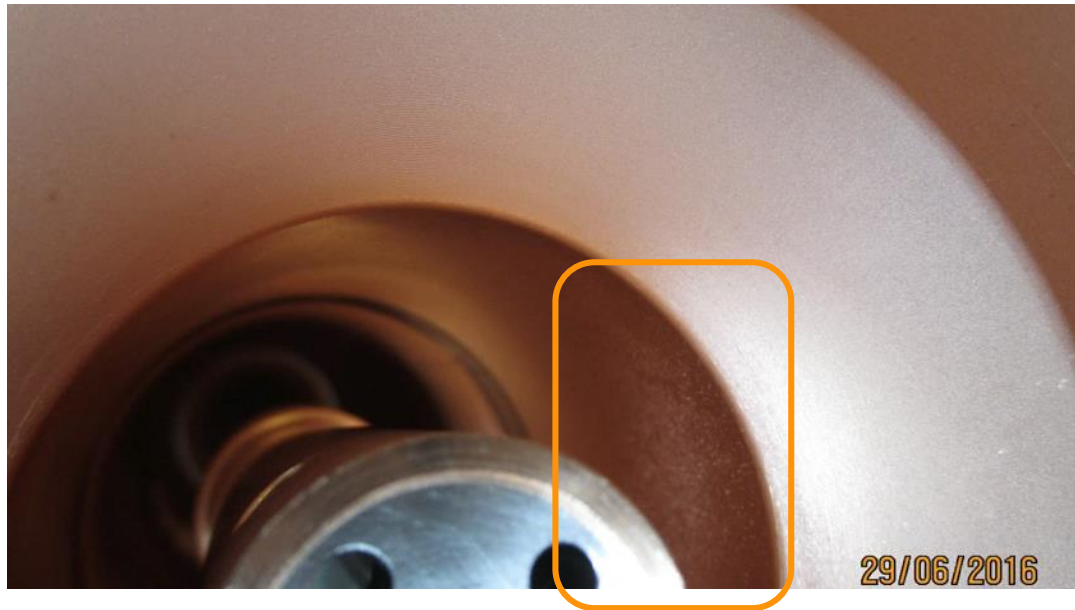
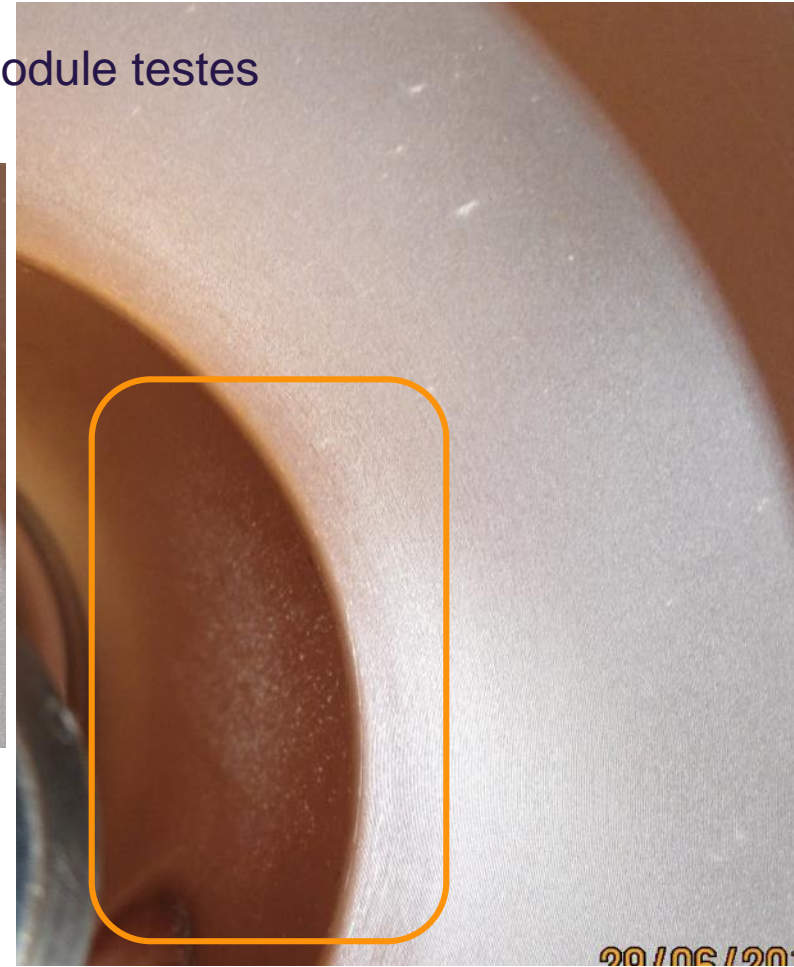
WPs inspection after observed Overheating in module testes

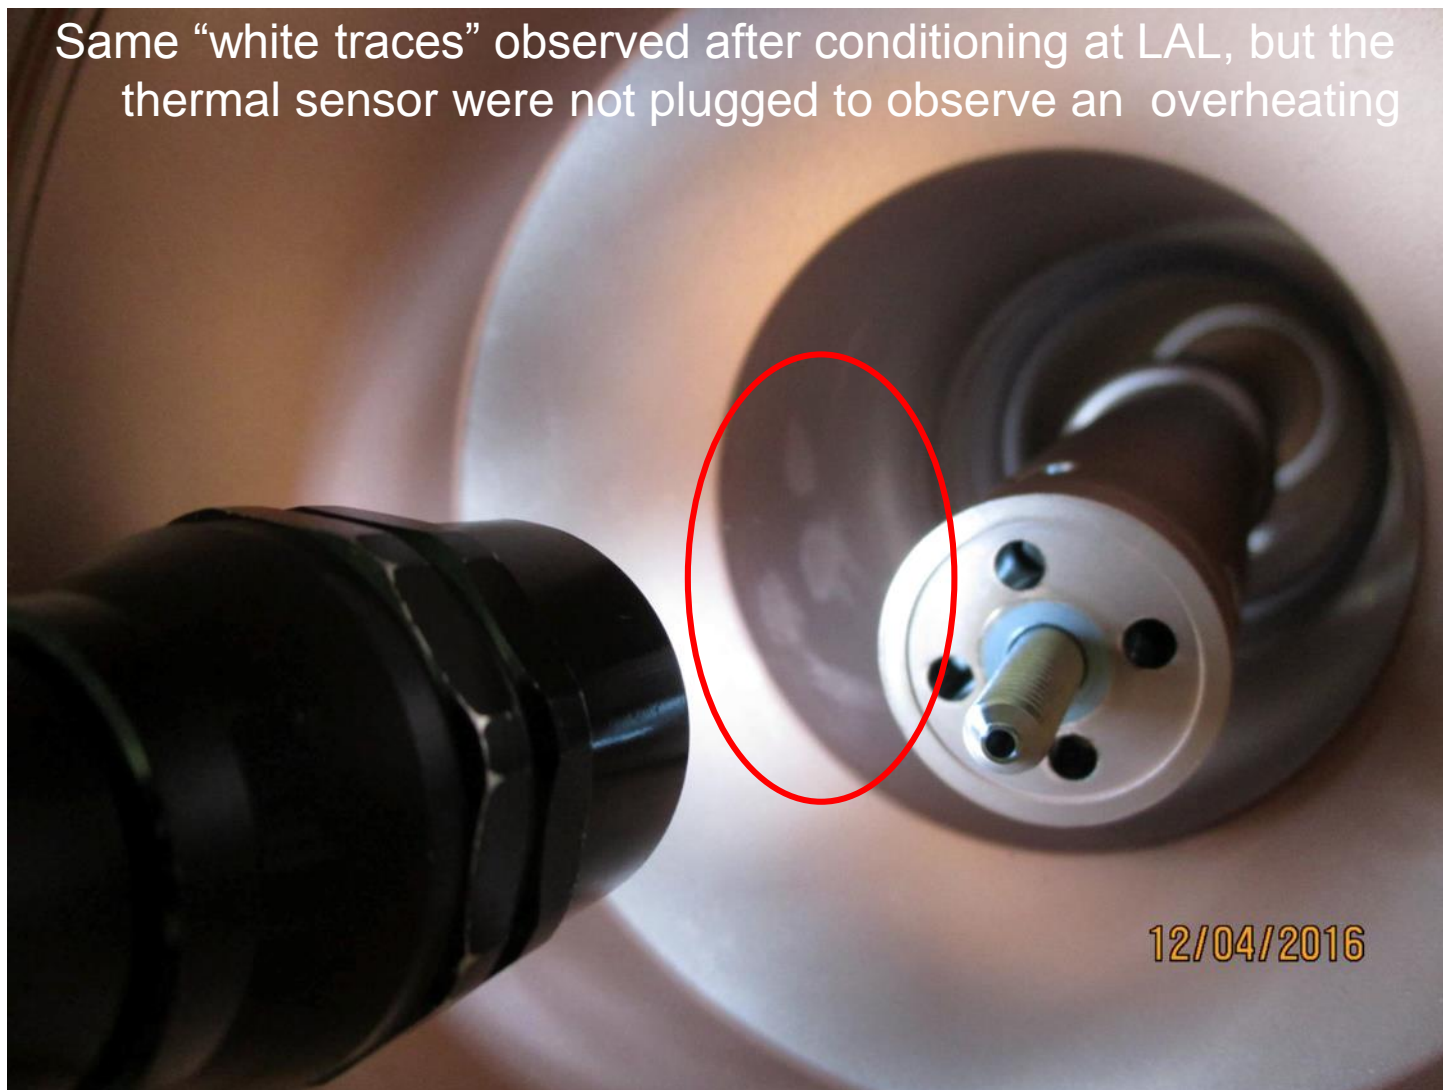
Same “white traces” observed after conditioning at LAL, but the thermal sensor were not plugged to observe an overheating

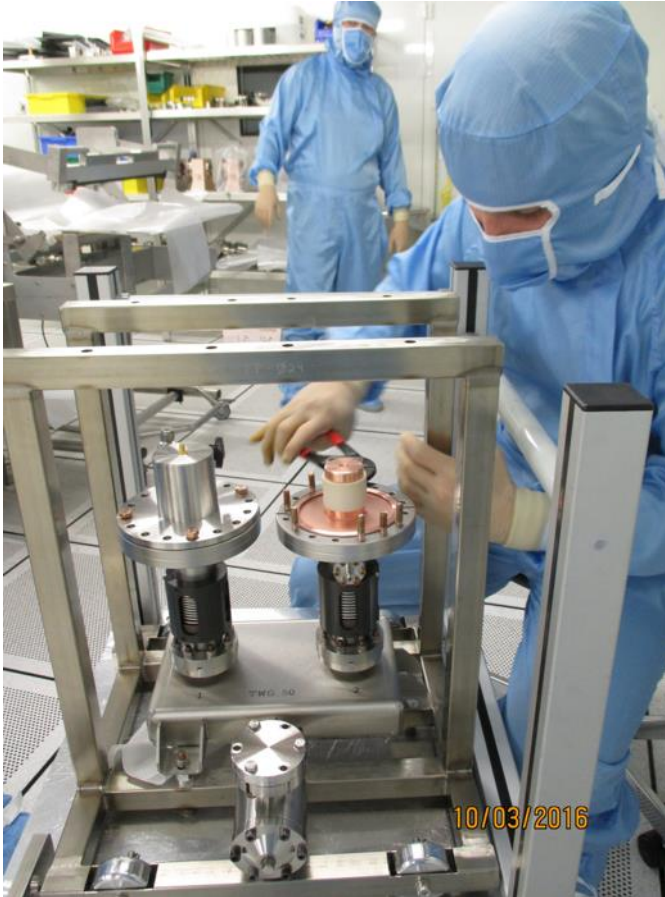
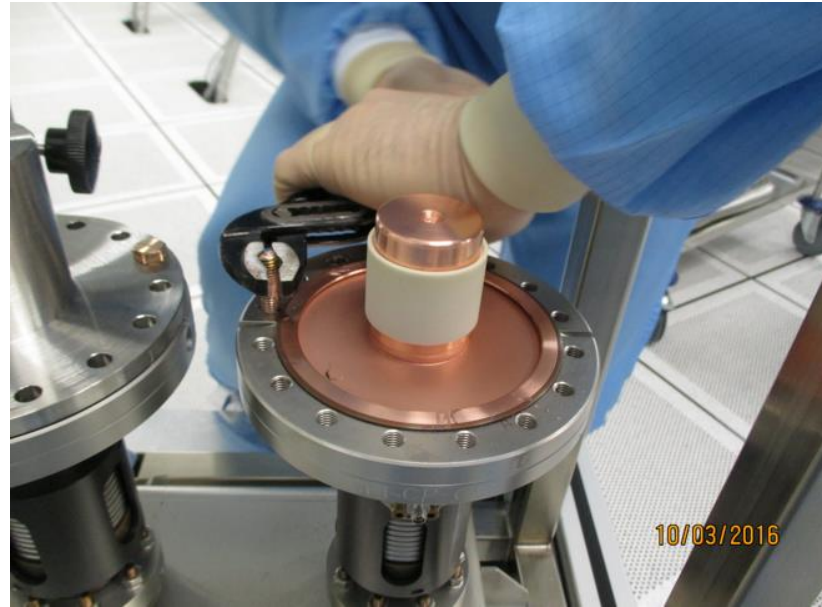
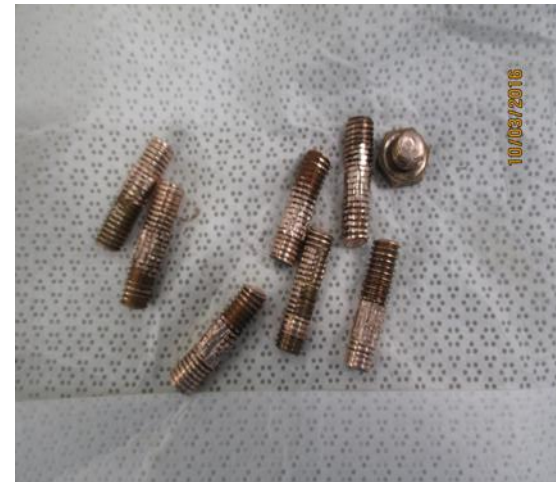
The 7 rods were then removed with a pliers, with the risk to heat the cold ceramic in case of bad handling, and to contaminate the parts with metallic particles.
