WWFP #2

E-XFEL Power Coupler status

July, 12-13, 2016

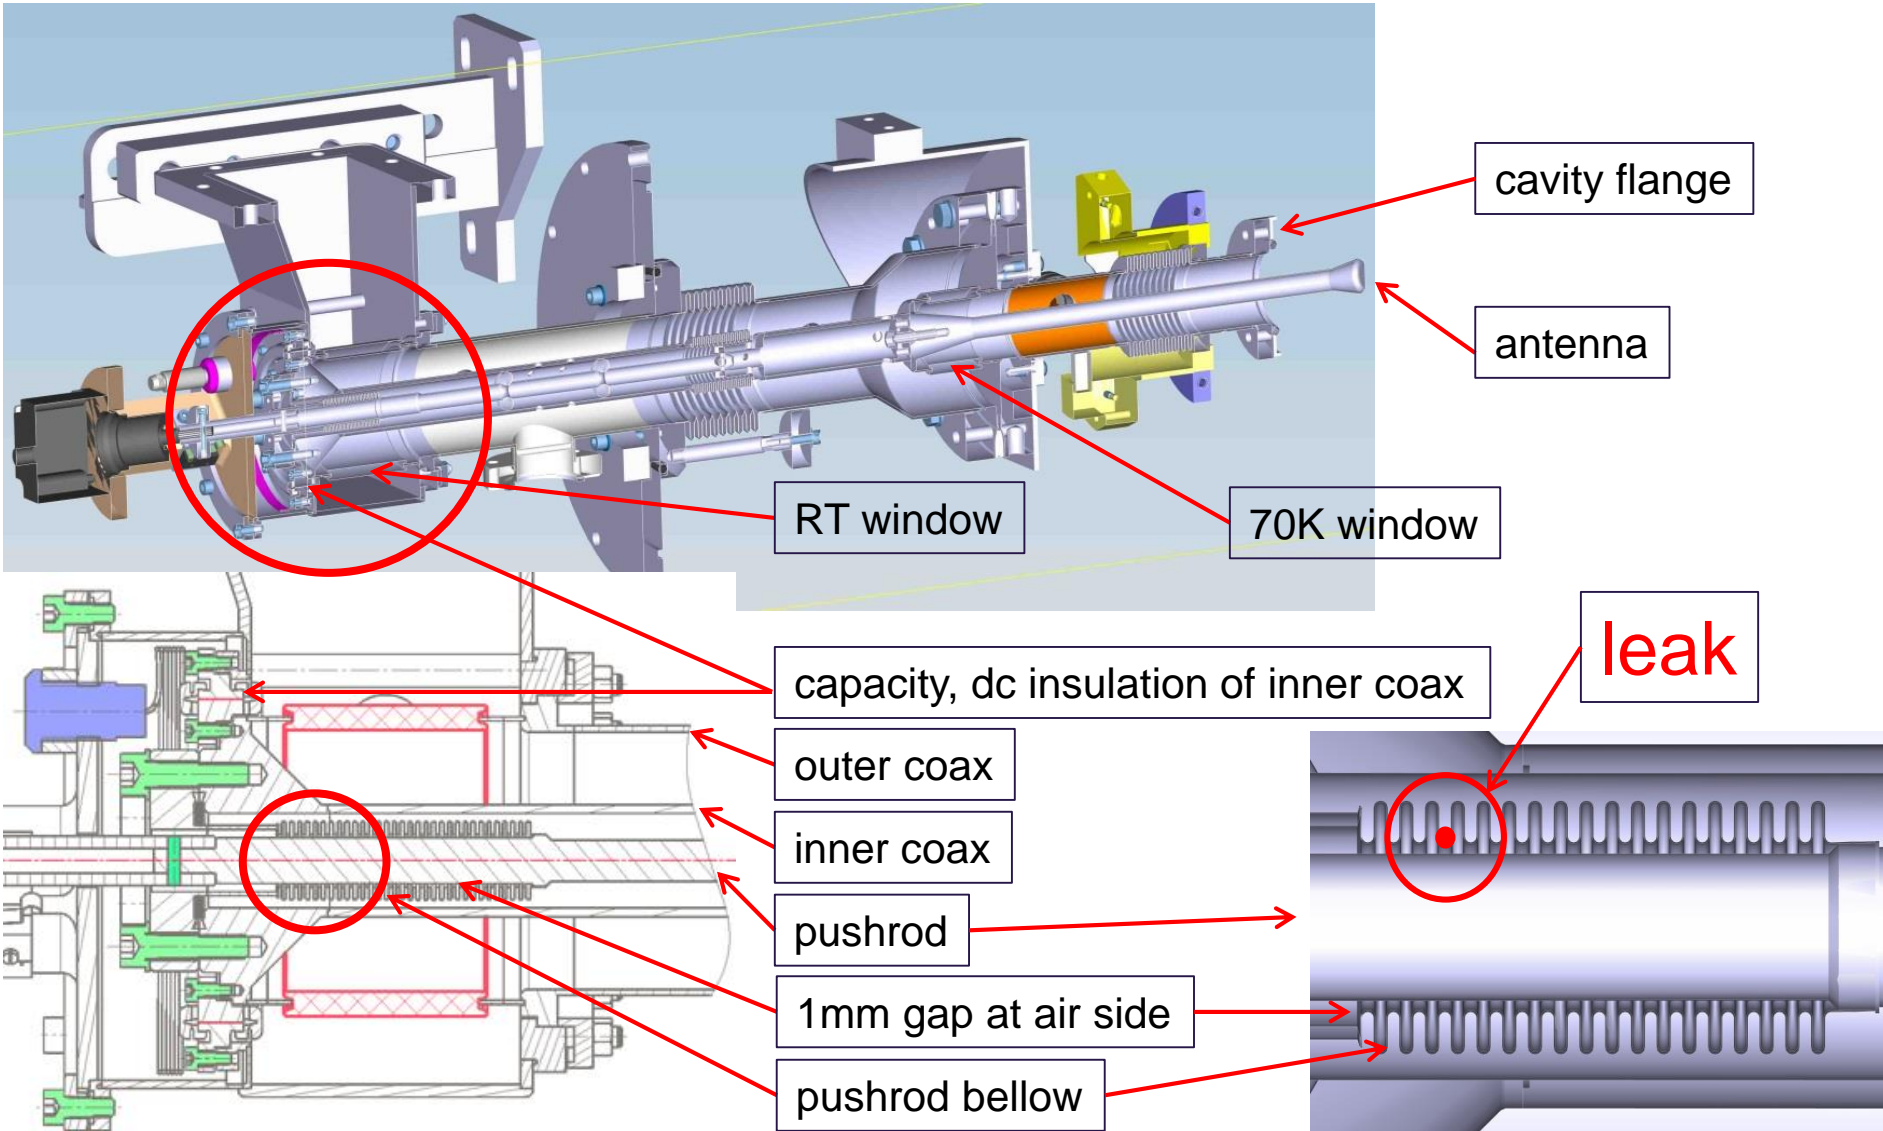
Pushrod leak, location

- 26 PR's developed a leak in bellow between coupler vacuum and air
- leak appears during RF conditioning of modules
- Leak appears always near 12th (± 3) convolution on inside valley

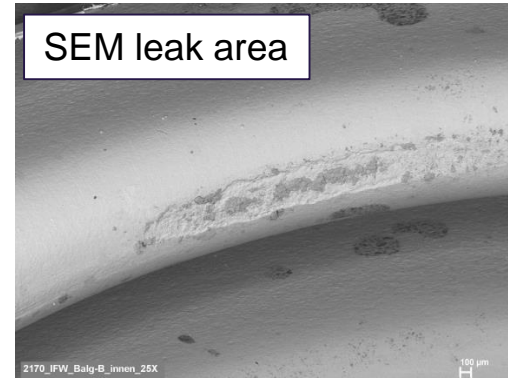
SEM leak area

- bellow supplier SKODOCK investigation result:
 - steel structure is locally changed by overheating, carbide precipitation on grain boundaries causes stress corrosion cracking
- RF simulations (DESY, SLAC):
 - RF leak of the capacity leads to 15V/m @ 1W
i.e. for 200kW full reflection: 6.5V/mm
 - The breakdown voltage in air is 3kV/mm
- **Sparking is only possible when the bellow is deformed and touches the inner rod.**

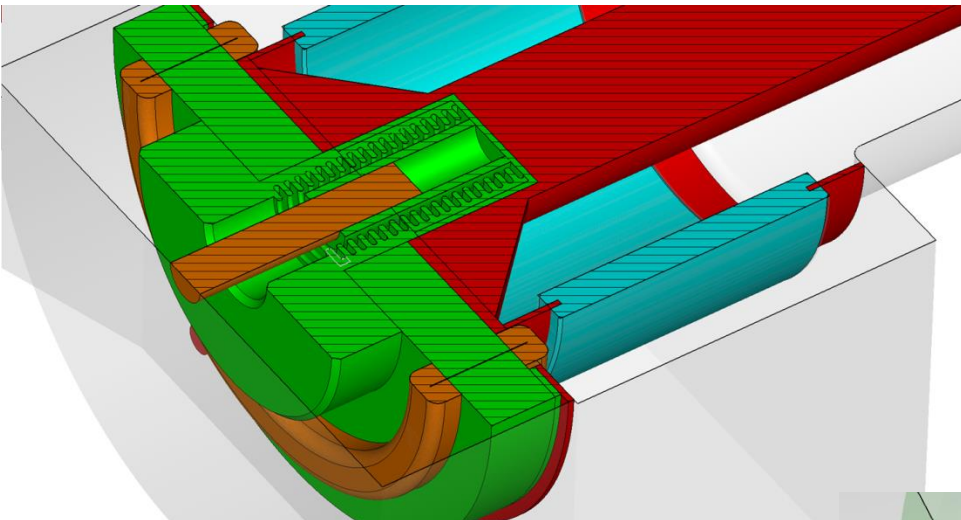
TTF3 coupler, short bellow, short PR, manual tuning

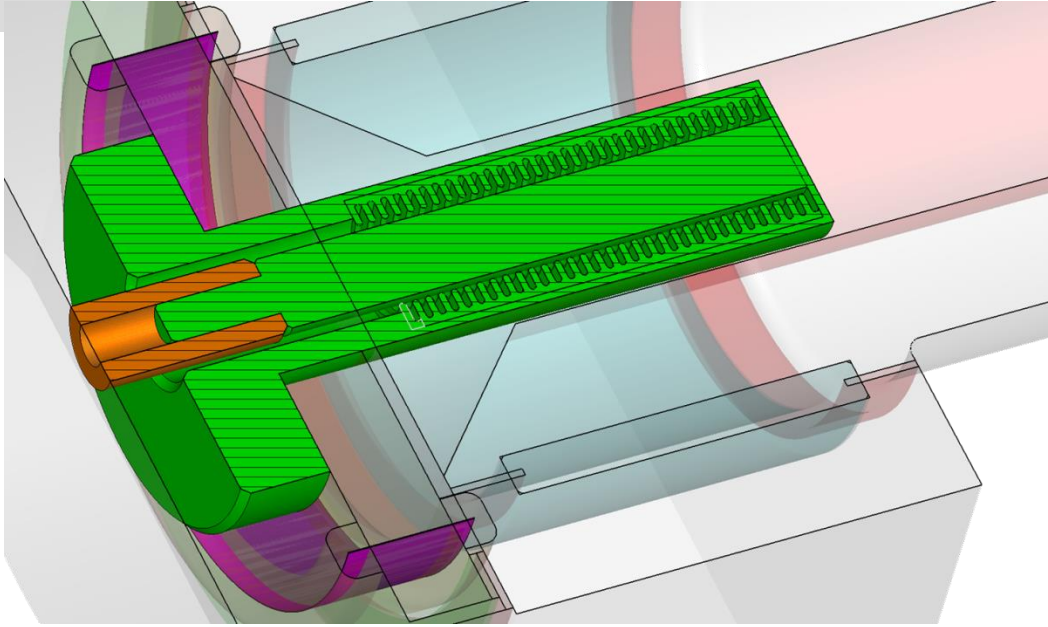
- >40 TTF power couplers in FLASH are operated since many years without any defects
- change for XFEL power couplers:
 - PR bellow is 26mm longer
 - PR geometry is changed

XFEL coupler, long bellow, longer PR, motor tuning
