Helium burst incident at the PROSCAN medical cyclotron facility

Peter Hottinger, Markus Kostezzer, PSI, Villigen, Switzerland

On the maintenance weekend in October 2016 a severe incident happened that caused an interruption of several days. The cryostat warmed up suddenly and the evaporating liquid Helium bursts out of the He tank. The poster will describe the sequence of events and presents the measures taken to prevent a similar event from happening again.

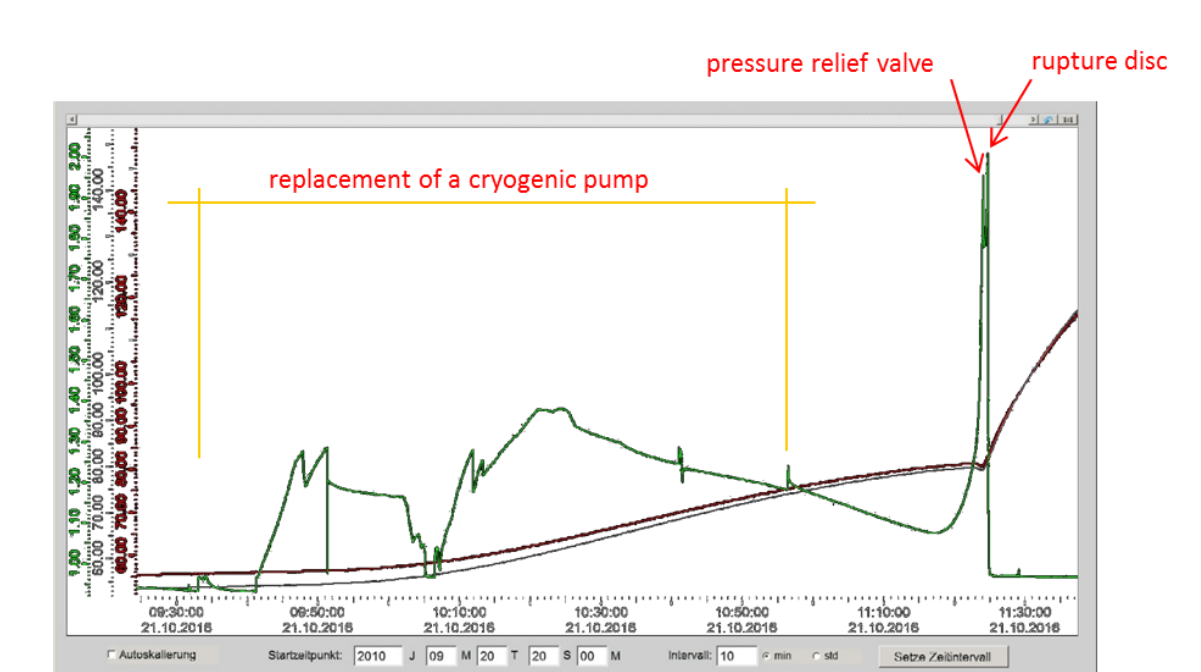
Pressure and temperature curve

the pressure is again normalized to 1.04 bar after the work by the cryogenic pumps and is kept constant (controlled) with a counter-heating. A short time later at around 11:16 o'clock a sudden pressure increase in the supply tank (L He) occurred. The pressure increase in the supply cryostat (L He), which resulted in the burst breakage, lead to a large volume of liquid helium to be spilled. An immediate repair had to be planned in order to minimize the disruption to patients.

- green: he pressure in the supply cryostat
- red: temperature 80 K shield near to the supply cryostat, (shield 1)
- gray: temperature 80 K shield far to the supply cryostat, (shield 2)

At about 1.95 bar, the pressure relief valve was released for the first time to lower the pressure, but this was not enough due to the rapid rise, which led to the breaking of the bursting disc.

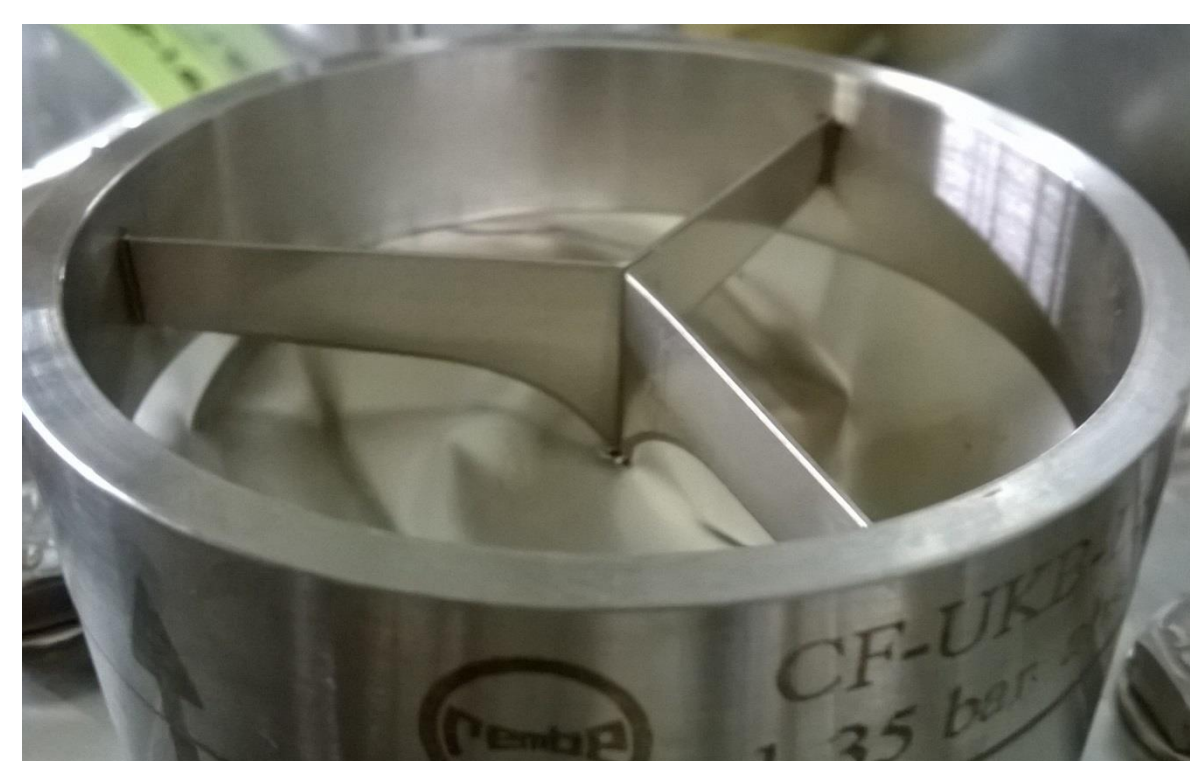
The bursting disc with a small hole in the centre

A first inspection revealed that all cryogenic pumps (cold heads and the two shield coolers) were in operation and functioning. In order to stop the liquid helium loss, the bursting disc was replaced immediately, but leading to a pressure increase in the support cryostat. The excess pressure was manually released. Although the pressure increase remained within the safety limits, the thin film was still damaged and a small hole was created. Further investigations showed a bad isolating vacuum and the ion getter pump was taken out of service. It took about 3 days to order a replacement for this burst disc to the supplier. After the incident the ion getter pump was replaced by the turbo pump. The liquid helium had to be refilled to a certain limit, this took 1-2 days and the damaged bursting disc was replaced. Patient operation could be resumed after 4 days.

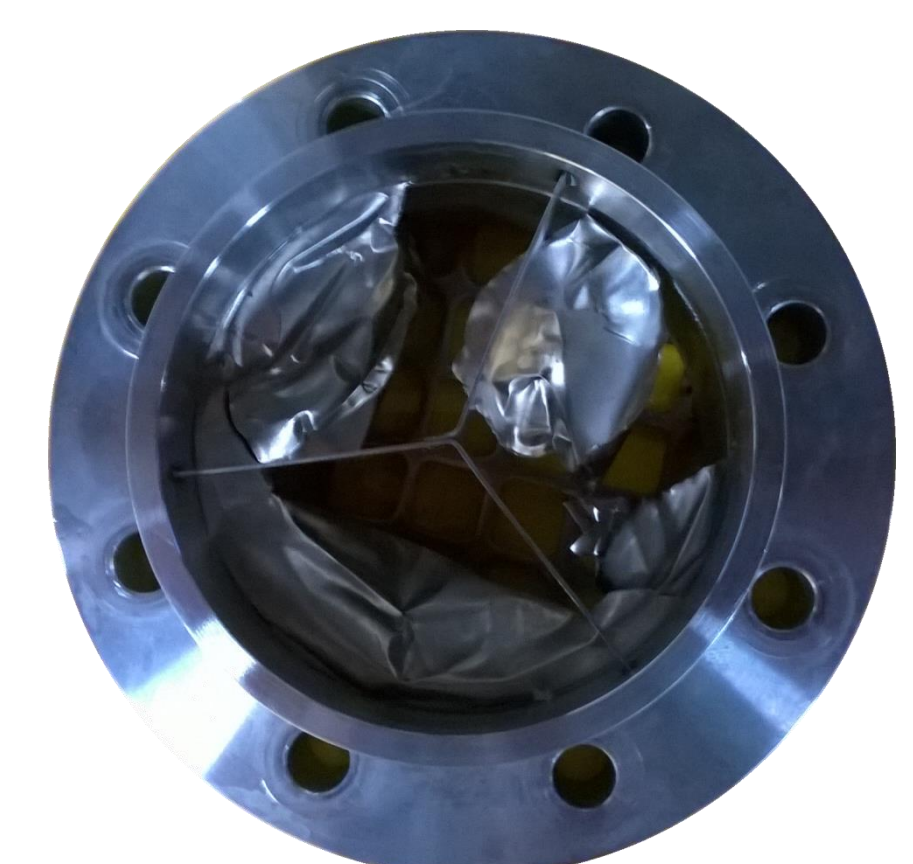
The broken burst disc after crash. The cryostat warmed up suddenly and the evaporating liquid Helium bursts out of the He tank.

In a scheduled shutdown in 2017 of about 8 weeks, some maintenance work had to be carried out in order to prevent and minimize risk. For this purpose, the cryogenic system was completely regenerated and defrosted to clean the isolation vacuum. In the warm state, new vacuum valves were installed, all seals were replaced and additionally a turbo pump was installed for future maintenance and replacement of the cold heads. The turbo pump, which replaced the ion getter pump in 2016, actively pumps at the isolation vacuum. This is to prevent the isolation vacuum from filling up with diffuse gases in liquid or solid form over time. In addition, the turbo pump is to be used to stabilize the pressure in the system.
