rMPP meeting 16/08/2016

Intensity Checklist July

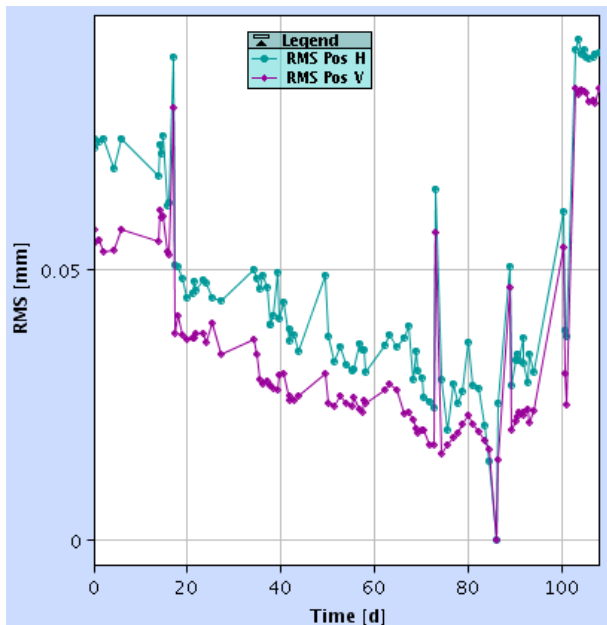
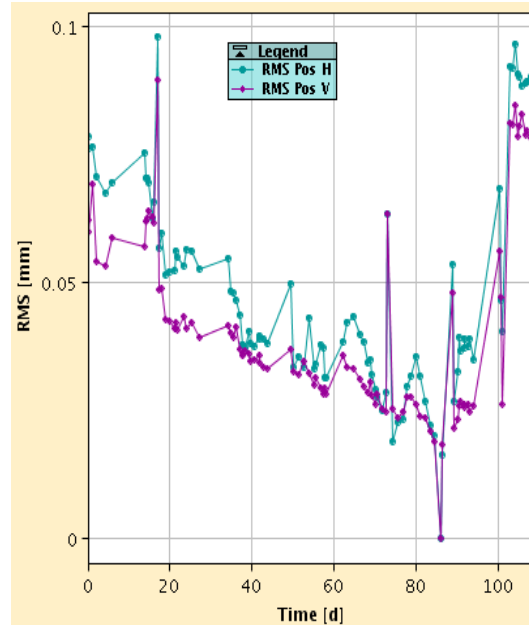
The jump just after day ~100 affects both beams & planes, and carries the signature of incorrect BPM calibration (for example). But the origin is not understood yet.
