The real "life" of operation

V. Baglin CERN TE-VSC, Geneva

Vacuum, Surfaces & Coatings Group Technology Department

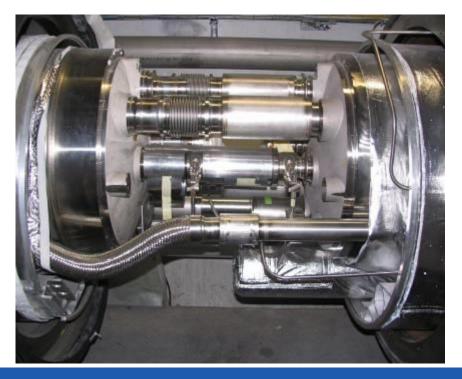
The Sector 3-4 incident (just before the 1st ramp)

19th September 2008 at 11:18.36 last test of the last sector: 7kA (4TeV) towards 9.3 kA (5TeV) Electrical arc at 8.7 kA in the interconnection Rupture of bellows, expansion of liquid Helium with superinsulation debris

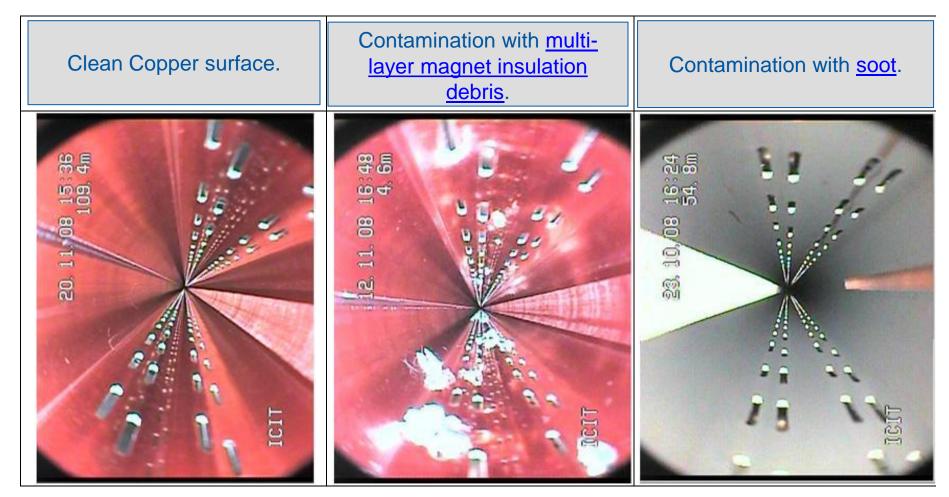
Impact on beam tube ...

• 2x 2.8 km damaged

\approx 60% of the chambers

$\approx 20\%$ of the chambers

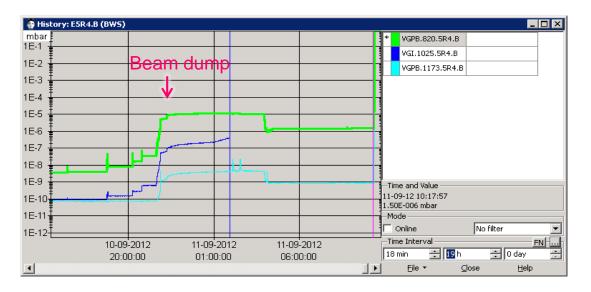
LHC: 1st Leak triggering a beam dump

• During operation, the bellow of a wire scanner broke, creating a leak

• The total amount of bellow's cycle was not recorded since the start of LHC and overpassed by far the acceptable limit ;-)

Varnished was applied without success

• The emergency procedure which consist in Ne venting allowed to replace the faulty component and resume beam operation after 2 days

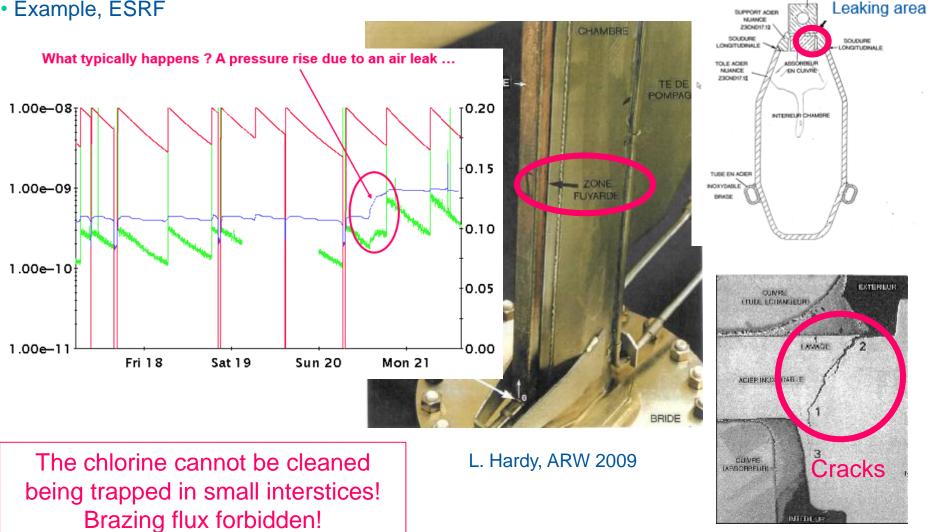
Brazing flux containing chlorine leads to corrosion.
Example, ESRF

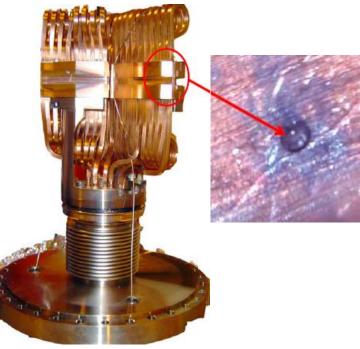
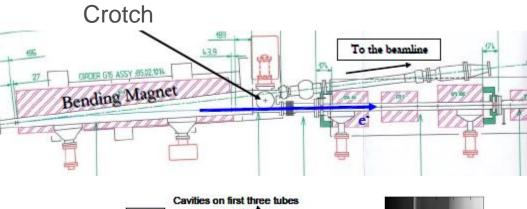
Water leak in cooled devices

- The crotch is a photon absorber (~ kw), used in SR machines. It need to be water cooled ...
- Example ESRF crotch, March 2005
- Water leak:
 - 50 m vented
 - water inside the vacuum system!
 - 5 days lost

Origin: de-ionised water+ Copper + radiations

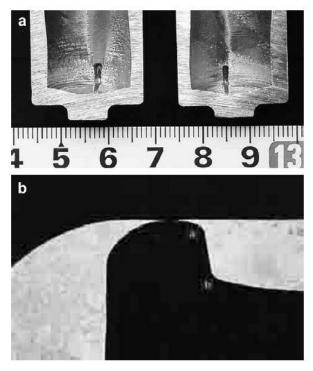
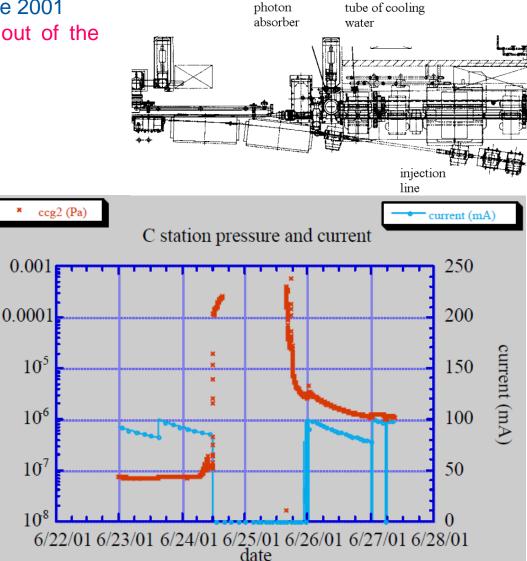
Fig. 5. Photographs of the cross section of the photon absorber removed from the RF cavity (a) and the cross section of the eroded part (b). Corrosion was found only inside the water pipe where the synchrotron radiation hits.

Example Spring 8 photon absorber, June 2001
 New design with cooling tube out of the SR fan

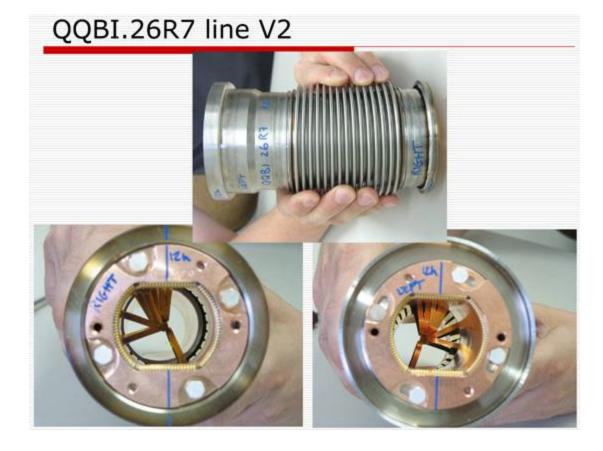
August 2007

- After warm-up of sector 7-8
 - A buckled PIM was discovered in interconnect QQBI.26.R7
 - Was really found by chance!

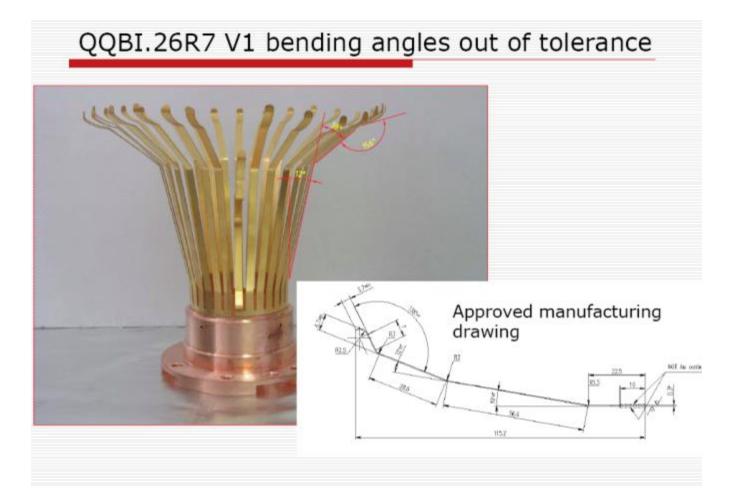
Why buckling ?

- Non conformity during manufacturing
- Not properly documented => Lesson: respect of Quality Assurance is a MUST

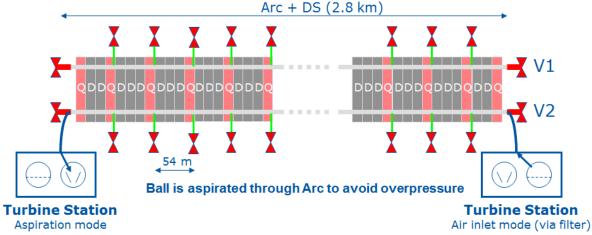
The consequence: RF ball emitter

- Identification of critical PIM :
 - Repair / consolidation when possible
 - ~ 1 mm longitudinal shift of quadrupole to gain margin
- Maintain arc below 130 K during stand-by period
- Recurrent observation after each warm up of arc with:
 - RF ball
 - Tomography
 - Endoscopes

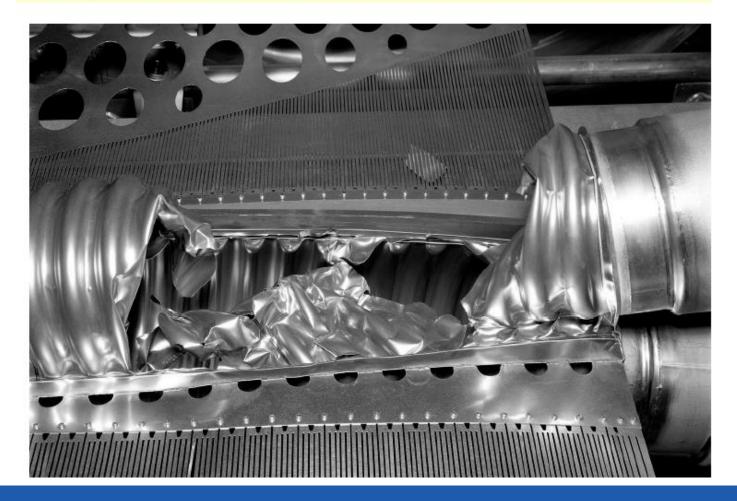
Imploded Thin Walled Vacuum Chamber

• CERN ISR vacuum chamber located at the interaction point

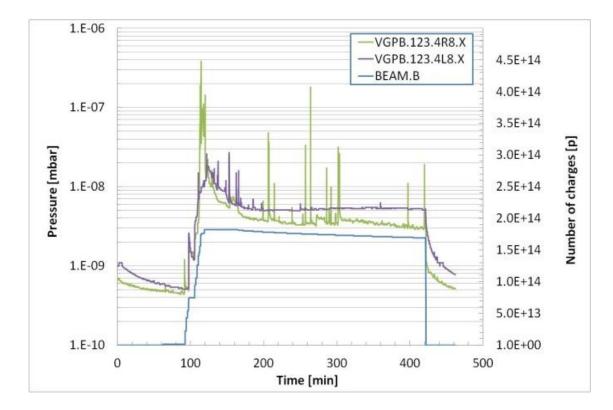
Observed Pressure spikes during a physics fill

- Design extrapolated and not mechanically validated before installation in the ring
- Pressure spikes located beside inner triplets generated interlocks and background

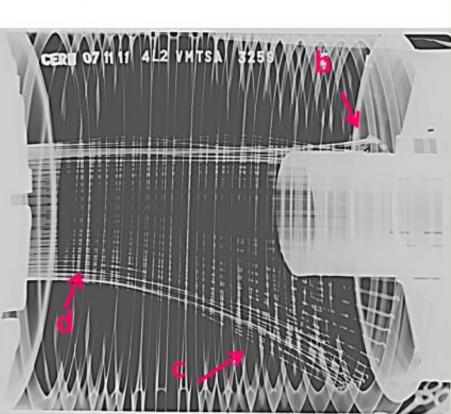
Typical default, DCUM 3259.3524

- X-rays done in May showed a conform module, in November the module was broken
- The RF bridge was destroyed by the beam !
- 8 out of a total of 20 in LHC were damaged i.e. 40 %

b) Metallic noise due to loose spring when hitting vacuum chamber

c) RF fingers falling due to broken spring

d) aperture reduced ?

Non Conform

Spring was broken between May and November 2011

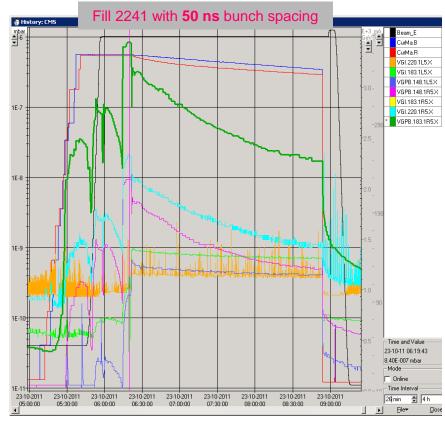
Typical Observation

• In 2011, frequent pressure spikes, some up to 10⁻⁶ mbar, were observed at CMS, 18 m, right side.

• When the local pressure was above 10⁻⁸ mbar, CMS background was larger than 100 % thereby reducing the detector capability

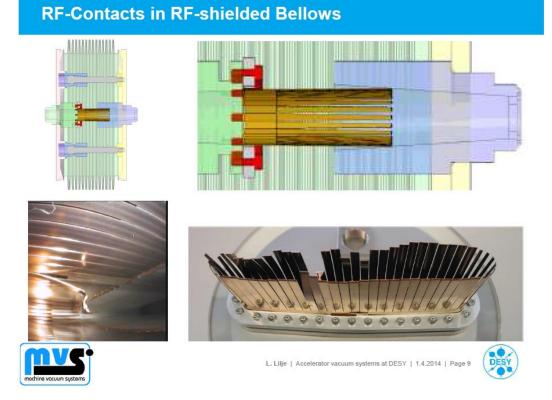
RF bridge: PETRA III

- PETRA III RF contact are placed inside the transition tube when the bellow are overextended
 - => beam intensity limited in 40 bunch modes to 80 mA till 2012 (design 100 mA)
- Define specification
- Check at surface mechanical and electrical specification

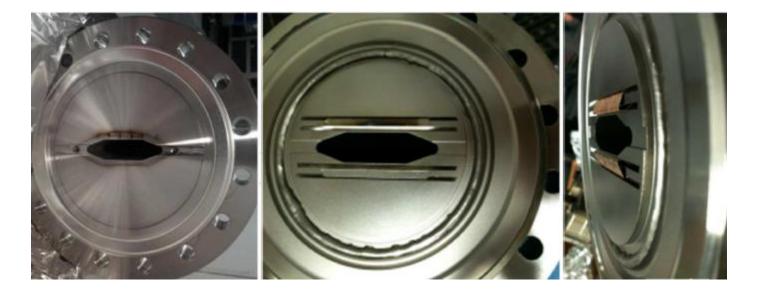
RF Contact: SOLEIL

Misplaced RF contact are producing arcing

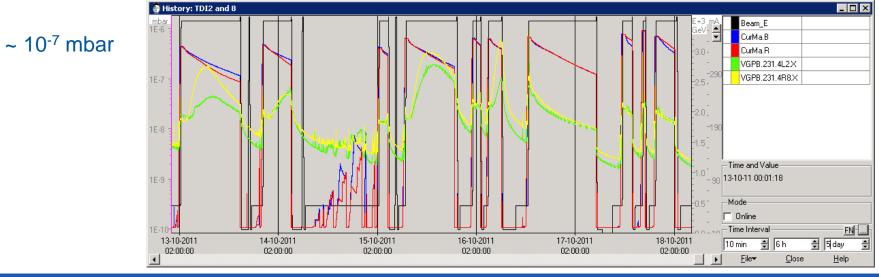
- A movable mask to protect ALICE during injection (Boron nitride jaw)
- Deformed beam screen observed during winter technical stop 2011-12
 - Suspected origin is a bad sliding point
 - Cu beam screen was deformed during bakeout at 300 deg

Beam induced, via impedance, thermal outgassing

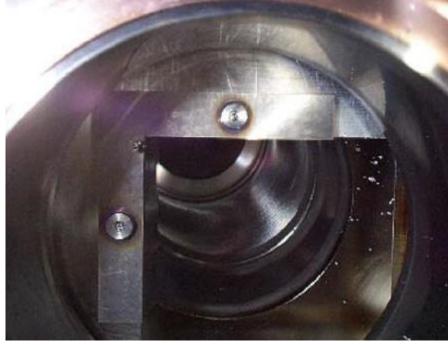
5 mm hole in a vertical W jaw

A roman pot moved into the beam

\bullet The beam moved by 0.005 mm/turn and touched a collimator jaw surface after \sim 300 turns

→ the entire beam was lost, mostly at the collimator

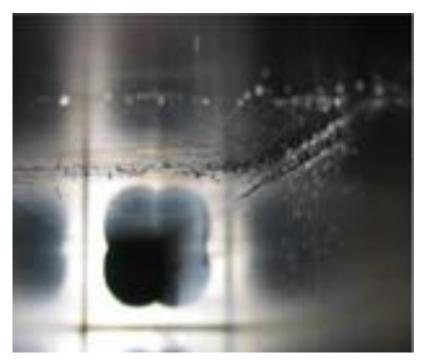
25 cm groove in stainless steel

→ the particle showers quenched 16 superconducting magnets

- · Beam loss monitor where switched off!
- 10 days repair

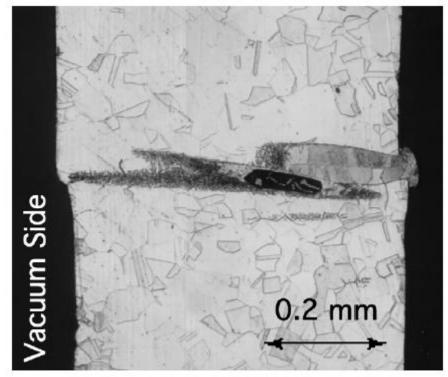
• 8 GeV electron beam with 15 micron vertical beam size on a 0.7 mm thick stainless steel wall

Fig. 6. Cross section of the injection chamber wall at the broken part. It seems that the electron beam hits the thin wall several times, since many traces of electron beam bombardment were found.

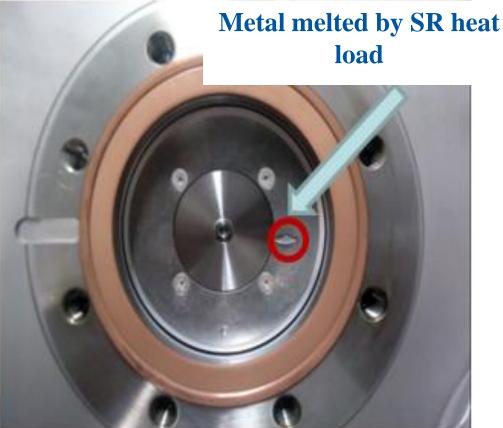
• Example of melted gate valve at SSRF, Shangai:

• The photon shutter was opened while the gate valve was closed, the synchrotron radiation produced by 3.5 GeV electron beam at 200 mA melted the stainless steel.

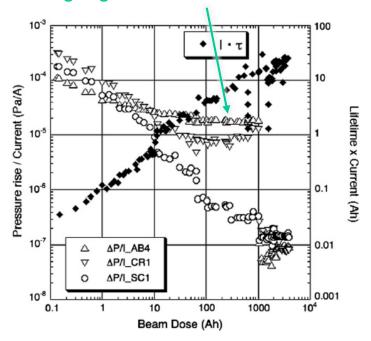
Photons produce photoelectrons, stray particles can ionised the cable or magnetic field can modified significantly the reading of pressure

The apparent absence of beam conditioning is due to scattered particles on the gauge collector and cable

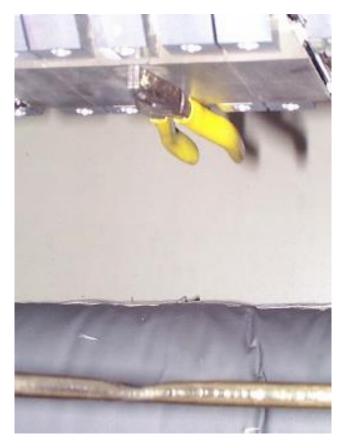
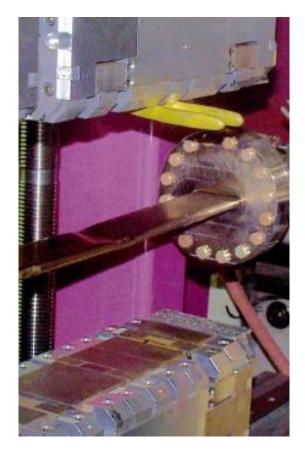
Someone forgot a tool on an undulator: The imprint of it is visible on the Al vacuum chamber!
