MKI ERRATIC 02/09/16

M.J. Barnes, W. Bartmann, E. Carlier, A. Lechner

MPP, 16th September, 2016

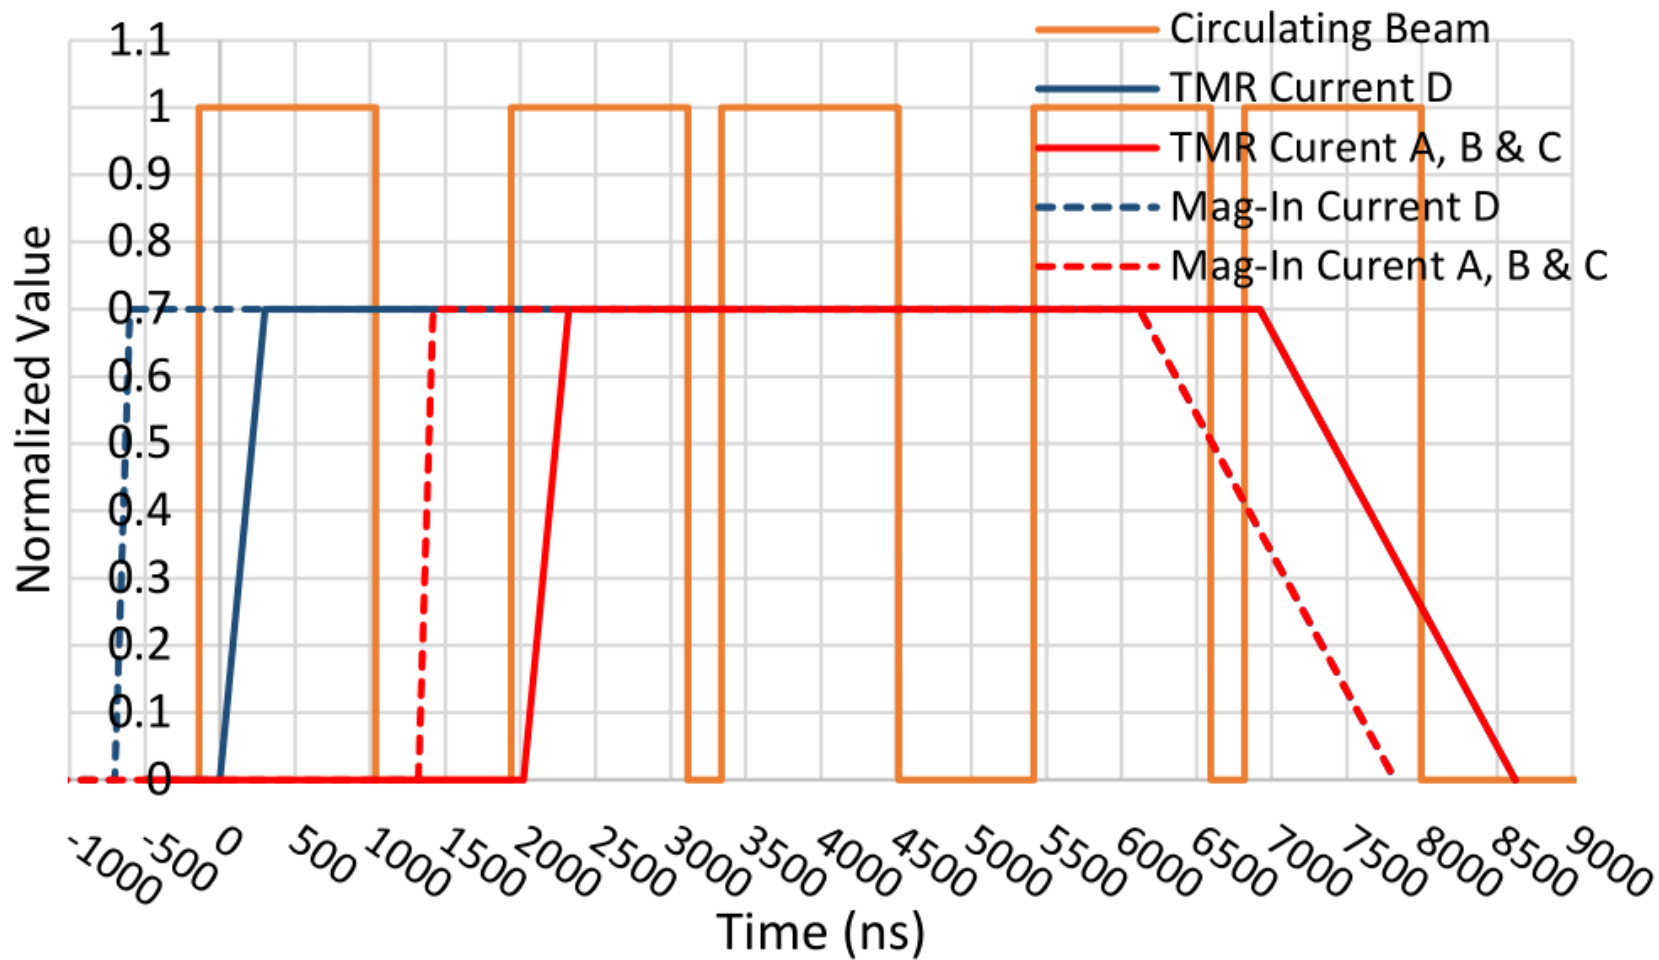
MKI currents wrt beam

- 02/09/2016 at 04:44:36
- 876 circulating bunches
- Erratic on the main switch of MKI2D at 35 kV PFN voltage
- The other three main switches were turned on within 1.9 - 2 us
 - Current in magnet C rises 90 ns after current in A and B – no compensation for e.g. turn-on delay when retriggering
- Controls turned on the MKI2D dump switch (and also the other units) within ~2 us of MKI2D erratic
- 18% of nominal kick for about 2 us – half a batch of circulating beam grazing on lower TDI jaw;
- Then 3.5 batches with high TDI impact parameter (70% of MKI kick)
- A few bunches again grazing during the fall time
- Q2 at the onset of a quench; no quench of D1 and Q3
- Vacuum valves closed

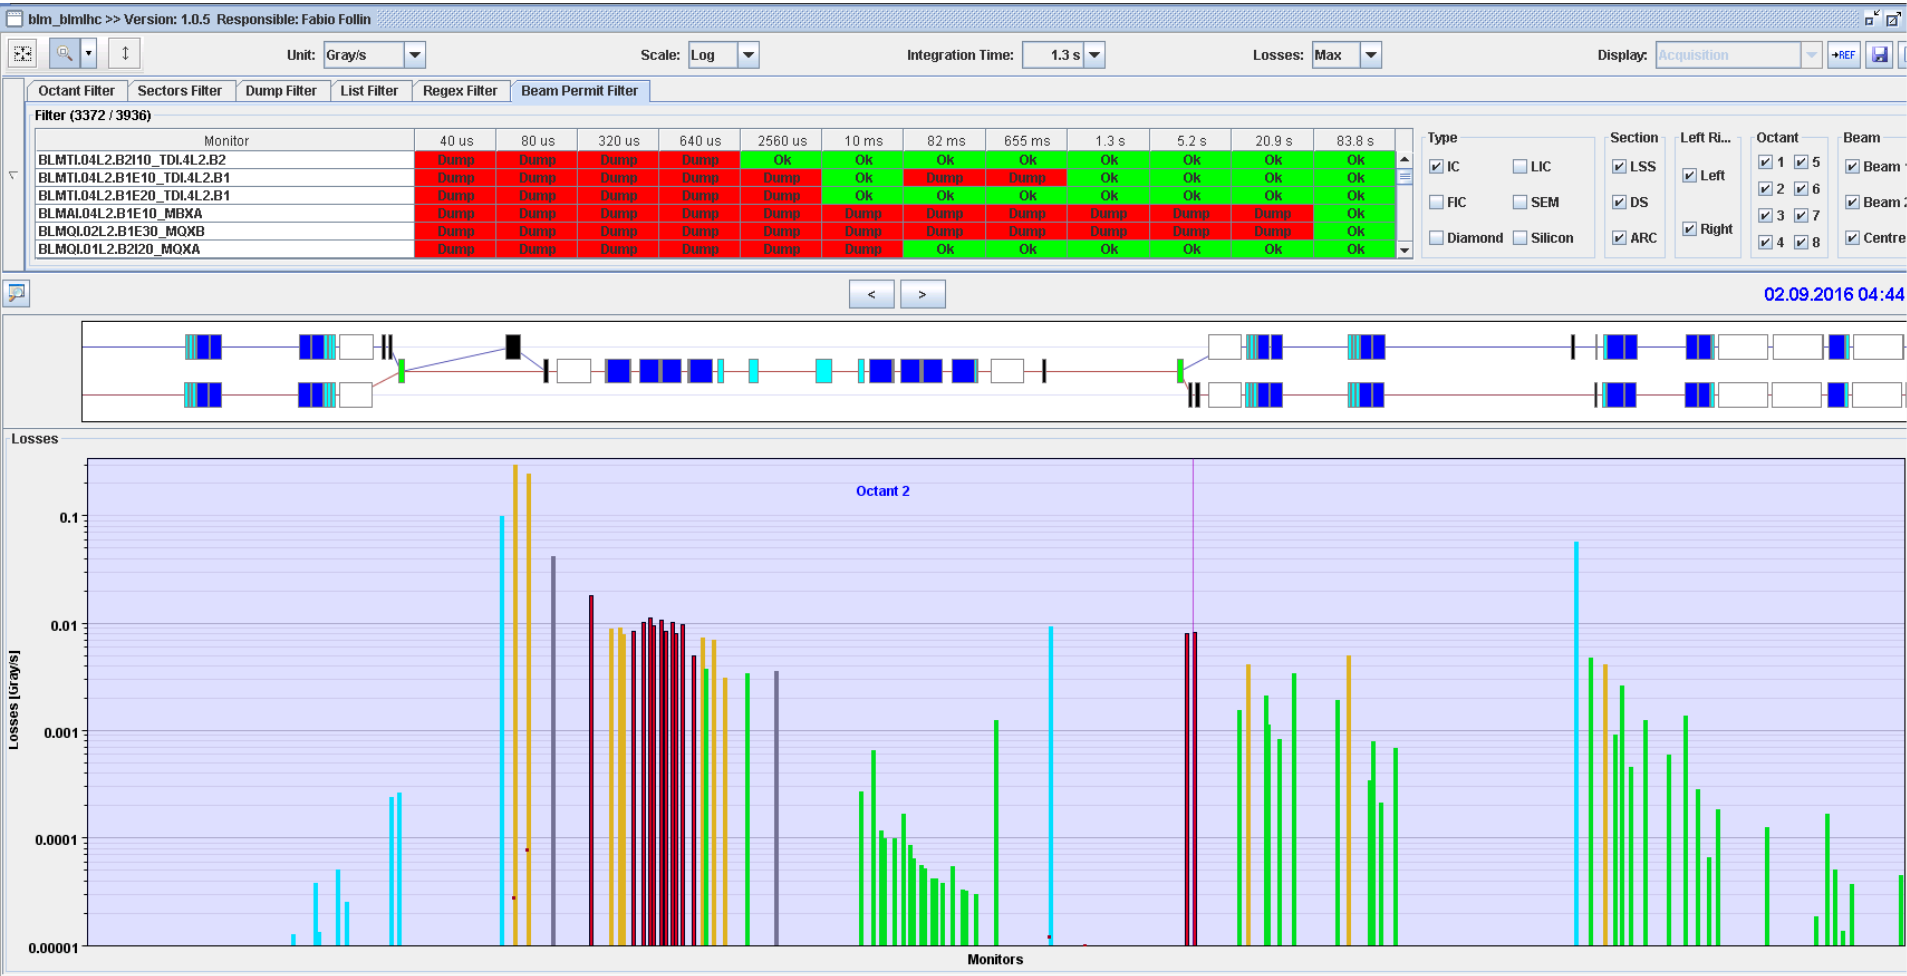
Losses

- Erratic turn-on of main switch is a statistical expected event, nevertheless it occurred at a relatively low PFN voltage – no erratics since
- The other magnets where retriggered as foreseen
- Half a batch (1 batch equals 48 bunches) with grazing impact on the TDI, 3.5 batches with high TDI impact parameter
- 210 bunches are missing in the dump pattern (compares roughly to 4 batches a 48 bunches)
- Loss pattern seems to peak at Q2

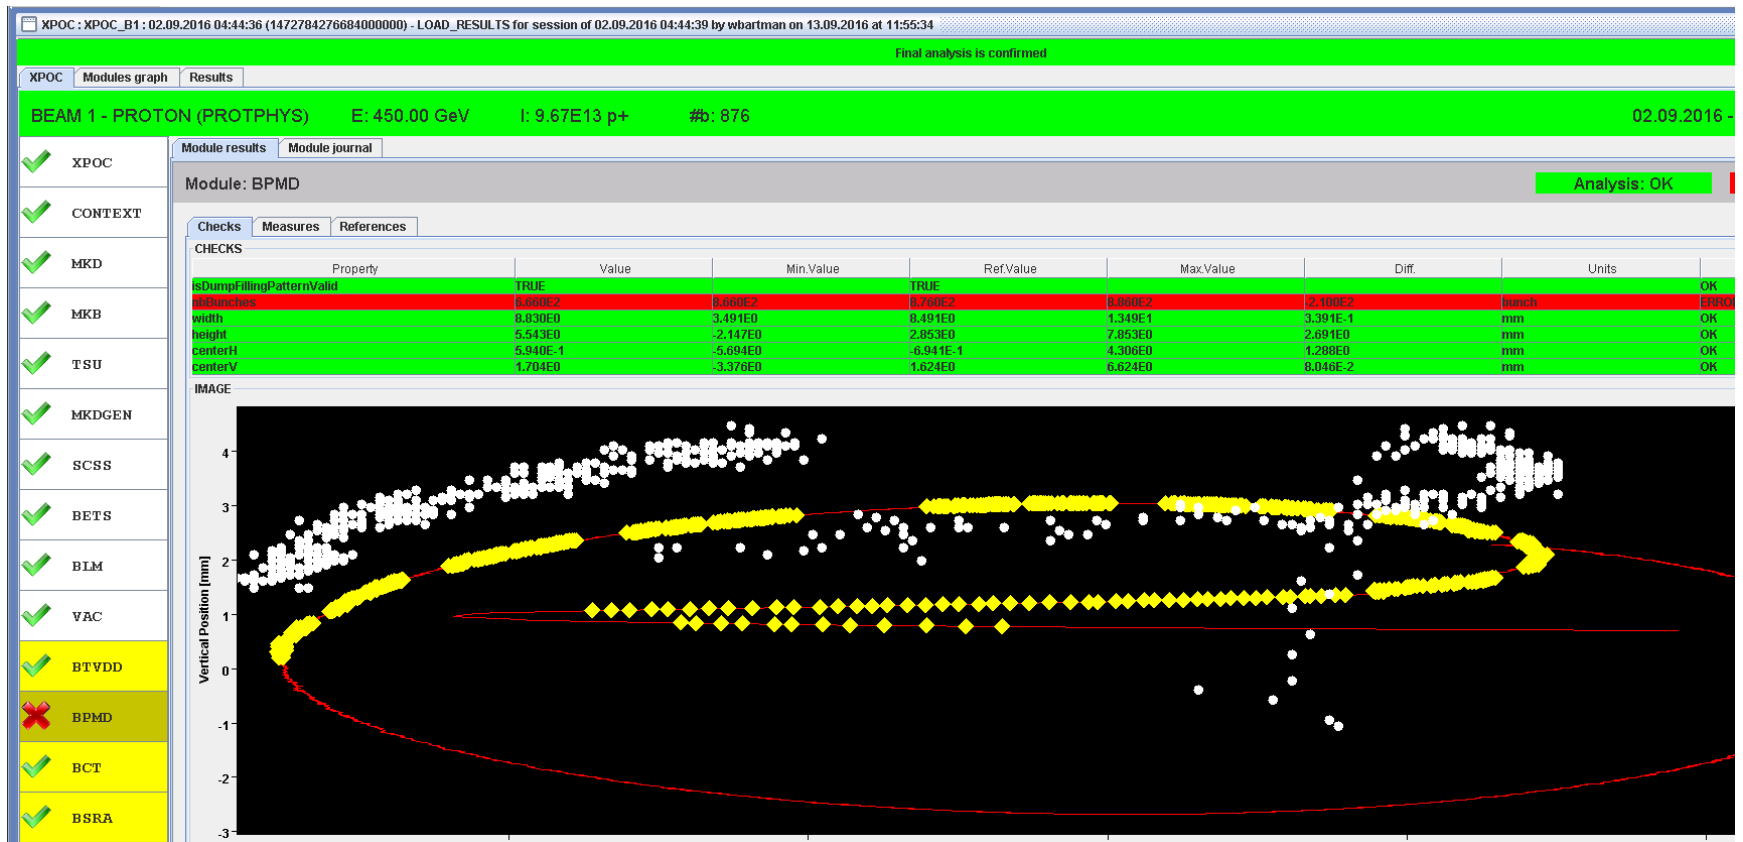
Dump

Bunch count in BPMDs measures 666 instead of 876 → 210 bunches missing
