MKBH sparking and retrigger –
Preliminary discussion – detailed
analysis and conclusions still to
follow

LHC MPP meeting, 11/11/2016

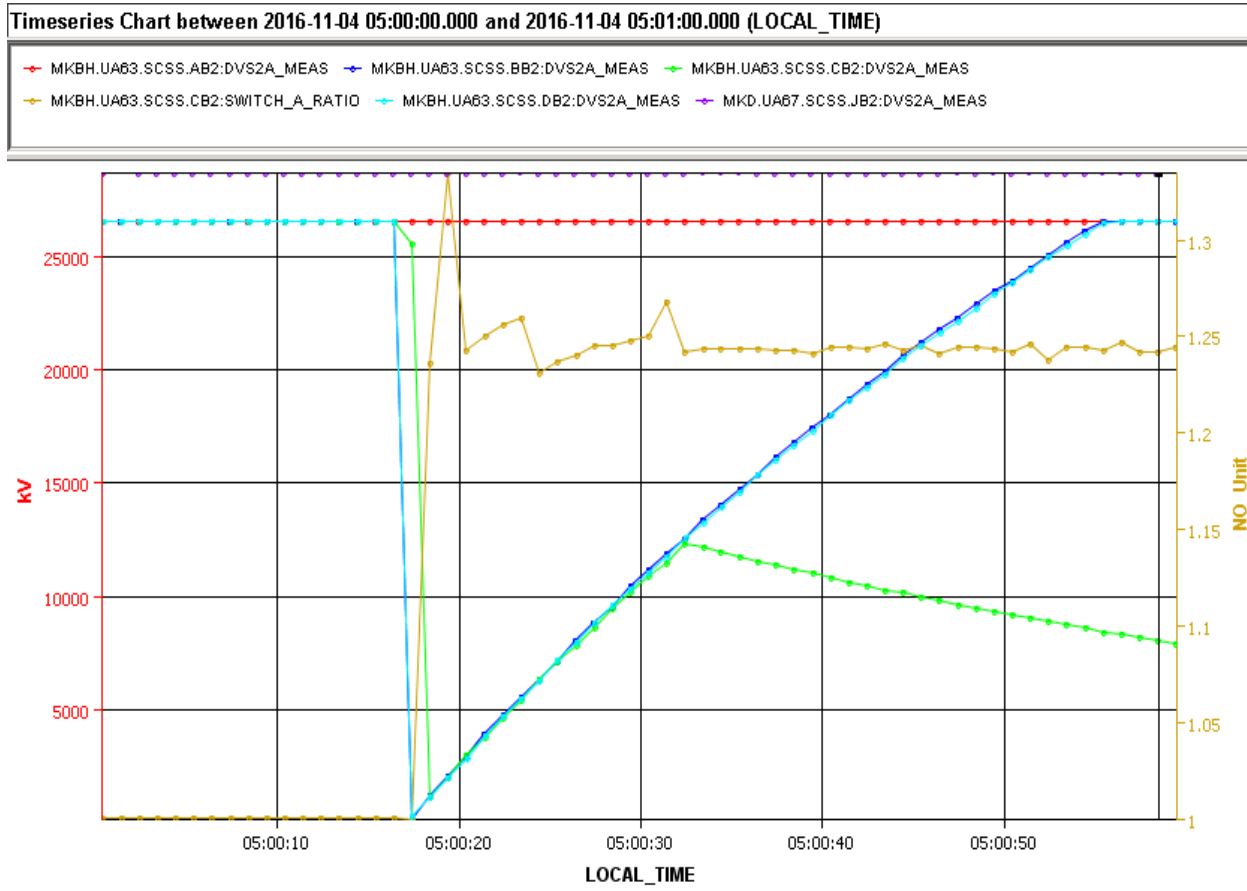
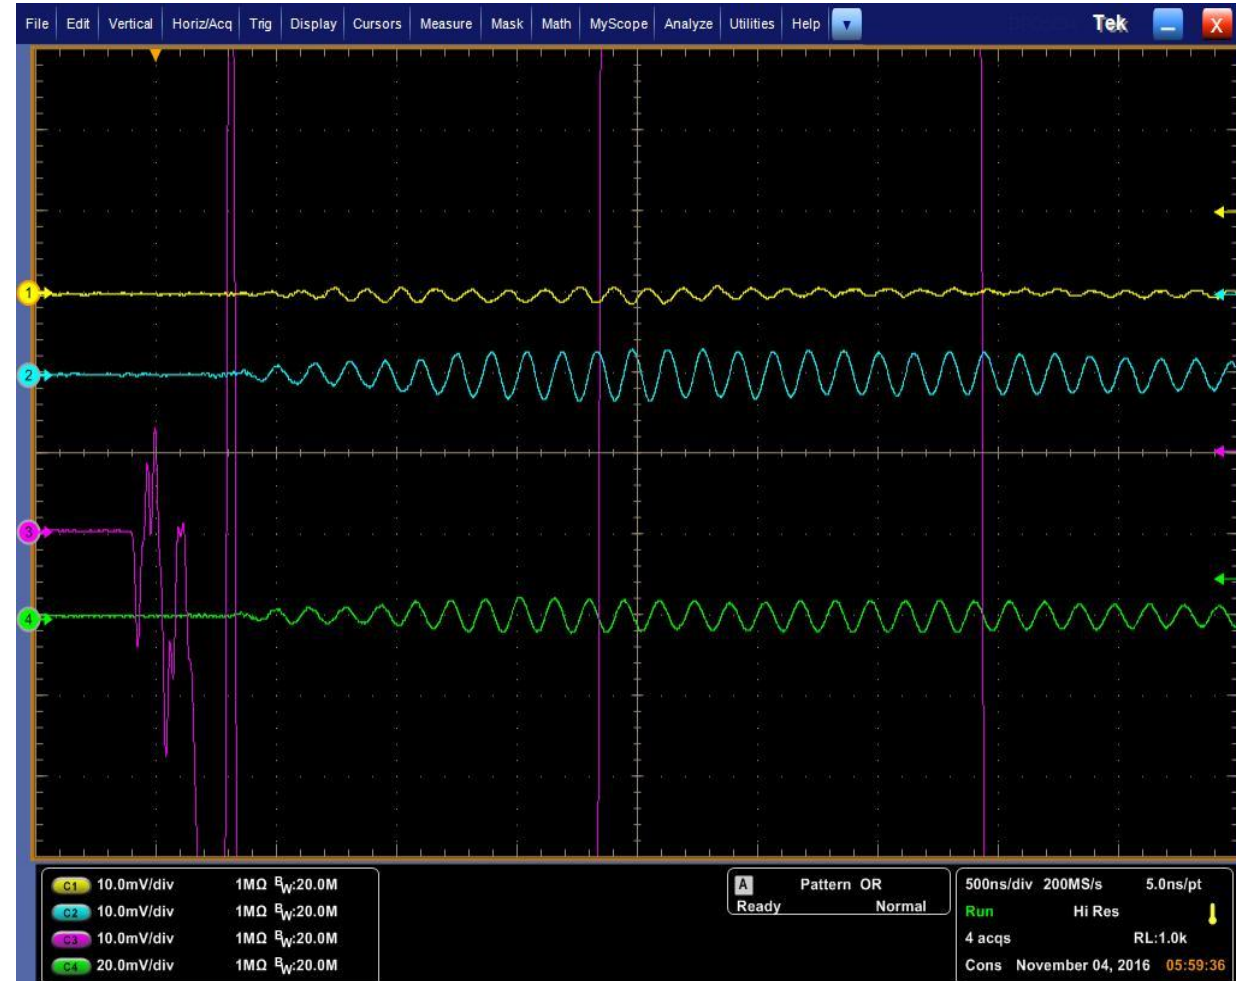
- Reliability run of 4 MKBH/B2: few small sparks A + B, strong spark D, erratic of C: GTO damaged
- MKBH C erratic provoked retriggering of its neighbors – MKBH B + D via retrigger line (5 to 6 us later – not captured by oscilloscope because of scope triggering hold-off time)

MKBH C/B2 erratic with retriggering of its neighbours

Data Set:	MKD.UA67.SC55.JB2.DVS2A_MEAS	X:	2016-11-04 05:00:58.338	Y:	28756.51	Units:	kV
Data Set:	CURSOR	X:	2016-11-04 05:00:58.447	Y:	28757.78	Units:	kV

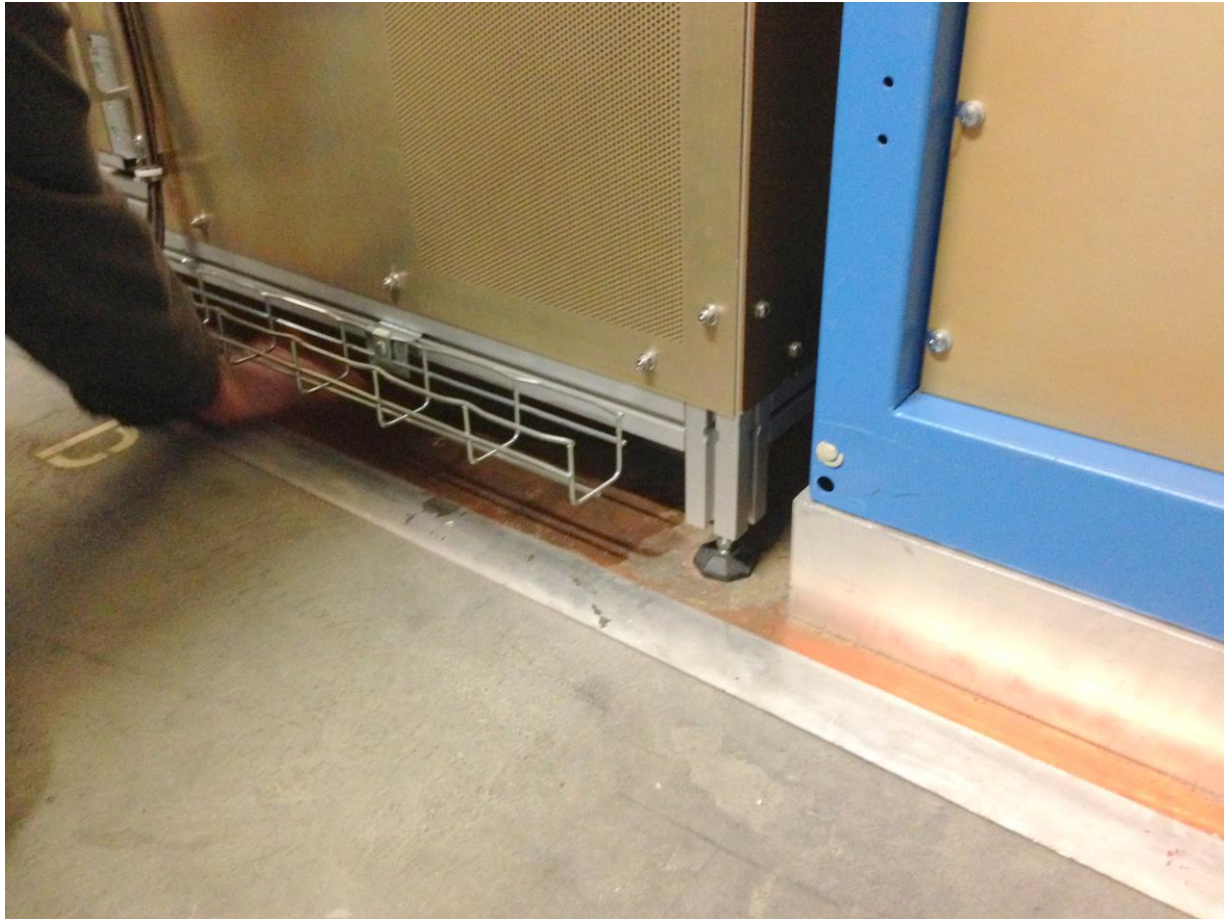
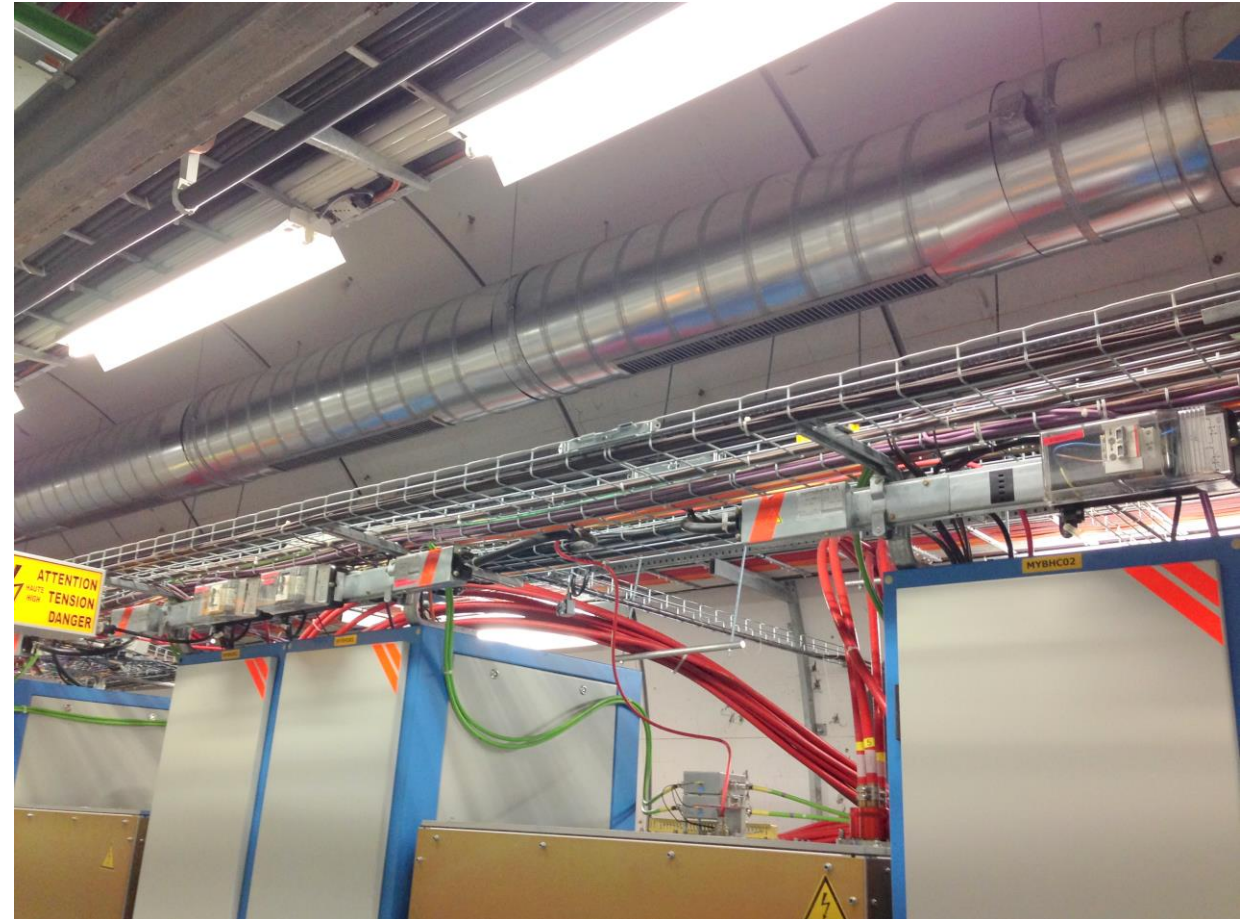
Potential sources of pollution

- Floor dust + strong VAC air blaster blowing the air above generators – dust suspension in air
- Manual earthling switch – friction of metal on vetronite almost straight above GTO stack
- Overheating (?) of discharging Ross relay with black matter deposit nearby

- Middle term:
 - Replacement of perforated panels by full ones (to avoid dust penetration), EYETS – to be tested
 - Cleaning of floor in the UA63/67 in proximity/underneath of MKB generators and their chassis

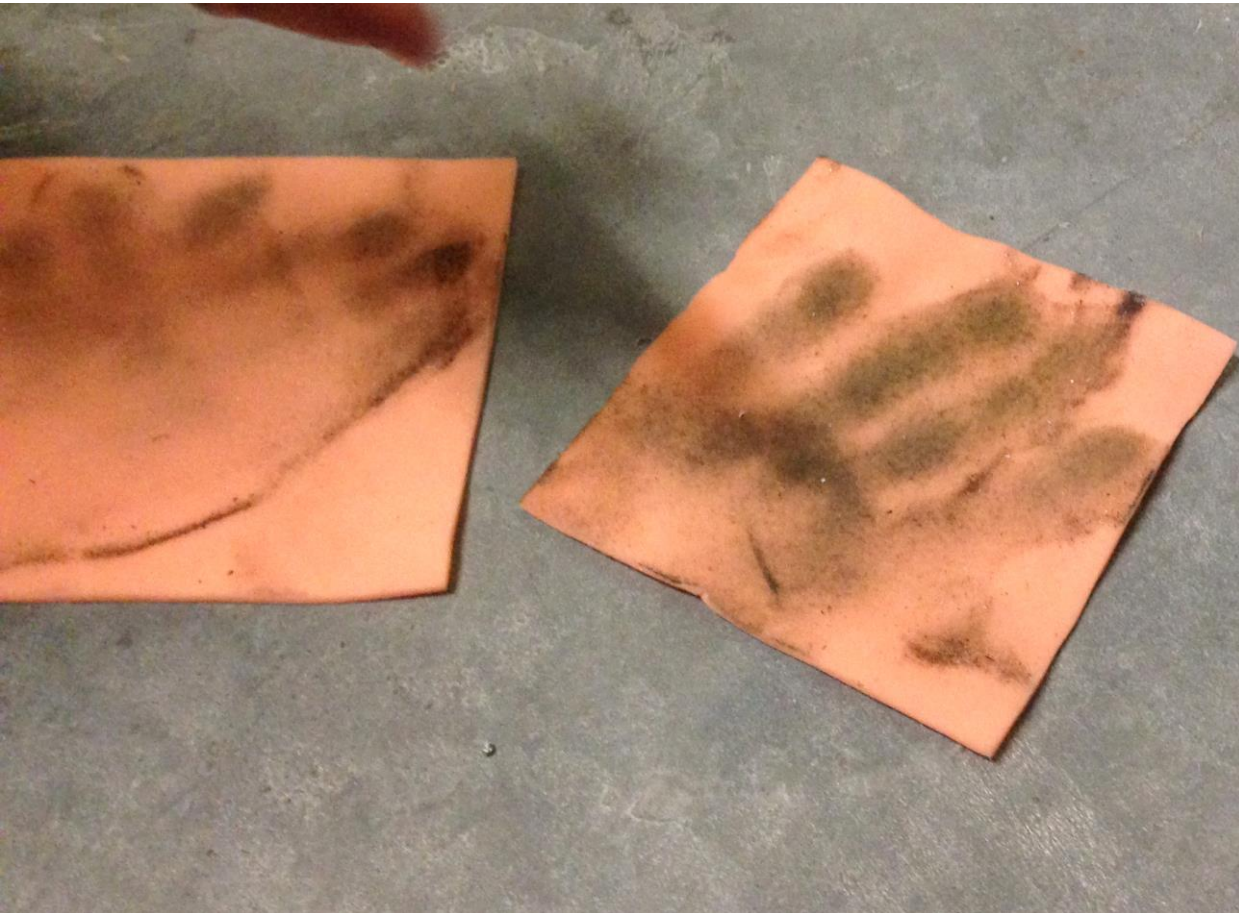
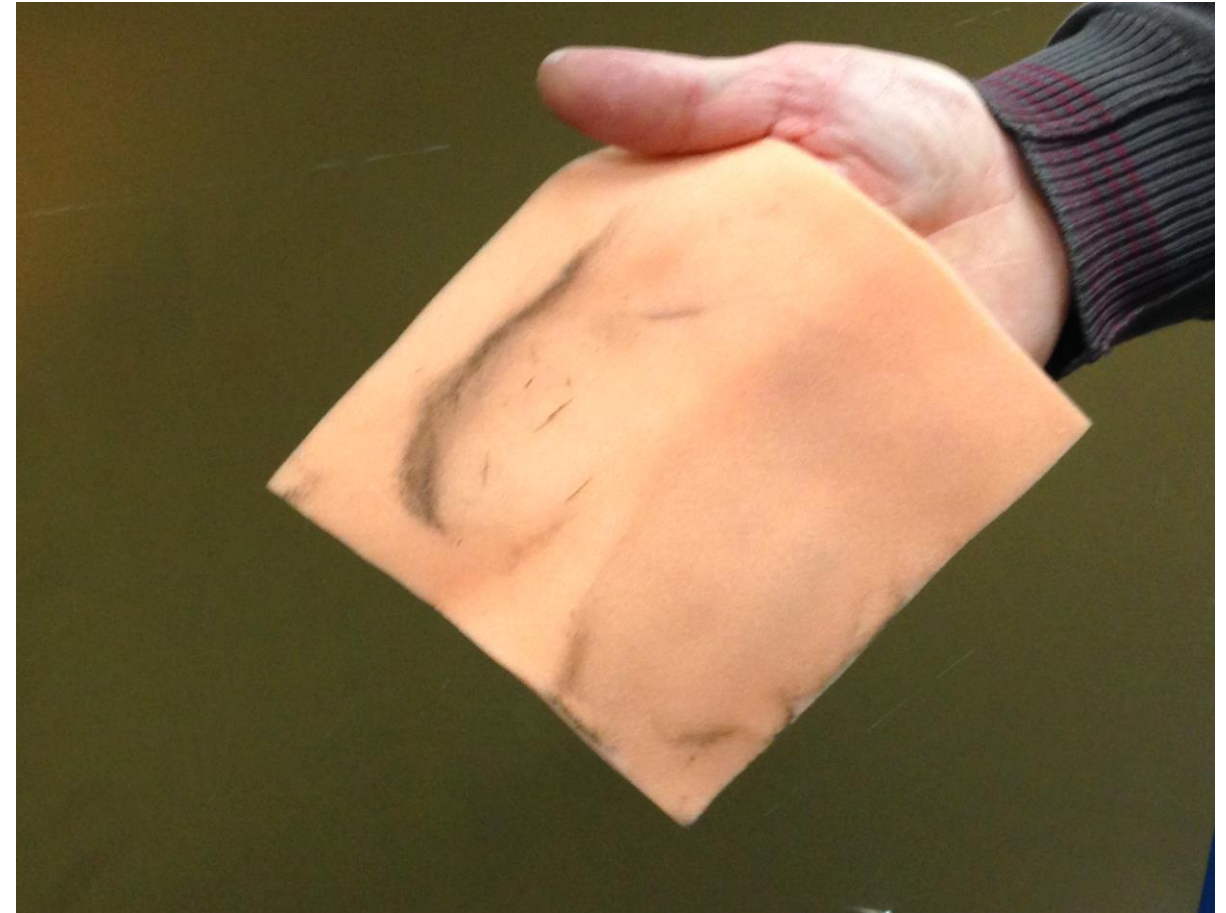
Dirt recuperated on $\sim 500 \text{ cm}^2$ of floor in front of/underneath/on top of MKBH generator

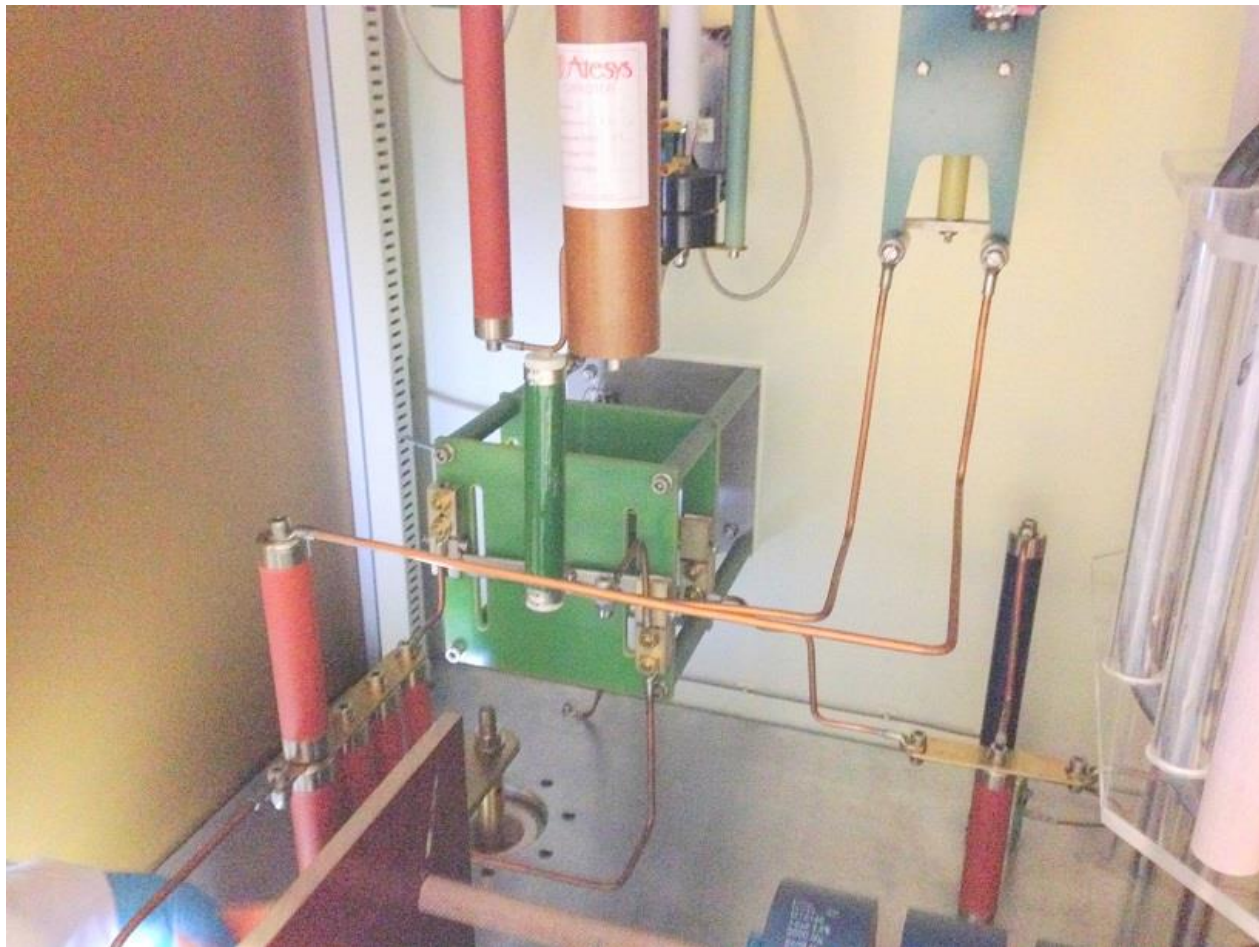
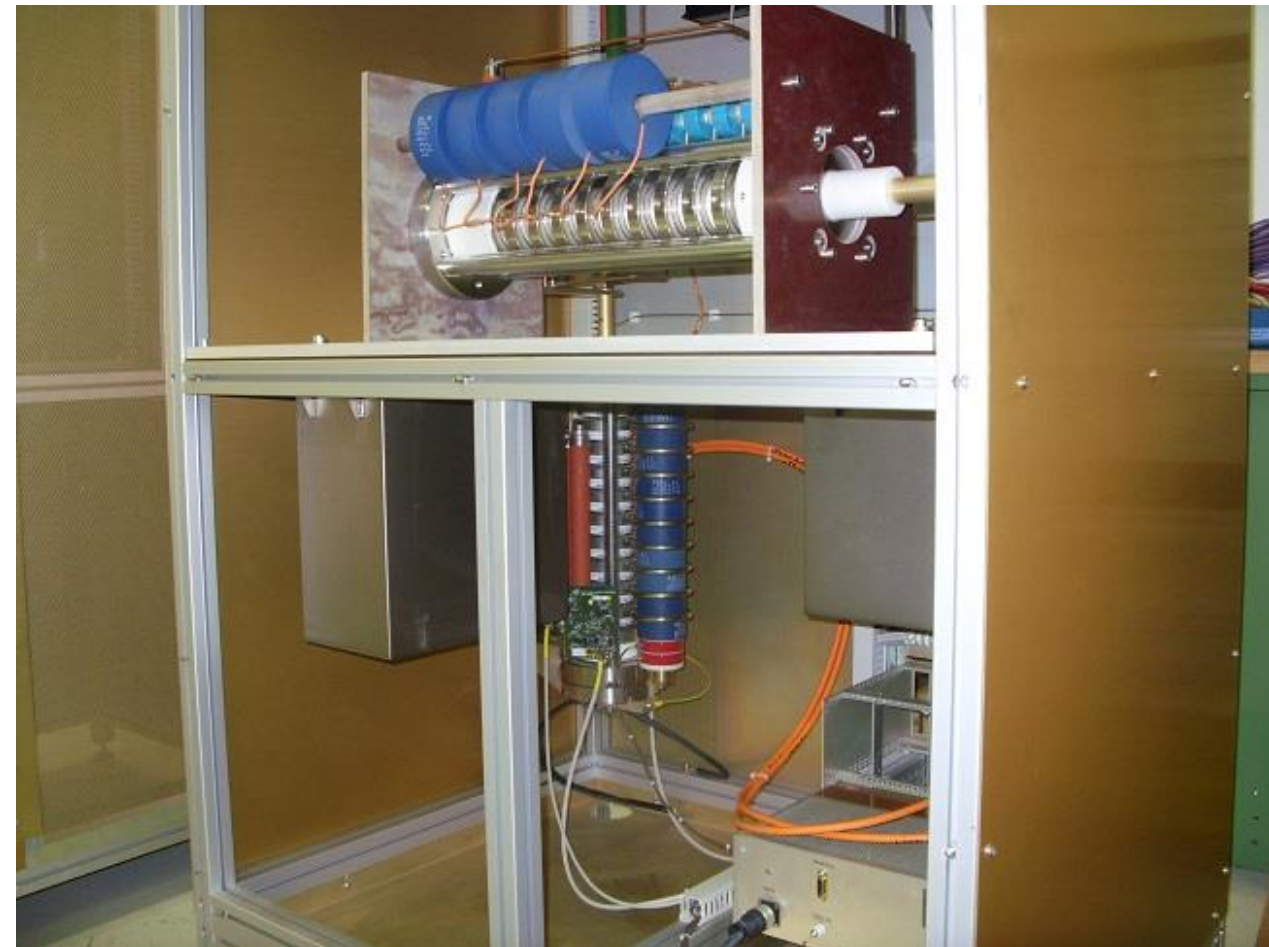
MKBH generator

- Consequence of connecting GTO stack bottom to generator chassis and to main copper grounding sheet under generator; 10 coax cables to magnet connected to the top; tanks in RA grounded – high inductance between UA and RA ground (return of 10 power coax cable connected to tank)

- Retrigger box metal housing is mechanically (and electrically) connected to the generator “top” ground but all electronics is referenced to generator “bottom” ground

- Inspection of MKBH and MKD generators Ross relay (the same type) – for presence of burning traces; replacement in case of need - EYETS
 - Test of coupling to retrigger line; cabling change, insulating of retrigger box, adding ferrites?
