Electro-migration driven failures on miniature silver fuses at the Large Hadron Collider

Nikolaos TRIKOUPIS¹, Juan CASAS-CUBILLOS¹, Ana Teresa PEREZ FONTENLA²

¹ CERN, Technology Department, Cryogenics group ² CERN, Engineering Department, Mechanics and Materials Engineering group

TWEPP 2017
Topical Workshop on Electronics for Particle Physics,
Santa Cruz, California, USA, September 11-15, 2017.

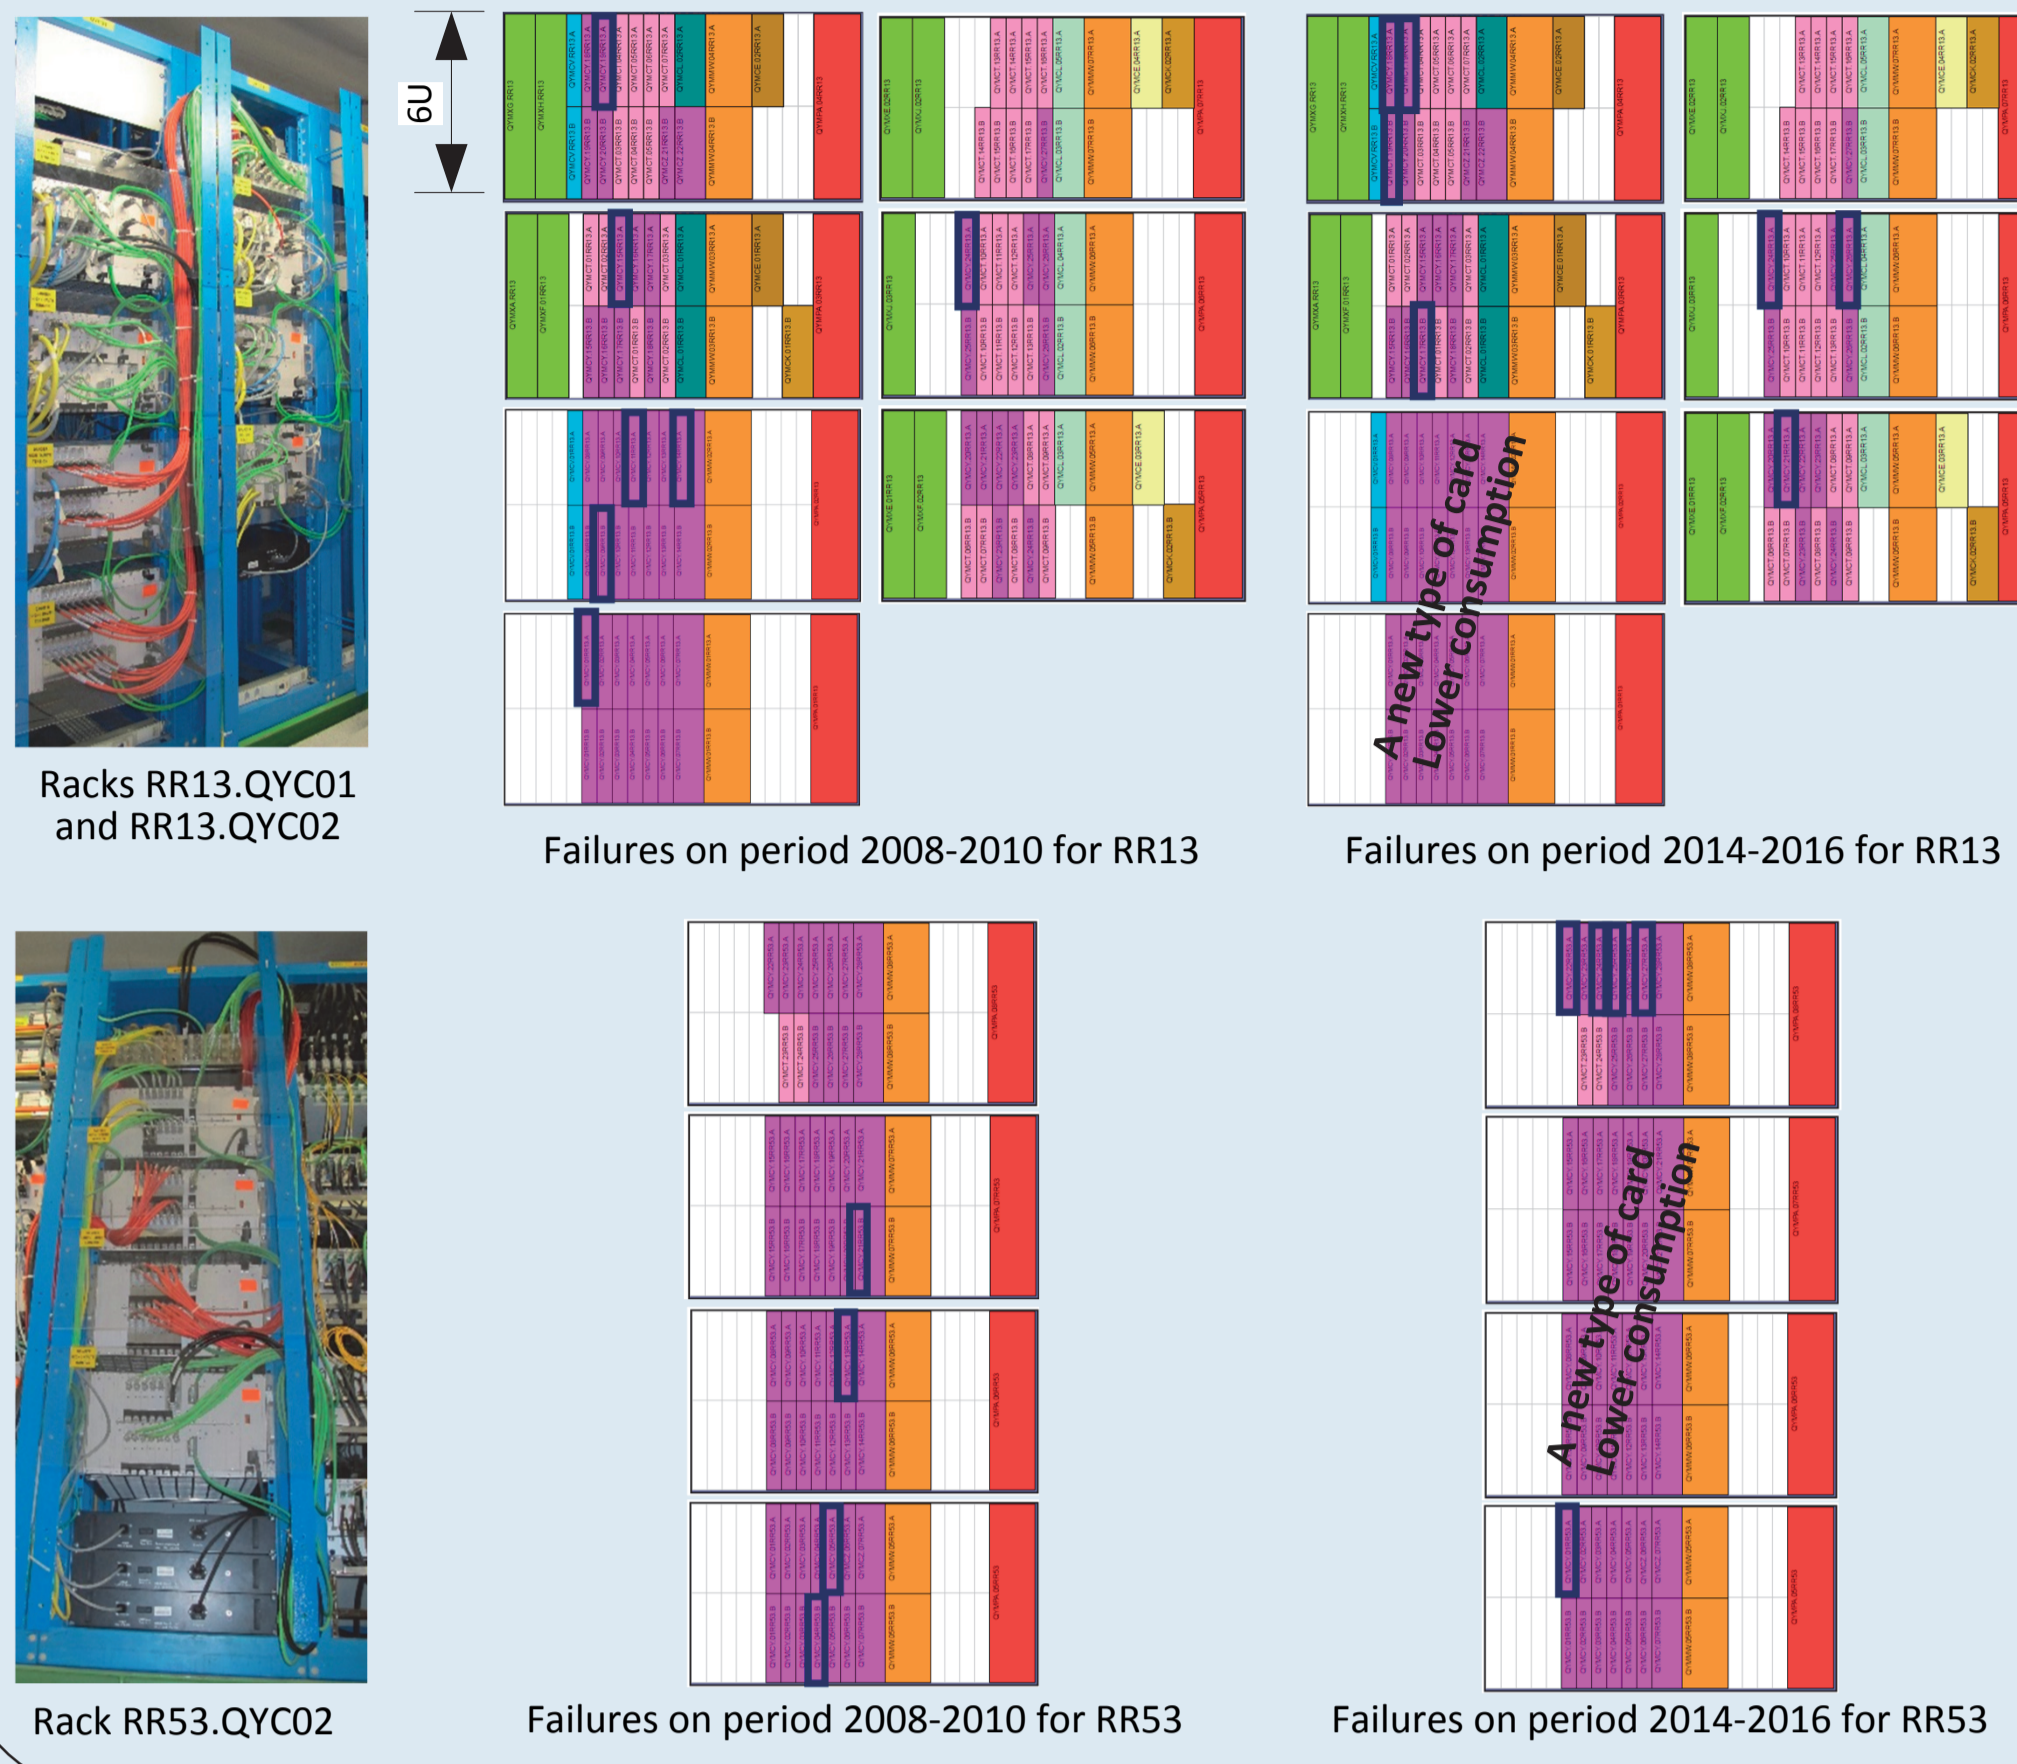
On the left, the racks containing LHC cryogenics instrumentation electronics are shown. Those racks are placed at 2 LHC locations where the most failures were observed during the periods 2008 - 2010 and 2014 - 2016. Each rack contains 3 or 4 double-level crates with various electronic cards. The failing card type is shown with a dark purple colour. The cards that actually failed are visualized with a blue square. After the first period, some of those cards were upgraded to another family as per updated requirements; no failures were observed at those newer cards which operate at a lower supply current.

It was observed that the failures were occurring mostly at the top level of the double crates indicating a possible correlation with the operating temperature. Those 2 LHC locations are among the warmest and in addition the cards were tightly packed without sufficient ventilation. Their operating temperature was measured in the range of 50 - 60 °C.

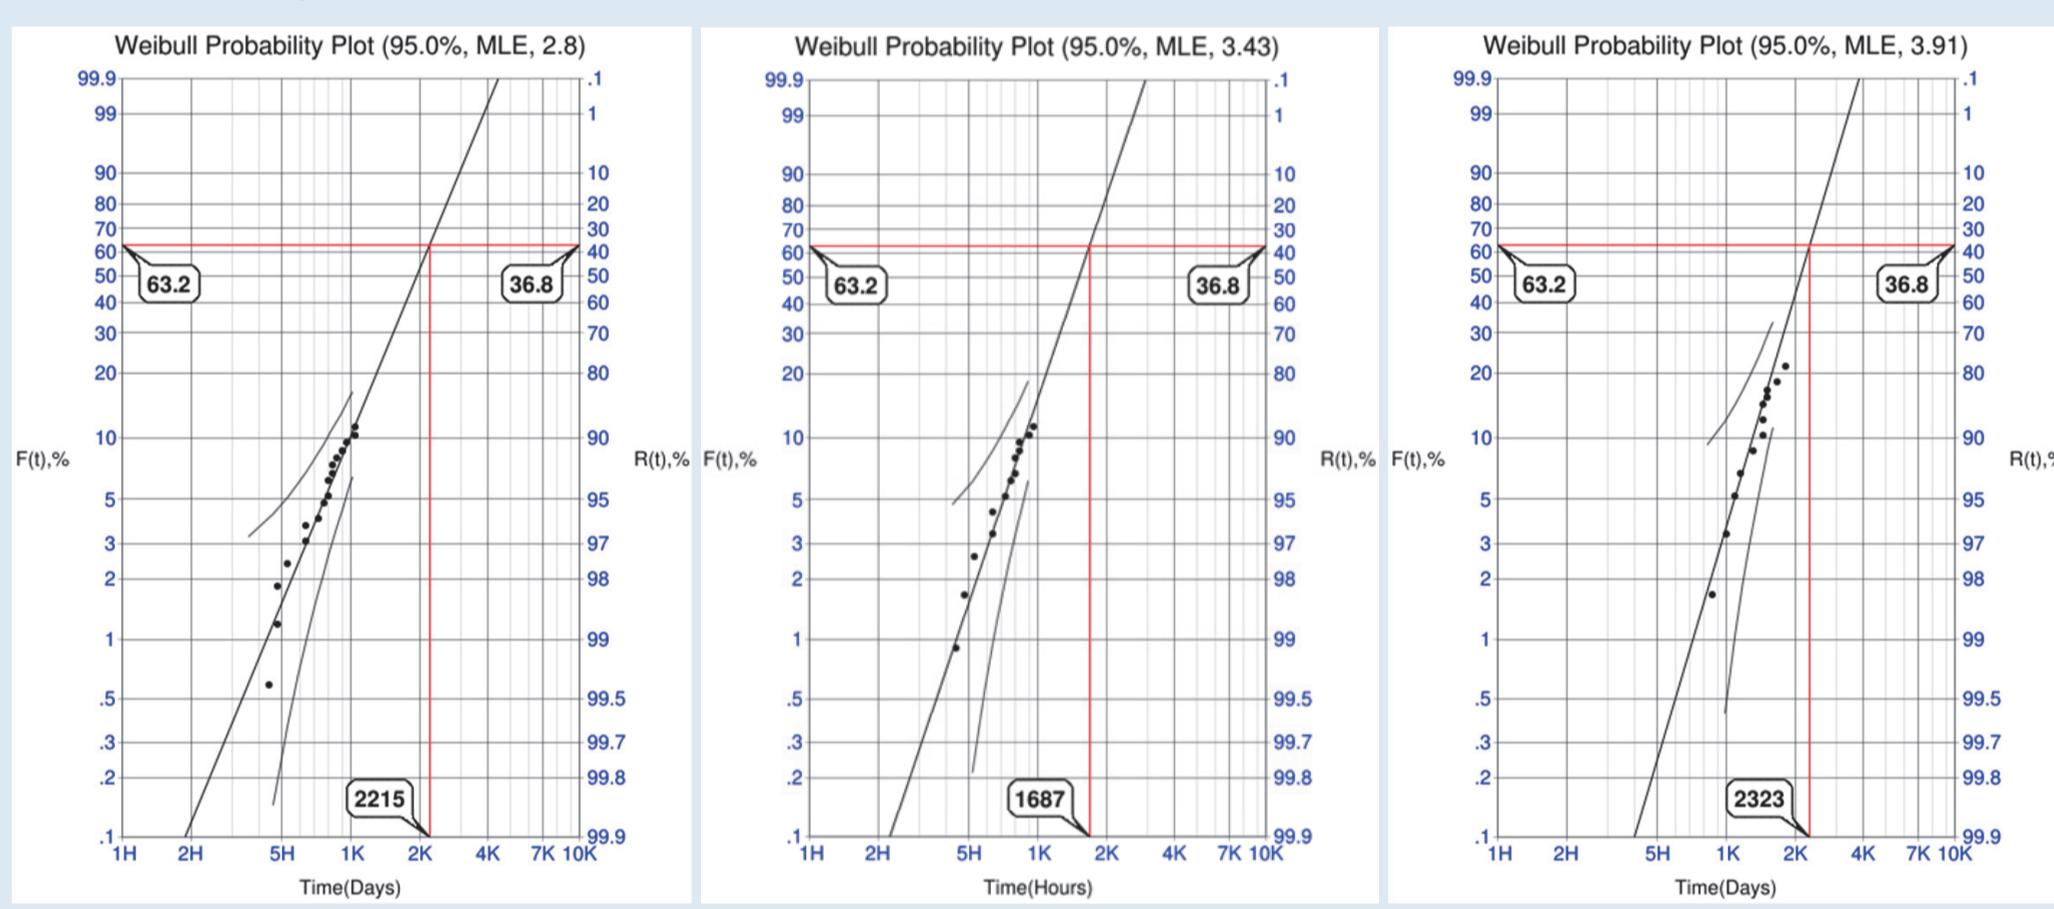
Period 2008-2010
Weibull distribution for 150 cards at 3 LHC locations RR13, RR53, RR57 (17 failures).
 $\eta = 2215$ days, $\beta = 2.8$.

Period 2008-2010
Weibull distribution for 102 cards at 2 LHC locations RR13, RR53 (13 failures).
 $\eta = 1687$ days, $\beta = 3.43$.
Reduced data set to compare with period 2014-2016 for same locations only.

Period 2014-2016
Weibull distribution for 46 cards at 2 LHC locations RR13, RR53 (12 failures).
 $\eta = 2323$ days, $\beta = 3.91$.

The results of the Weibull reliability analysis are shown in the above charts. Weibull β factors $\gg 1$ indicate strong end-of-life wear-out failures. When comparing periods 2008-2010 and 2014-2016, for the same LHC locations, it becomes clear that the increase of the fuse rating led to an increase of the MTTF (Mean Time To Failure) from 1687 to 2323 days but the underlying failure mechanism remained the same.

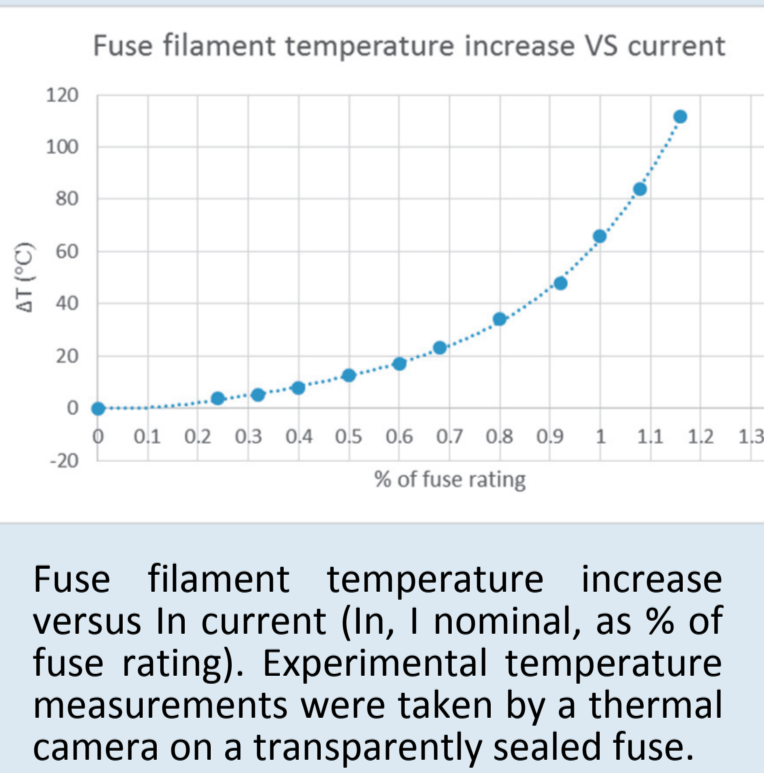
The MTTF increase can be explained by the increase of the fuse rating which resulted in a reduced operating temperature of the fuse filament (lower resistance). As per laboratory measurements shown on the right, the fusing element temperature decreased from +12.5 °C with respect to ambient temperature (typical card consumption is 0.5 A, loading of fuses was decreased from 50% for the 1 A fuses to 40% for the 1.25 A).

Fuse filament temperature increase versus In current (In, 1 nominal), as % of fuse rating). Experimental temperature measurements were taken by a thermal camera on a transparently sealed fuse.

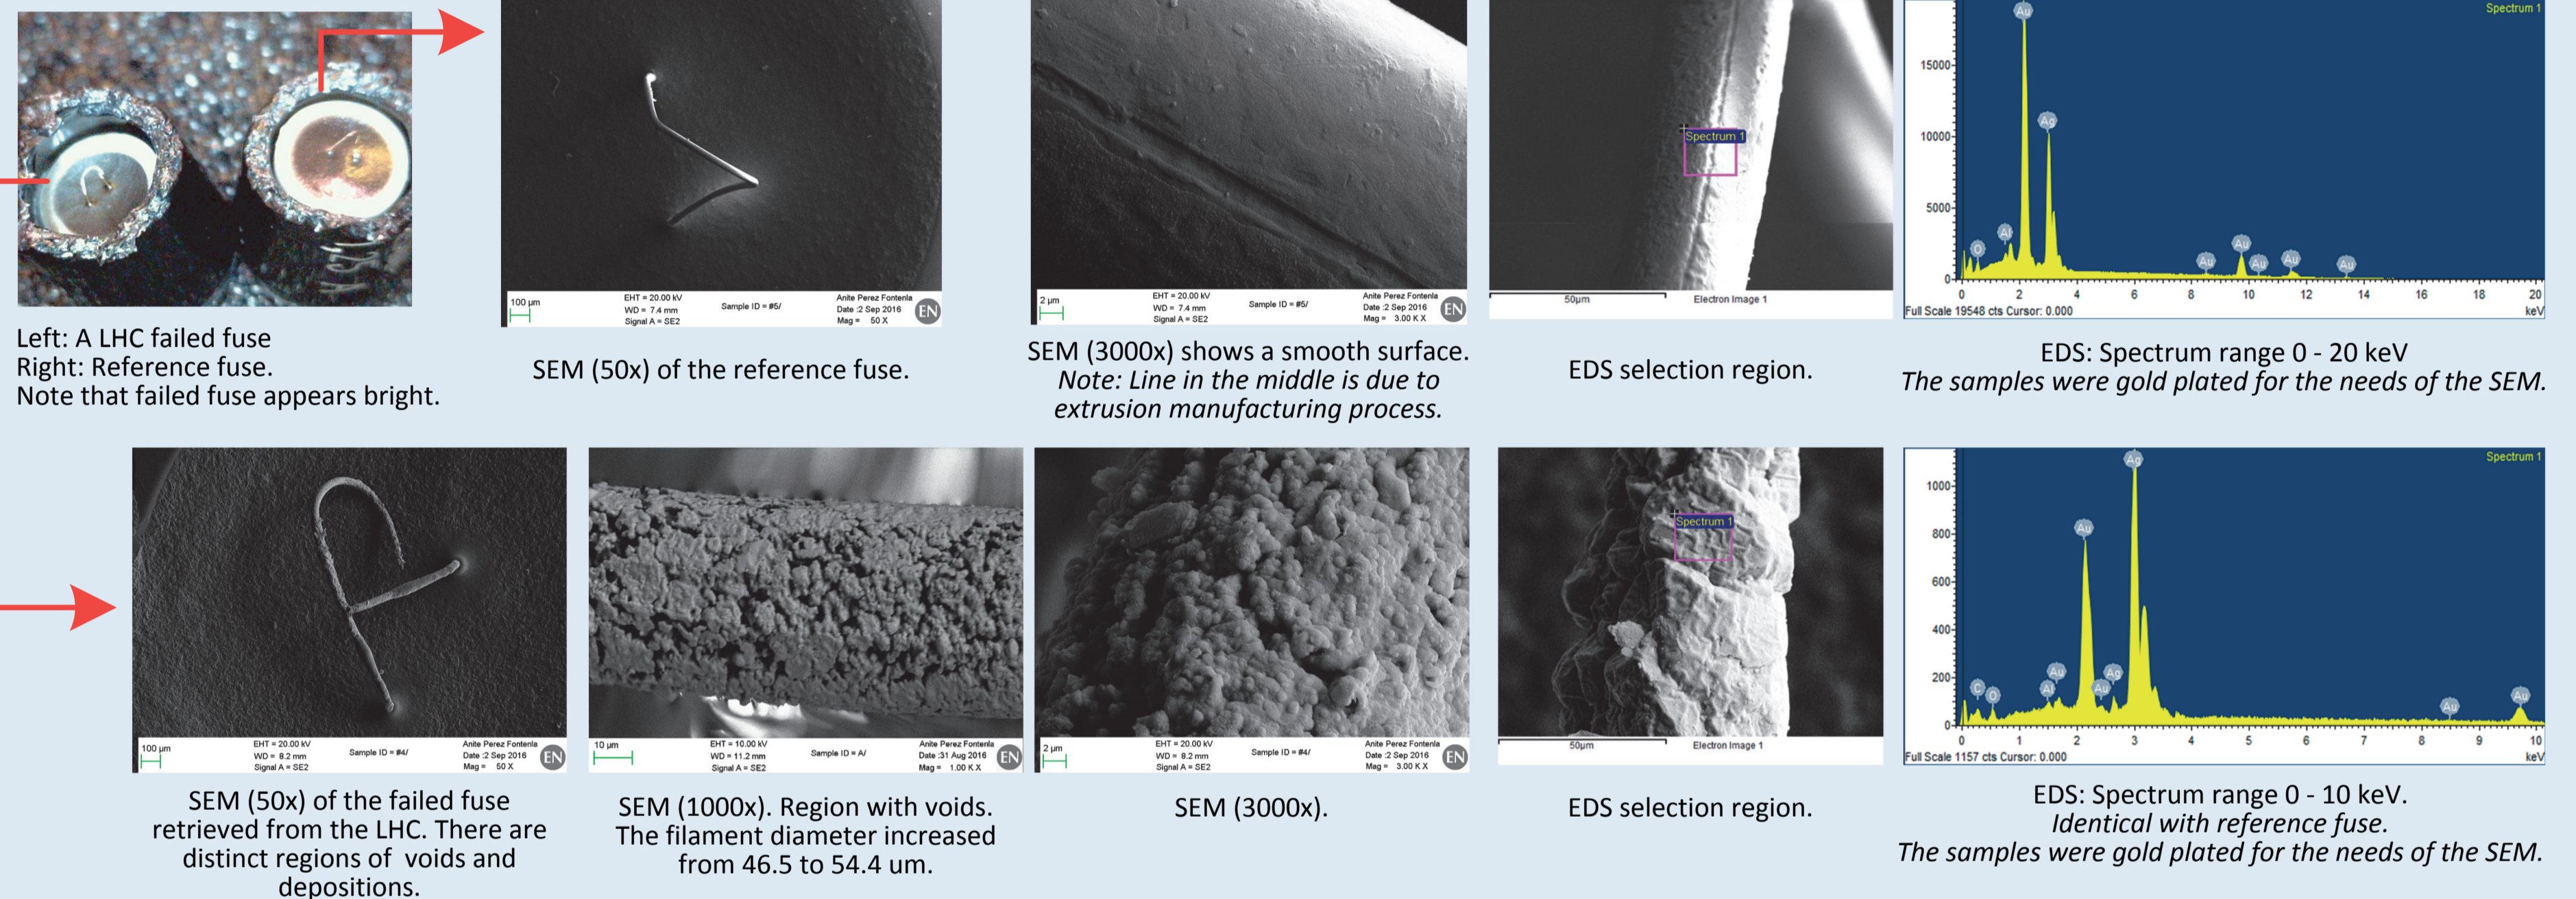
SEM & EDS of 2 samples, an unused reference fuse and a fuse that failed in the LHC, are shown below. It can be seen that the failed fuse has formed distinct regions of material voids and depositions, an indication of electromigration as explained later. No spectral differences can be observed between the 2 fuses indicating that there was no chemical pollution/contamination.

Left: A LHC failed fuse. Right: Reference fuse. Note that failed fuse appears bright.

SEM (50x) of the failed fuse retrieved from the LHC. There are distinct regions of voids and depositions.

SEM (1000x). Region with voids. The filament diameter increased from 46.5 to 54.4 um.

EDS: Spectrum range 0 - 10 keV. Identical with reference fuse. The samples were gold plated for the needs of the SEM.

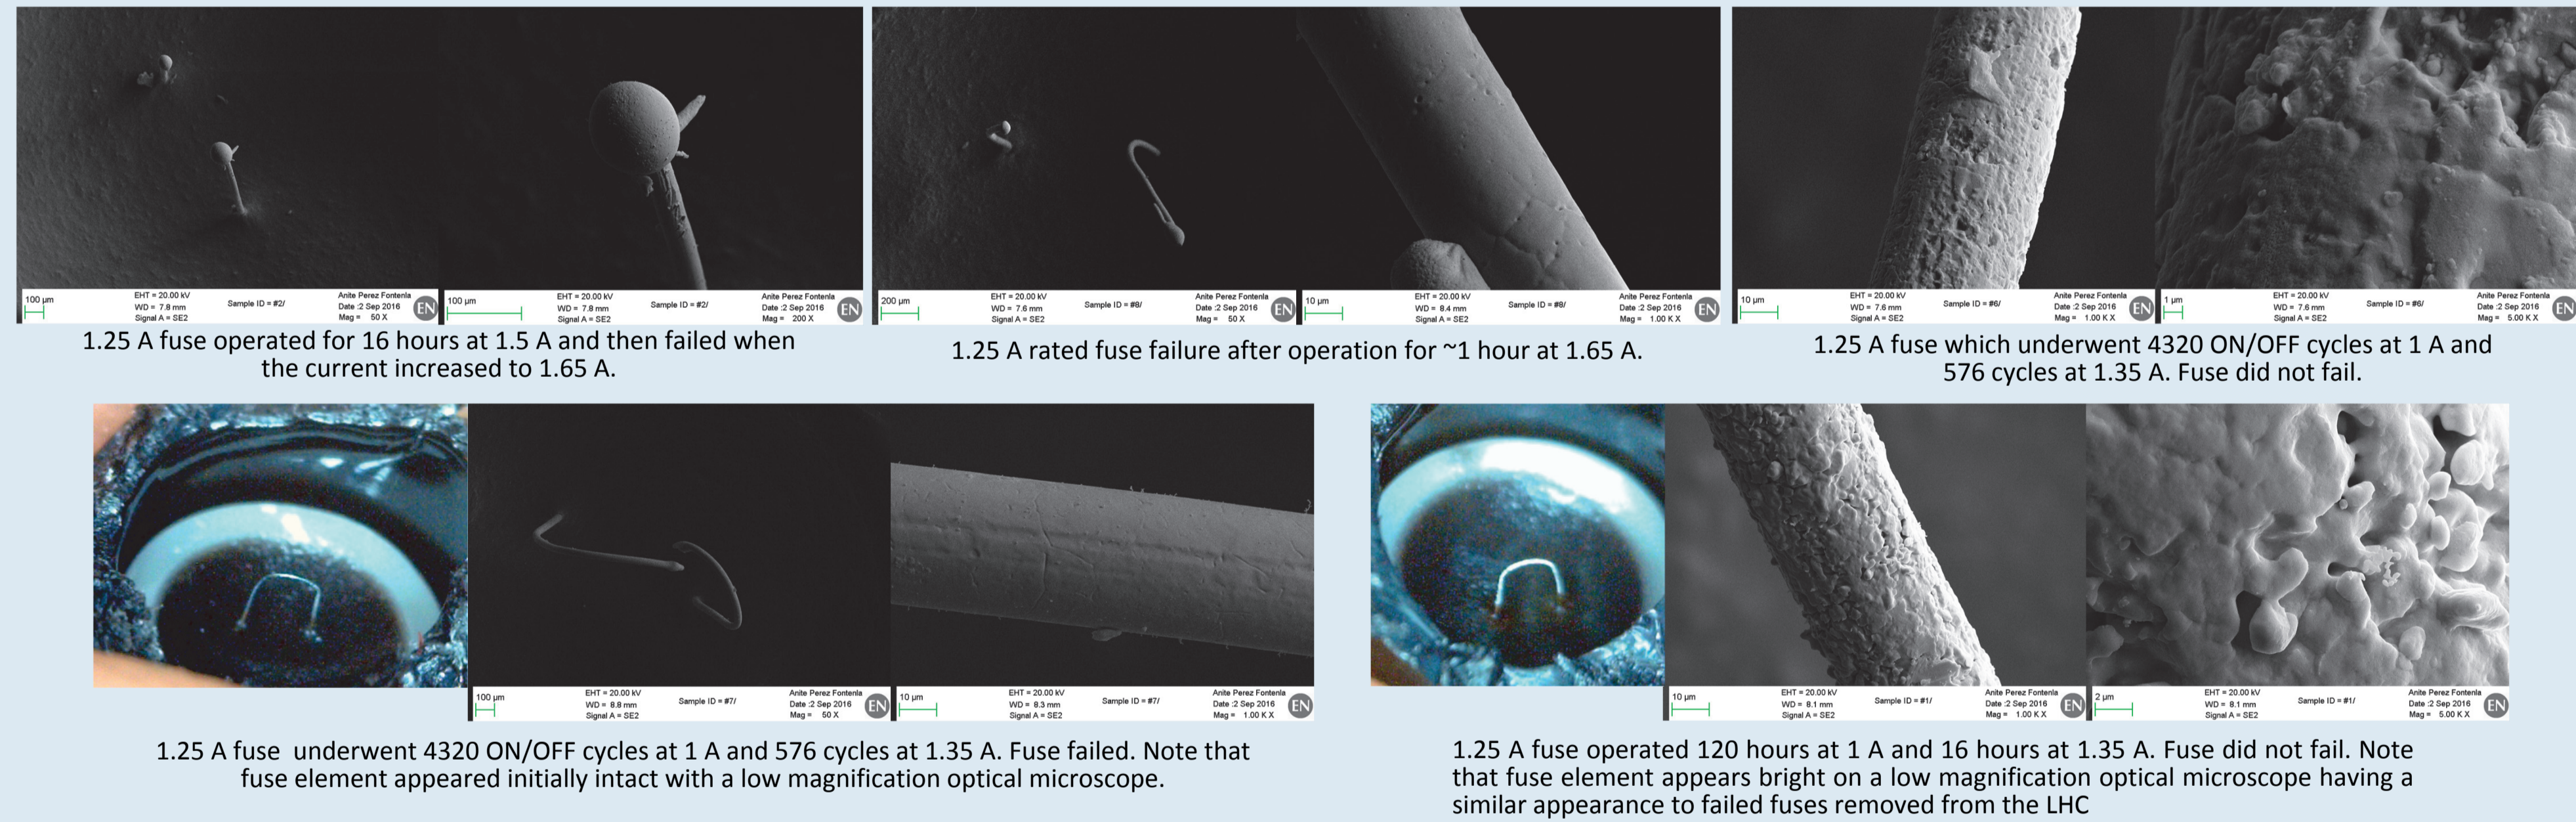
1.25 A fuse operated for 16 hours at 1.5 A and then failed when the current increased to 1.65 A.

1.25 A rated fuse failure after operation for ~1 hour at 1.65 A.

1.25 A fuse which underwent 4320 ON/OFF cycles at 1 A and 576 cycles at 1.35 A. Fuse did not fail.

1.25 A fuse underwent 4320 ON/OFF cycles at 1 A and 576 cycles at 1.35 A. Fuse failed. Note that fuse element appeared initially intact with a low magnification optical microscope.

1.25 A fuse operated 120 hours at 1 A and 16 hours at 1.35 A. Fuse did not fail. Note that fuse element appears bright on a low magnification optical microscope having a similar appearance to failed fuses removed from the LHC

Top left and top center: Fuse failures on overcurrent show spherical structures due to material melting.
Top right: Thermal cycling stresses (no failure) form "cracks" on the surface.
Bottom left: Failures due to thermal cycling stress do not show spherical structures of melted material.
Bottom right: Extended operation at high currents revealed material transportation phenomena (electromigration) as seen on LHC samples.

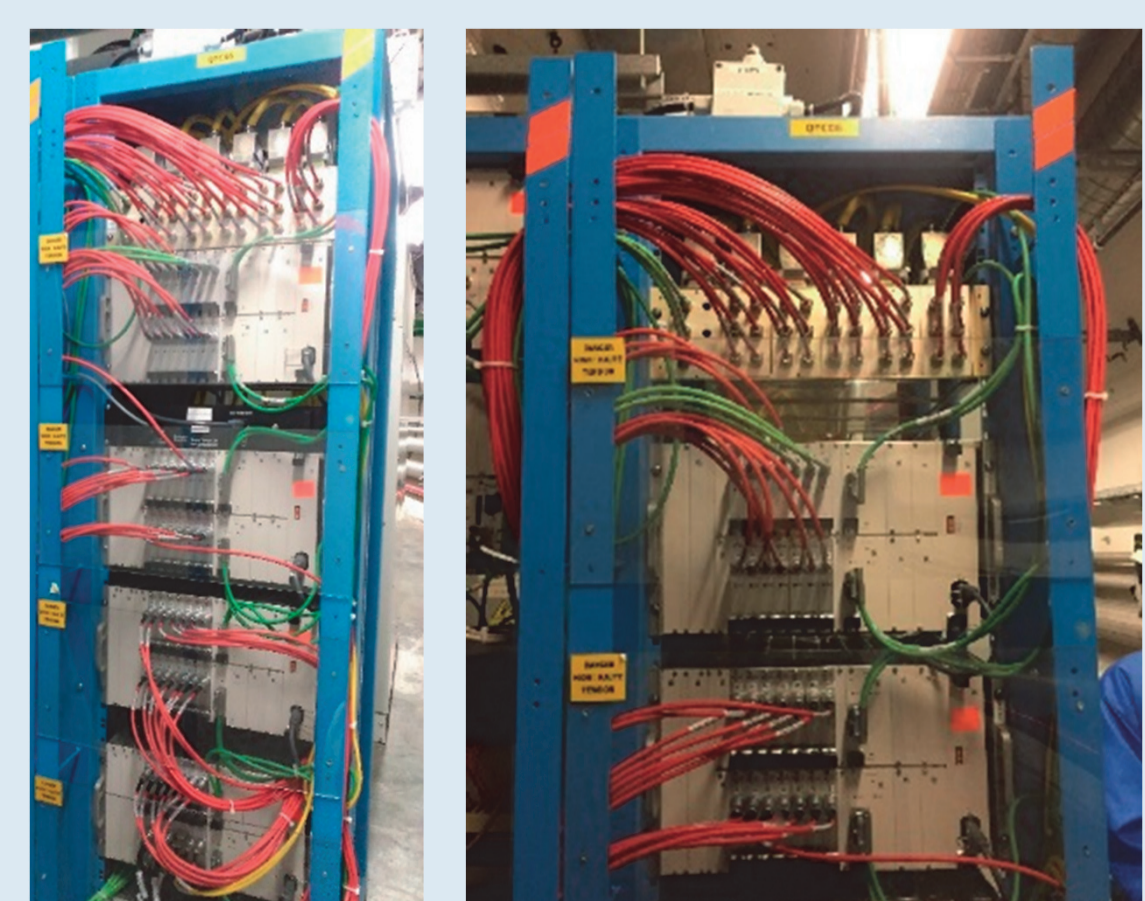
Left: A cabinet with limited airflow on top-most crate. Right: Improved airflow by separation.

- A fuse with a higher stated reliability was used. Due to limited time, the new fuses were not tested under SEM/EDS to reveal their composition but such a test will be performed in the future.
- In certain cases, the electronic cabinet separation was increased to improve the natural convection resulting in a lower fuse temperature.
- Cooling fans were installed at some racks exhibiting higher temperature values; reduction of 20 °C was achieved in one rack.
