# **LHC BLM SYSTEM: SUMMARY OF CHANGES AND RE-COMMISSIONING AFTER EYETS**

Machine Protection Panel 07/04/2017

Christos Zamantzas on behalf of the BLM team.

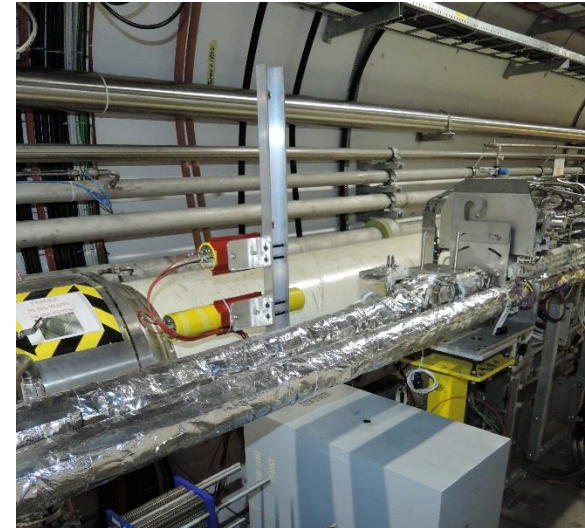
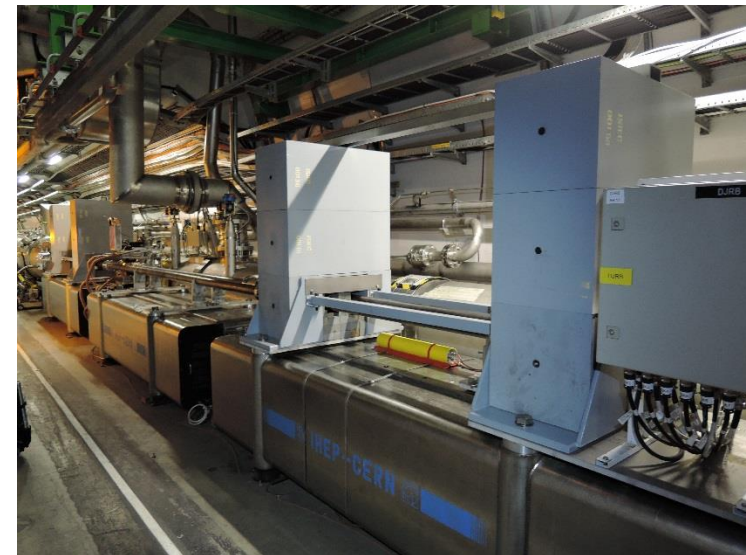
ECR [LHC-BLM-EC-0008](#) v.0.1 summarises the changes in the tunnel installation and the name changes during EYETS

- Removal of IP1 D1 detectors
- New or renames of detectors for TCPCV.A6R7.B2, TCPCH.A5R7.B2 and TCSPM.D4R7.B2
- New detectors for ATLAS/AFP
- Rename of detectors next to ALICE BCMs

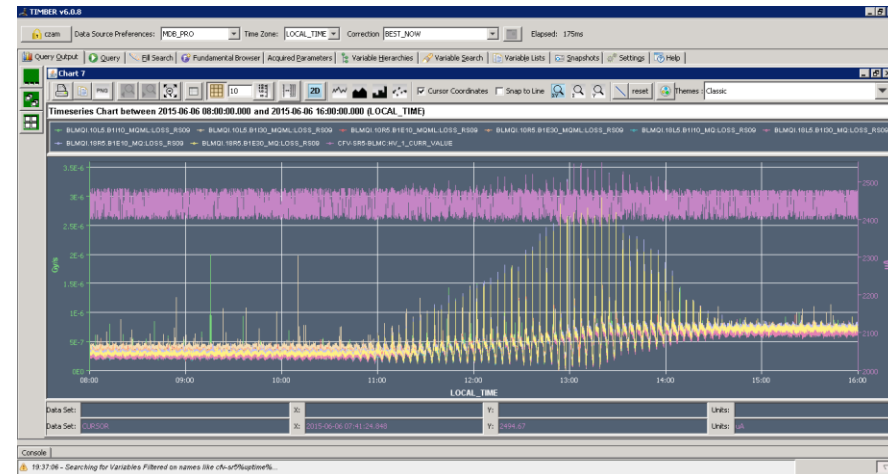
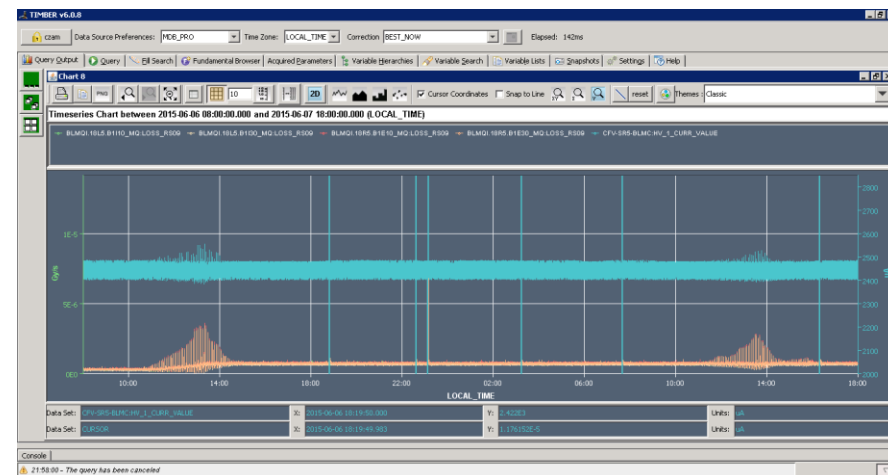
## [BIBML-1257](#): HV PSU Issues

Investigated deeper the issues seen with the high voltage power supplies of the detectors such as:

[BIBML-1256](#) [BIBML-1036](#) [BIBML-1037](#)

which have costed several hours of downtime.

- Replacement of some components
- Redesign of the output stage

New design given to the manufacturer and replaced all PSUs.

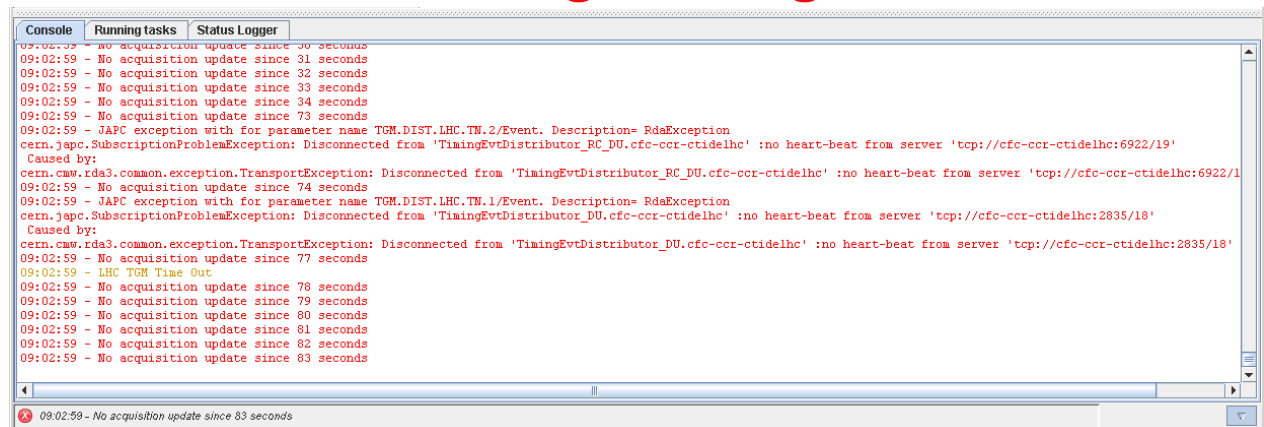
- Some disconnections and timing missing is seen:

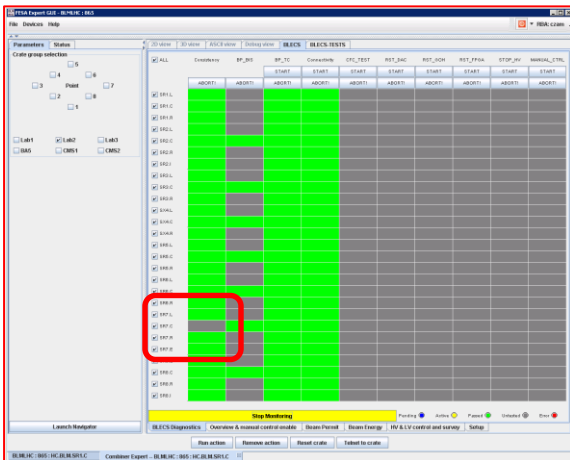
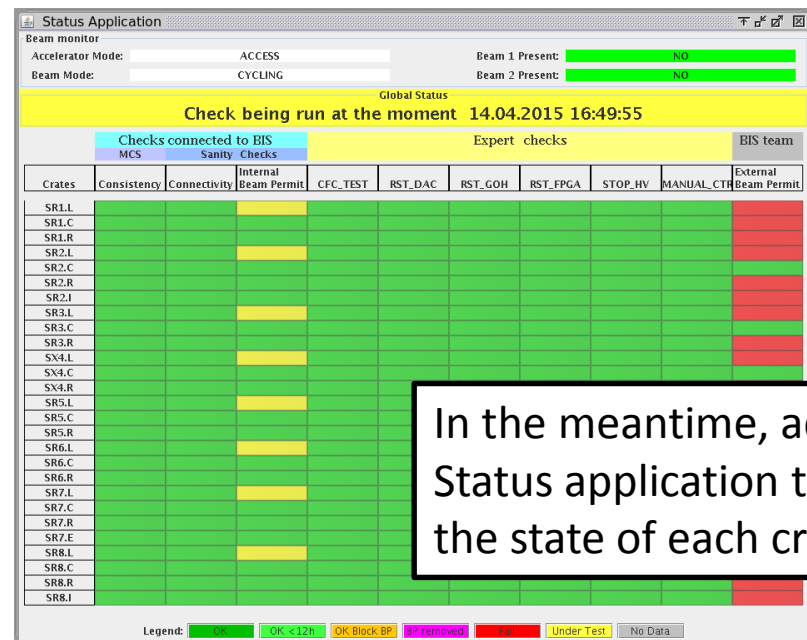
BIBML-937: Sanity Checks' result in the Sequencer does not always gets registered in the BLECS

- Several calls from the CCC that checks cannot complete
- MCS Check had passed (thus the Sequencer showed as green, but the BLECS did not get the result as TRUE to release the permit). During the retries, MCS was being skipped.

Not yet sure what is the cause.

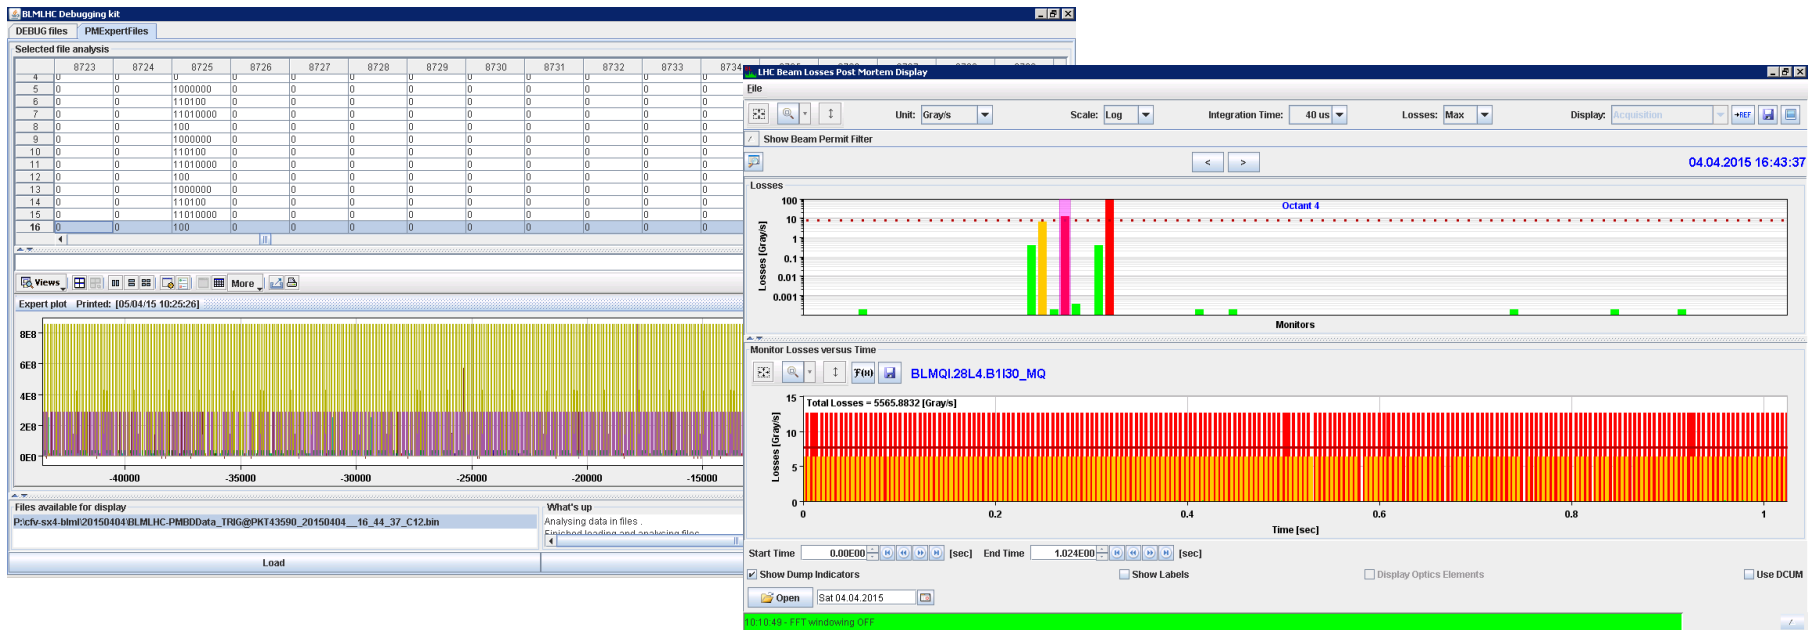
[BIBML-881](#): In few cases the GPM Buffer is not working correctly

- The issue is on the SRAM recording of the data.
- The spikes seen are the markers between channels.

Card has been exchanged (Note: had 5 similar cases in Run 1)

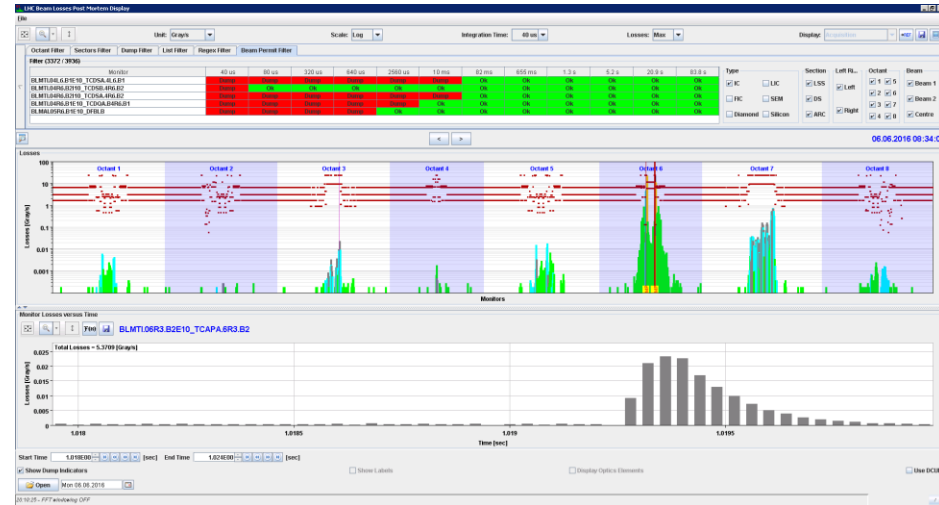
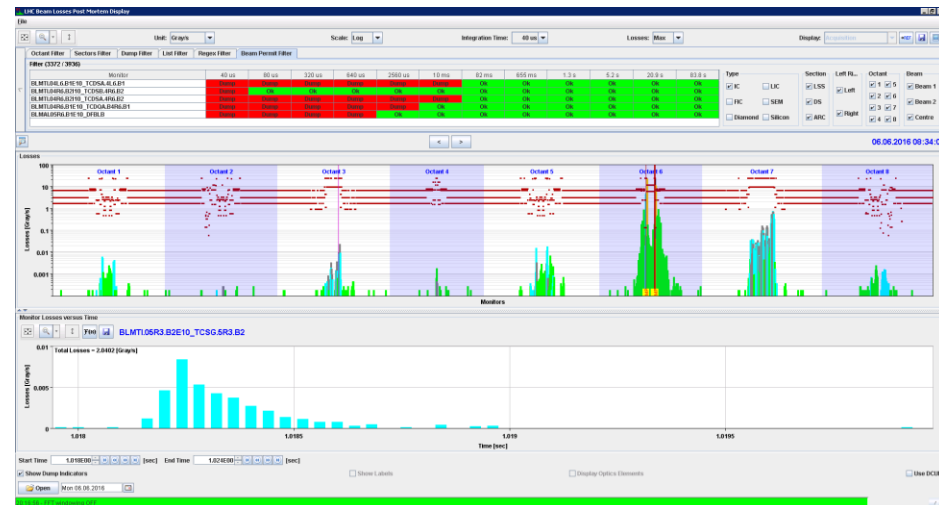
[BIBML-1249](#): PM data sometimes not in sync between crates

- In few of the PM data recorded it is visible 1 ms misalignment
- A common factor on those observed events is that the BeamDumped1 & 2 events had a ms difference
- One possible explanation is that the PM data for the misaligned crates have been readout from a different buffer than the rest
