Validation of redundant UPS power distribution during HWC'17: Test results

I. Romera (TE-MPE), V. Chareyre (EN-EL)

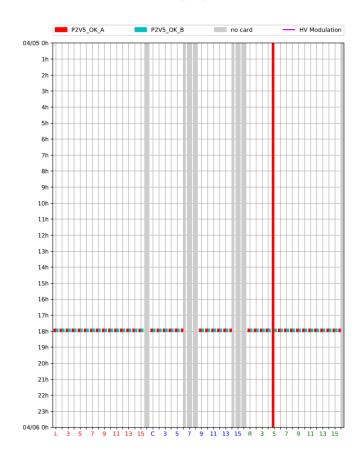
IP1 P2V5 OK

Report showing the status of one of the 2.5V power supplies in the BLM-R crate in IP1

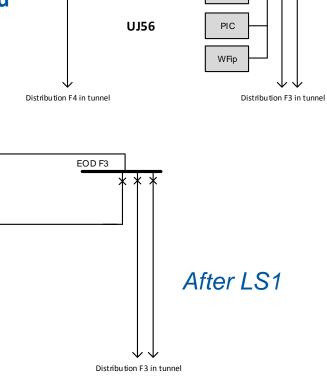
- F3 switchboard left in UJ56 and UJ76 because tunnel distribution remained unchanged
- Racks in UL55 and TZ76 connected to F4 switchboard installed in the same zone while they should be connected to F3 network

- New procedure was highly appreciated by most of UPS users as simplifies the validation of Machine Protection Systems and reduces collateral effects
- Impact on cryogenics is reduced compared to the old procedure (e.g. redundant 24V DC power supplies only partly switched off) and recovery time estimated to 3-4 hours for powering tests / 1.5 days for final physics configuration (2nd option chosen this year).
- Less and less non-conformities revealed during the 3rd campaign
- Non-negligible effort to prepare the new test campaign and impact on powering tests
 - => MPP to review the necessity of repeating these tests on a yearly basis
 - => MPP to decide what to do with singularities affecting powering of MPS in UL55 and TZ76
