European-XFEL Power Coupler status

June, 27-28, 2017

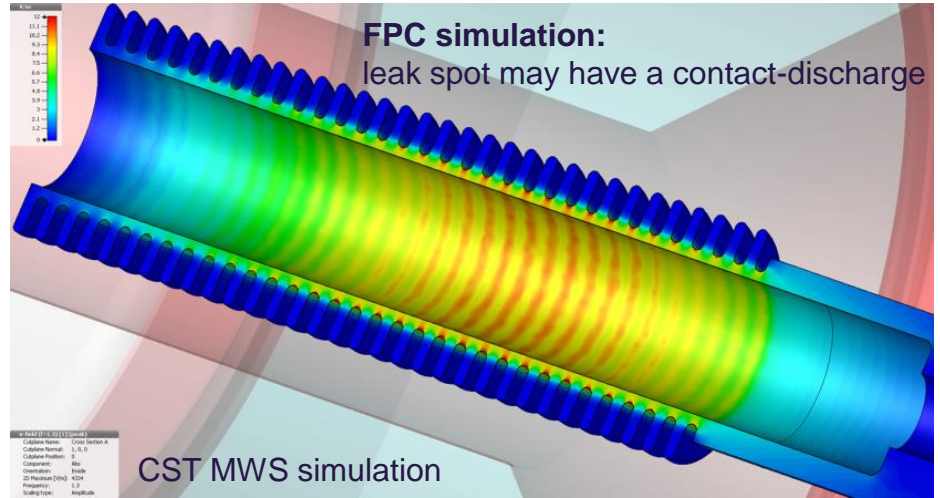
FPC coax-gasket:
capacitors are replaced

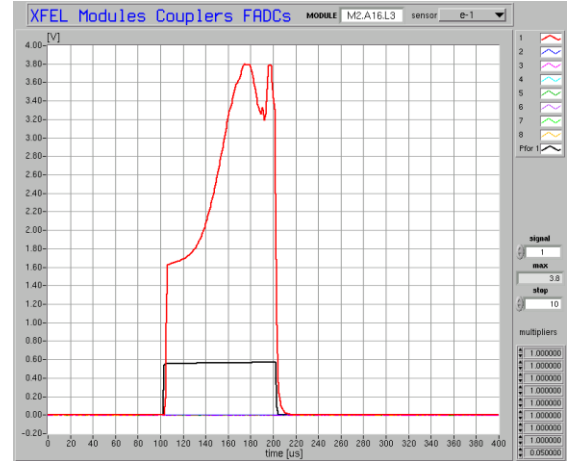
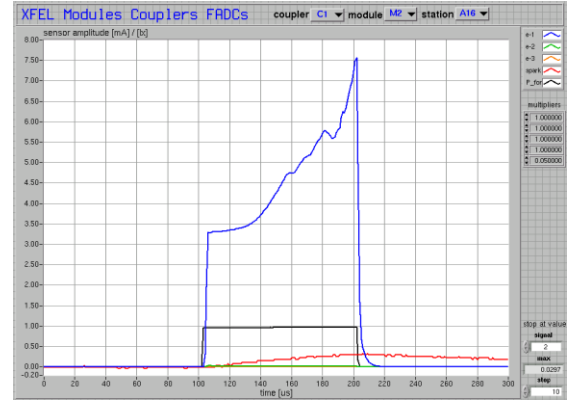
A16.M2.C1.e- ADC signals:

XTL A16.M2.C1
 warm coupler conditioning
 cold part problem example

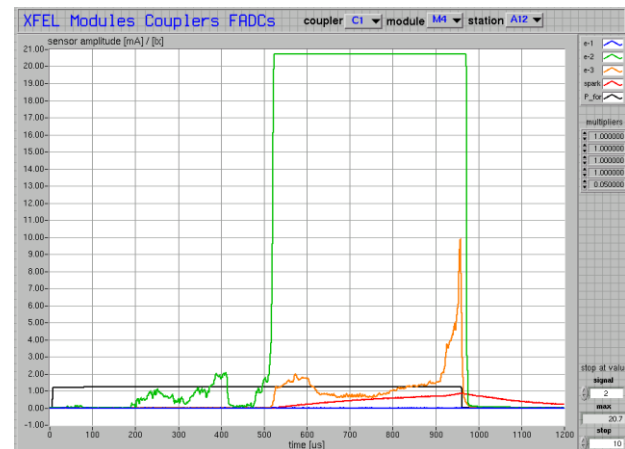
A12.M4.C1.e- ADC signals:

XTL A12.M4.C1
warm coupler conditioning
warm part problem example

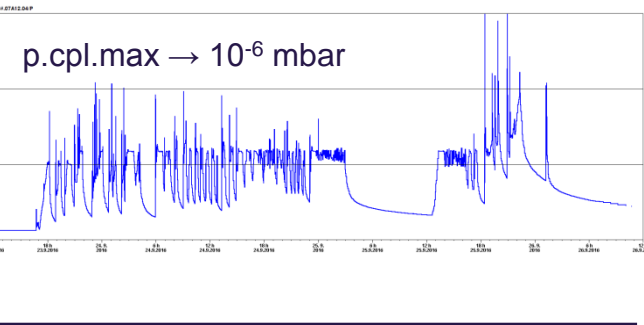
A12.M4 bad coupler vacuum as well:

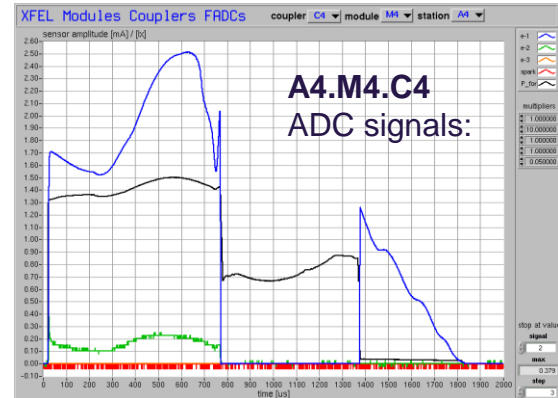
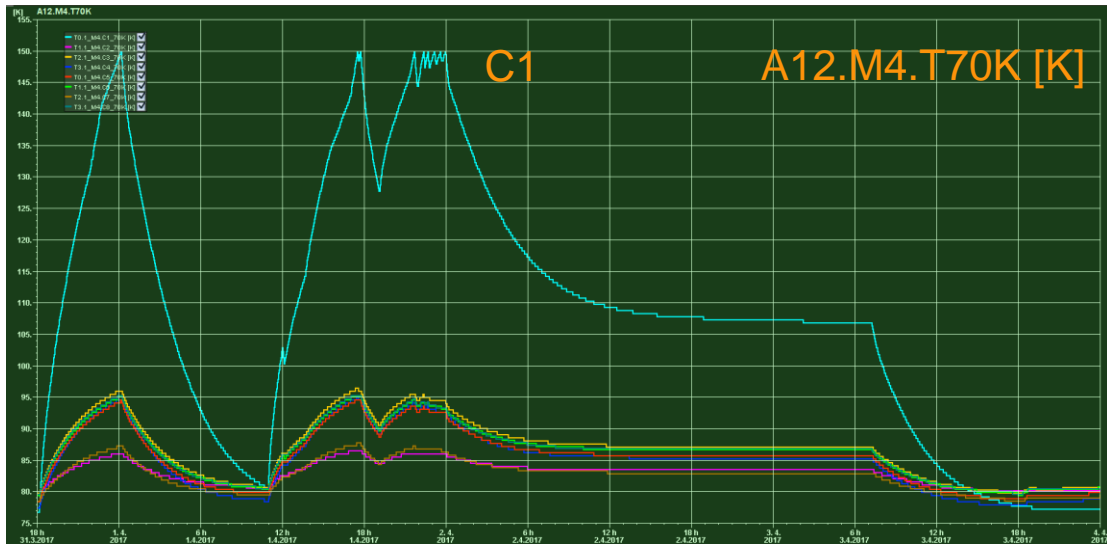
XTL A4.M4.C4
T70K overheating and RF discharge (at cold)

both couplers shorted

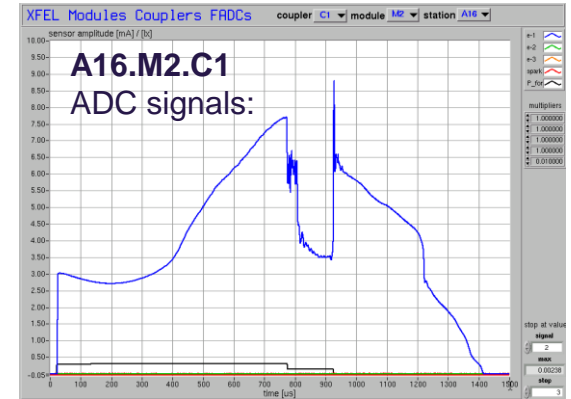
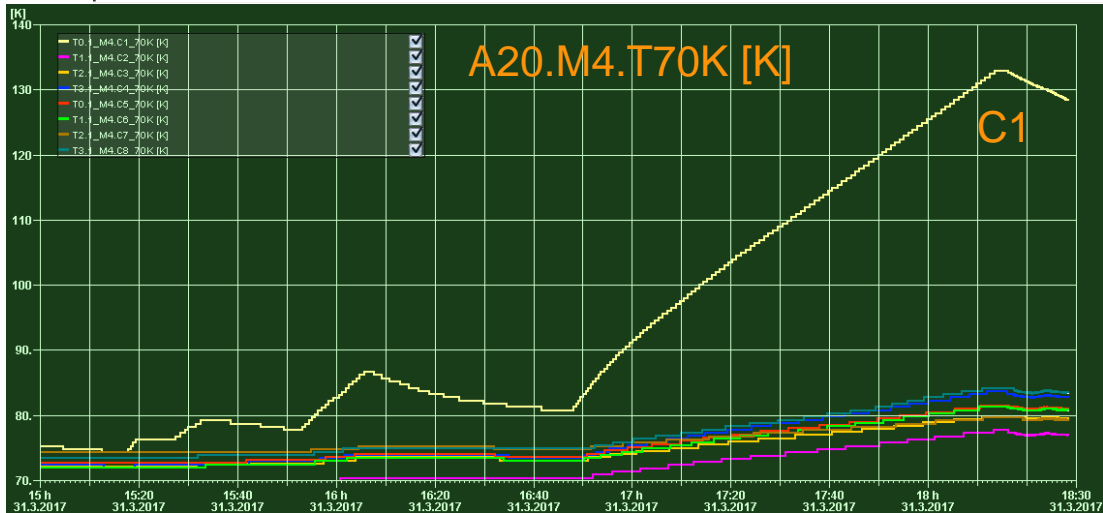
both couplers shorted

XTL A16.M2.C1
T70K overheating (at cold)

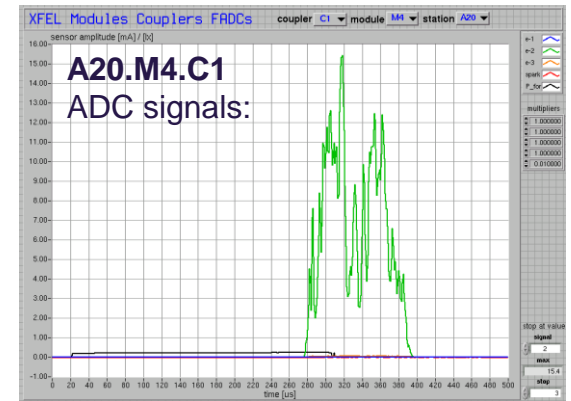
XTL A20.M4.C1
T70K overheating (at cold)

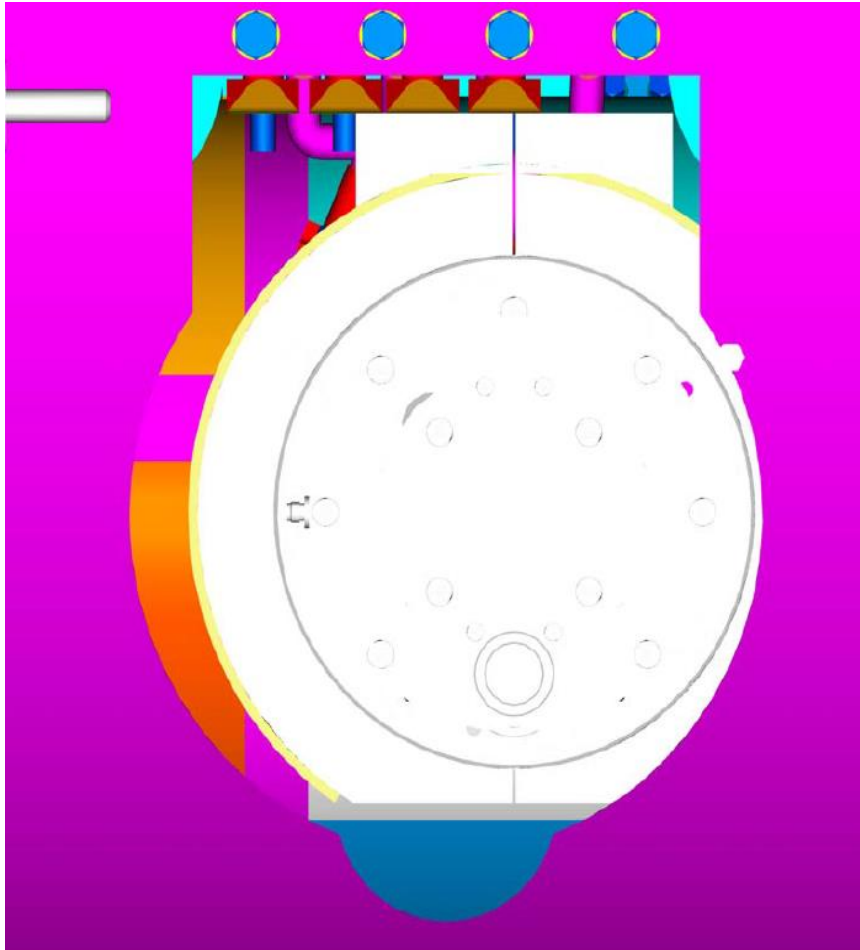
FPC WP shift may be limited by module 80K shields

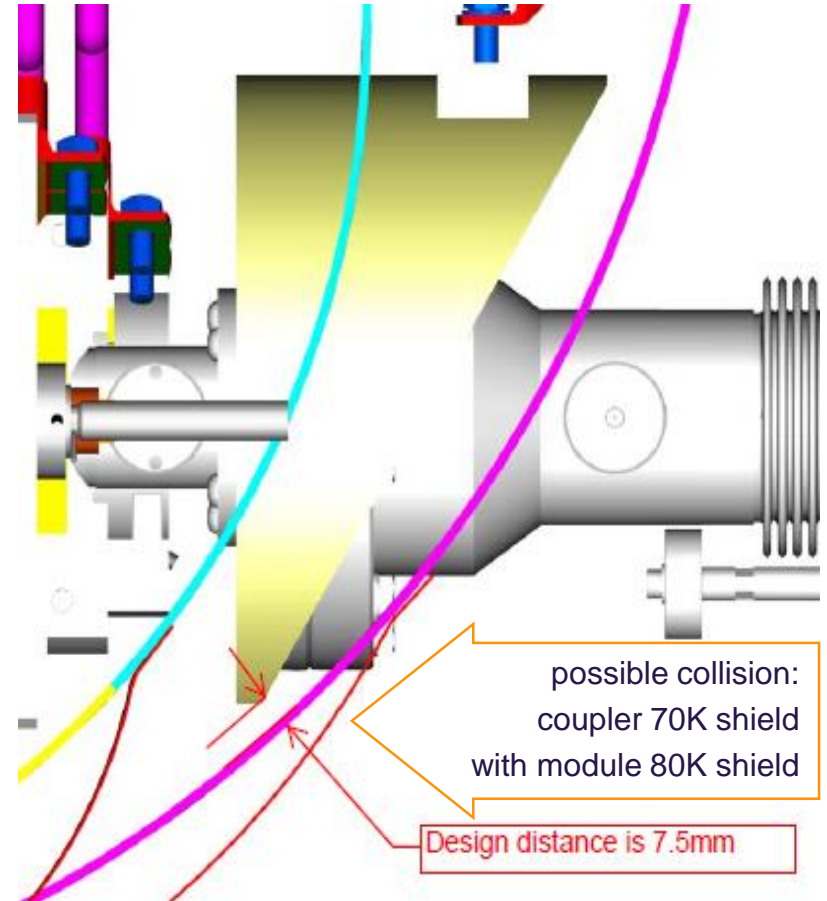
example - cavity 1 layout

possible collision:
coupler 70K shield
with module 80K shield

Design distance is 7.5mm
